**Intersection Safety Study
Milford Parkway & Chamber Drive
Milford, Ohio**

**Milford Parkway & Chamber Drive/River's Edge Road
Clermont County, Ohio**

**Prepared For:
The City of Milford
745 Center Street, Suite 200
Milford, OH 45150**

February 2009

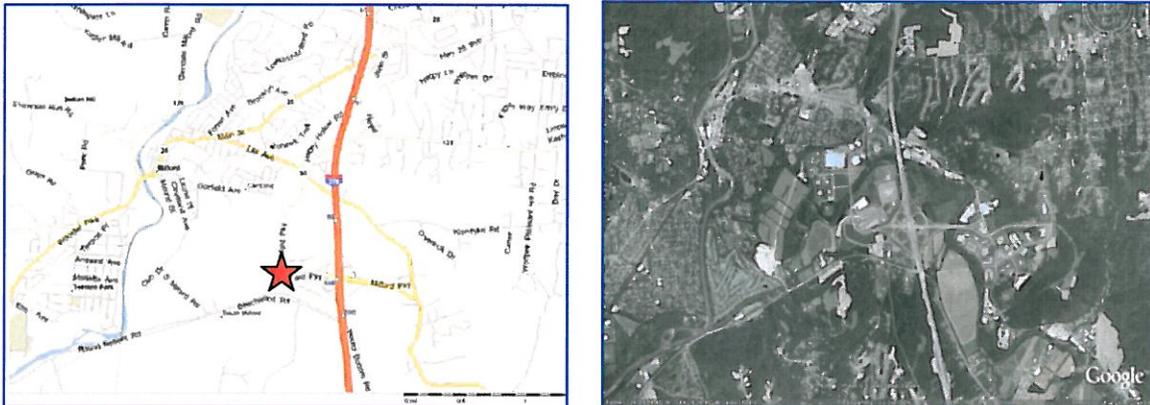
Figure 1: Vicinity Map and Aerial Photograph

Milford Parkway is a major route connecting I-275 to the City of Milford. This intersection is a signalized intersection and is also the connection from I-275 to large shopping centers on either side of Milford Parkway. *Figure 1* shows a vicinity map and aerial photograph of the intersection.

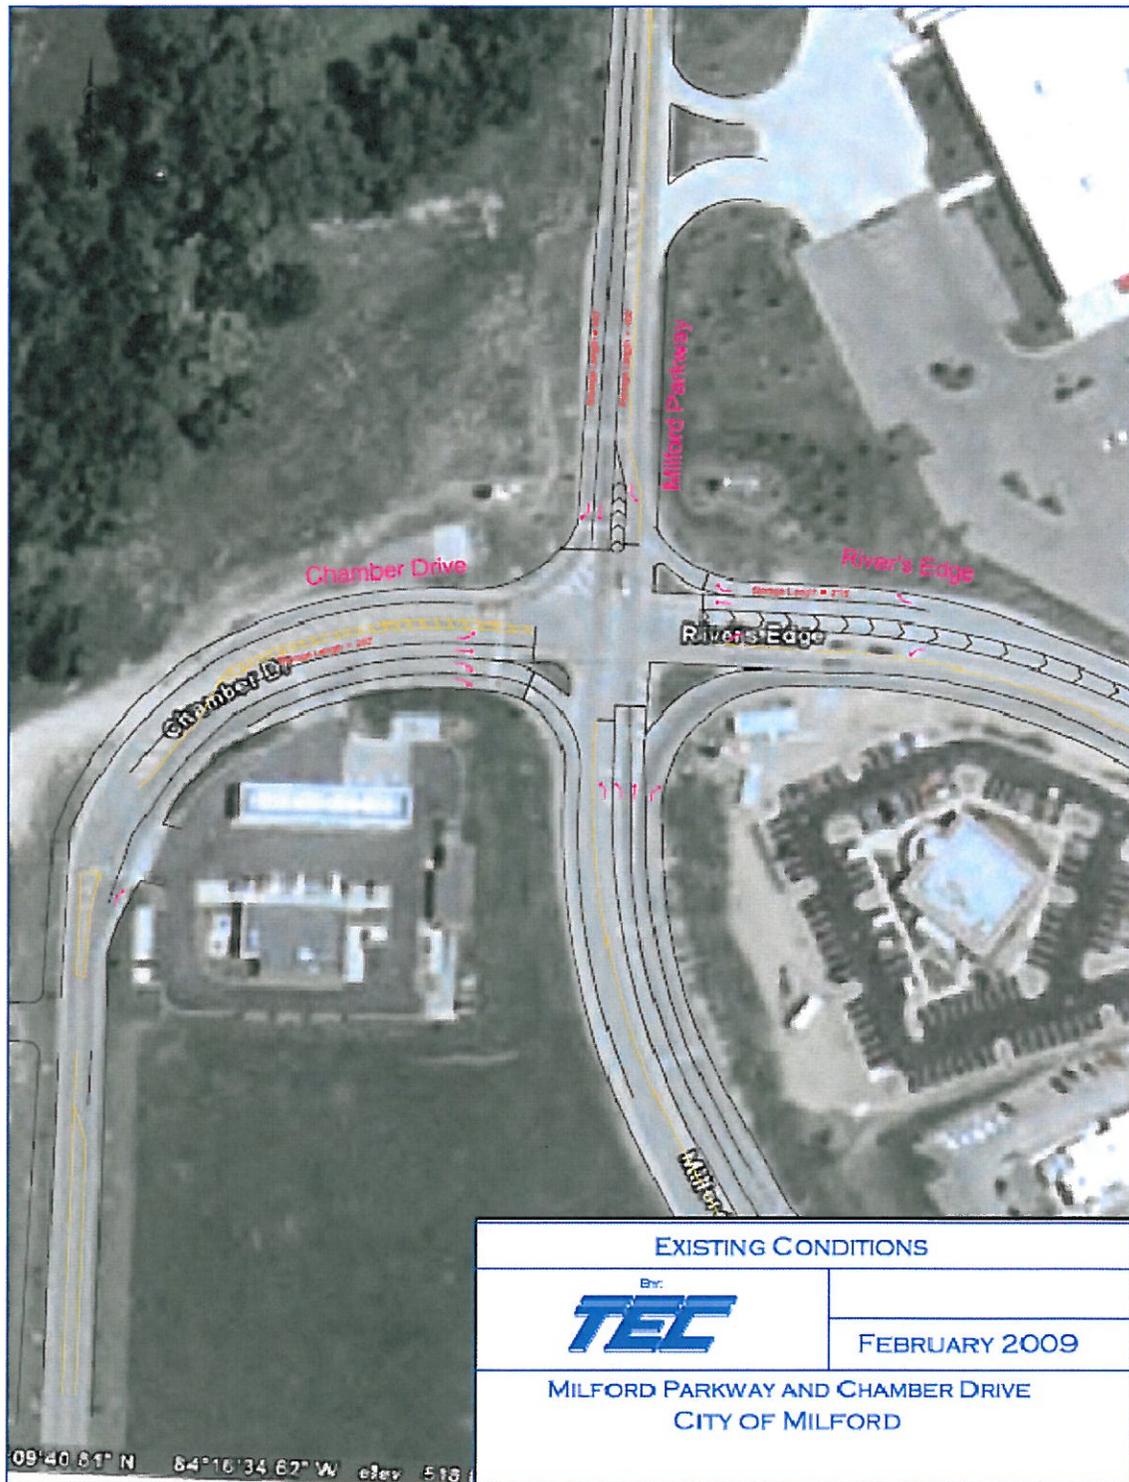
Figure 2: Existing Conditions

All approaches have both left and right turn lanes with northbound dual left turn lanes and eastbound dual right turn lanes. The pavement markings and signage near the intersection are in good condition. *Figure 2* shows the existing lane configuration. Intersection pictures are provided in *Appendix A*.

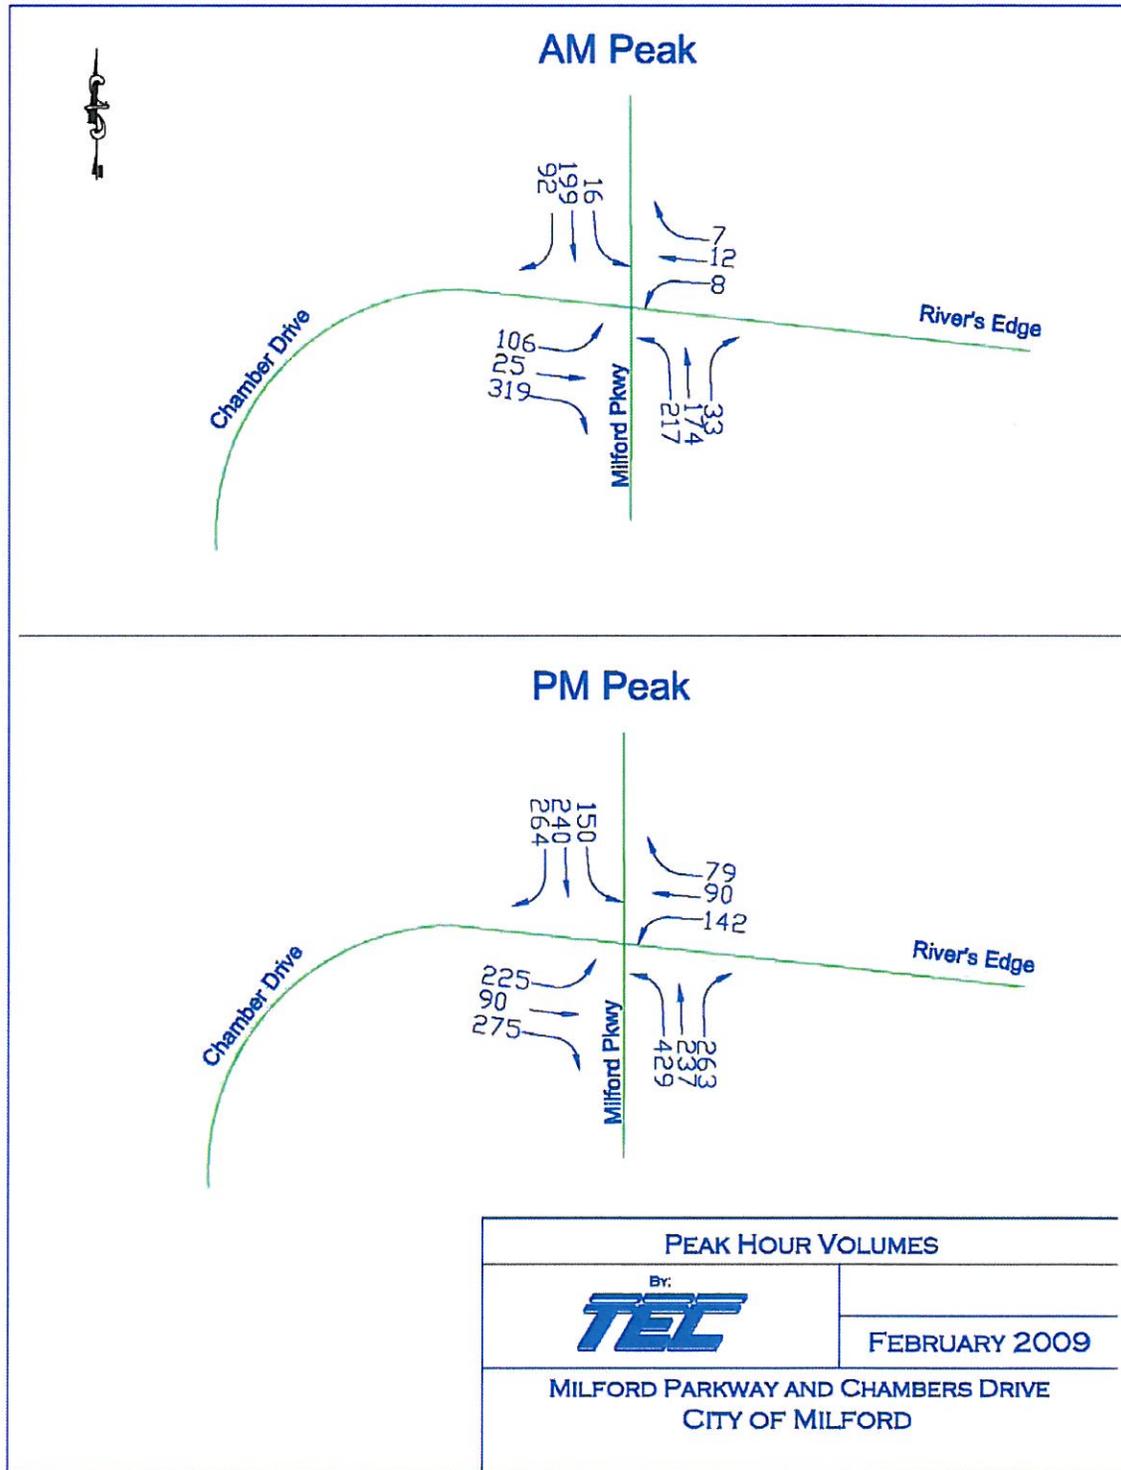
Figure 3: Peak Hour Volumes

Figure 3 shows the existing peak hour turning movement volumes at the intersection. Full traffic count data is provided in *Appendix B*.

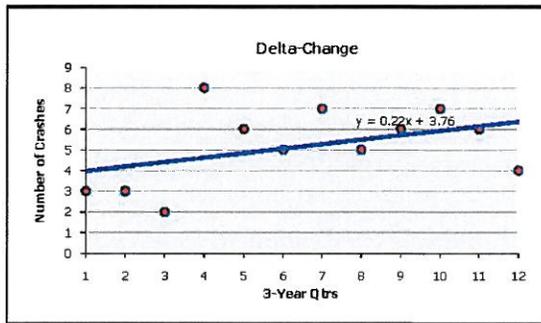
Delta Change			
	1	2	Quarter
3	6	6	1
3	5	7	2
2	7	6	3
8	5	4	4
1,400	-0,100	-0,700	ΔYear
	1,100		ΔChange

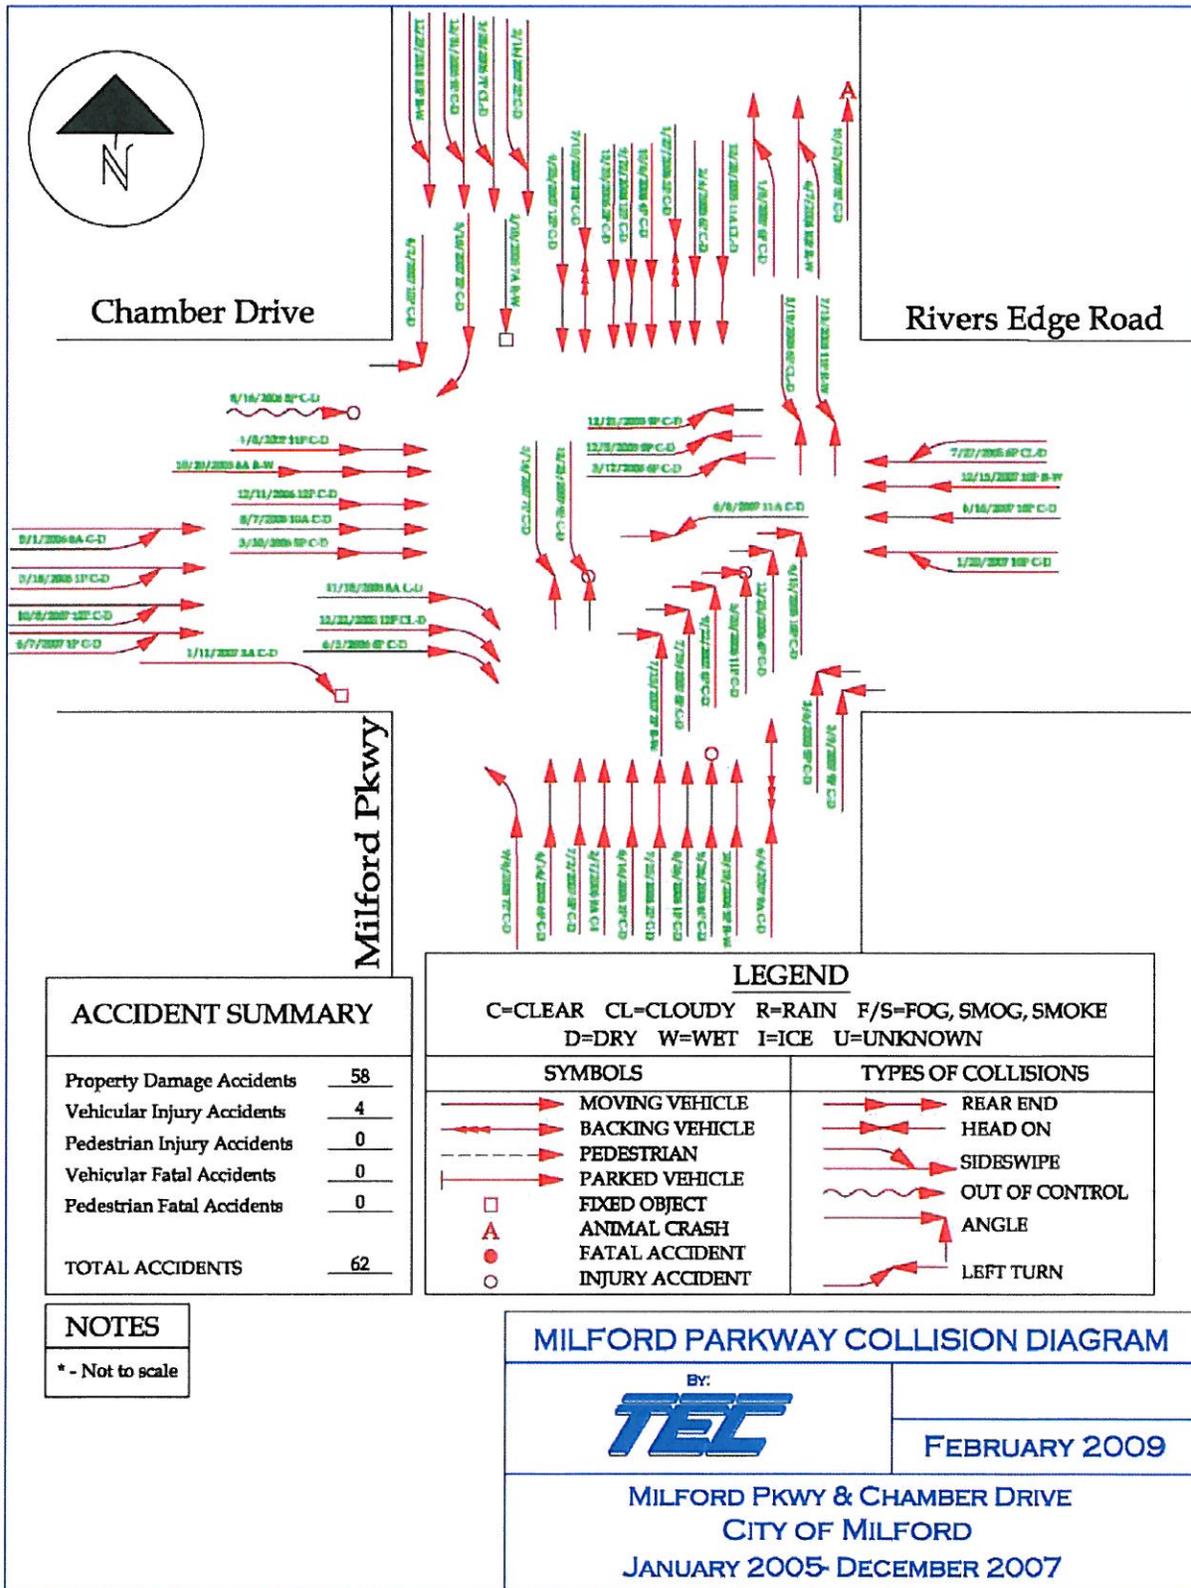
Figure 5: Collision Diagrams

The crash reports were grouped using several different criteria, including crash type, severity and environmental conditions among others. Collision diagrams were created to provide a visual depiction of the accidents. The crash summaries are provided in *Figure 4* and the collision diagrams are shown in *Figure 5*. More comprehensive crash data is presented in *Appendix C*.

The predominant crash type along this section during the study years was rear end. Forty percent (40%) of the accidents were rear end accidents. The other accident types included Angle (23%), Sideswipe/passing (19%), Fixed Object (5%), Head-on (5%), Backing (5%), Animal (2%) and Other/Non-collision (2%).

The most prevalent crash type at this intersection is rear end crashes. Possible causes for rear end crashes include driver inattentiveness and signal timing problems and excess speed. Poor visibility, especially around the curve on Chamber Drive can also be a factor in these crashes.

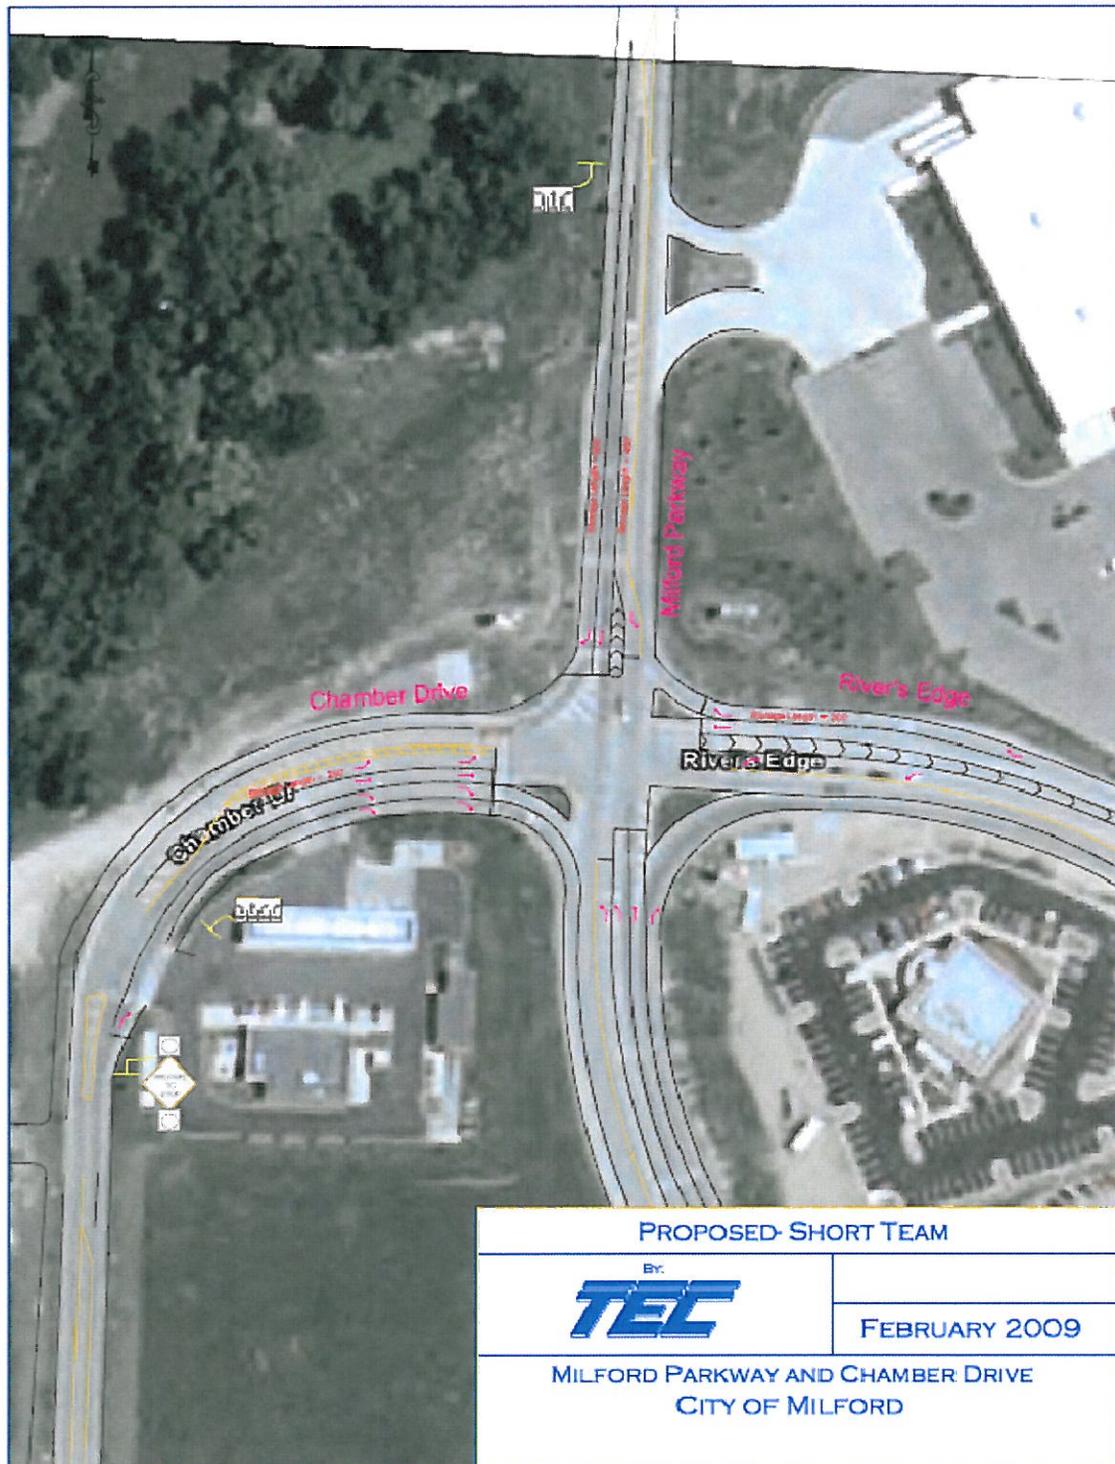
Figure 6: Short Term Schematics

The second short term recommendation is to install additional lane use signs. Additional signs should be installed on EB Chamber Drive and Southbound Milford Parkway. The signs will better advise drivers of which lane to be in before they get to the intersection. This will decrease the number of sideswipe/passing accidents which often occur when drivers change lanes abruptly. The cost for this improvement is approximately \$300.

The third short term recommendation is to install a “Prepare to stop when flashing” sign for EB Chamber Drive. Due to the curvature of the road, the signal is not visible upon approaching. A flashing sign would make the drivers more aware of the signal ahead. The cost for this improvement is approximately \$8000.

The fourth short term recommendation is to revise the location of the stop bars. An analysis was completed which determined that the left turn radii are not adequate for some approaches. The northbound left most turn lane should be moved back 20 feet. The southbound left turn lane should be moved back 10 feet. The westbound left turn lane should be moved back 20 feet. The cost for this improvement also includes the replacement of the loop detectors. The cost is approximately \$8800.

The final short term recommendation is to increase the storage lanes to the lengths recommended in *Section 4D*. Two of the storage lanes are not built to the recommended standard. The westbound right turn lane and the eastbound left turn lane. The eastbound left turn lane cannot be lengthened due to the westbound left turn lane into the UDF parking lot. The westbound storage lane should be lengthened from 200’ to the recommended length of 300’. The approach will accommodate the longer turn lane with

just minor pavement marking changes. There is a 12 foot section of pavement that was previously a left turn lane and is now a striped island. The thru lane can be shifted over slightly into this striped area to accommodate a longer right turn lane. The total cost for this improvement is \$2,600.
