February 2009
TEC PN – 08095-002

**Intersection Safety Study
US 50 & SR 131/Milford Parkway
Milford, Ohio**

INTERSECTION SAFETY STUDY

**US 50 and SR 131
Clermont County, Ohio**

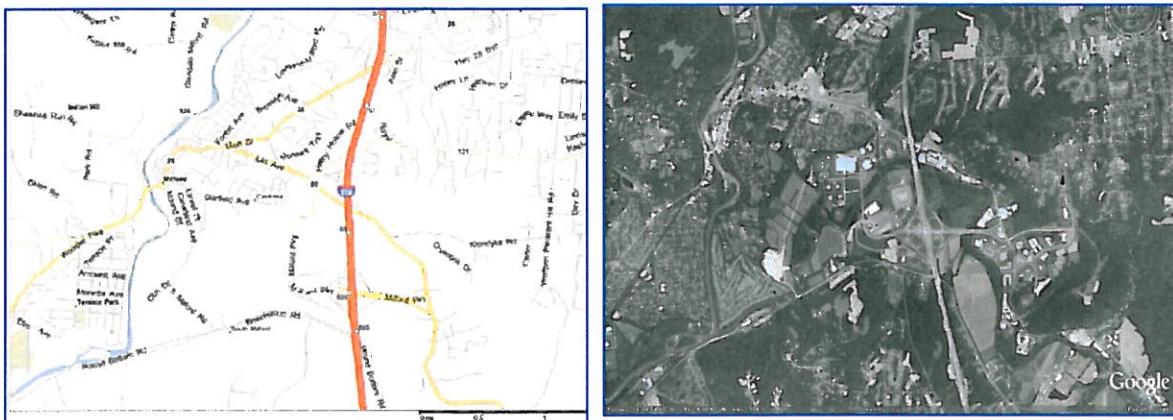
Figure 1: Vicinity Map and Aerial Photograph

US 50 is a major route running through Clermont County and is a major east-west connection to Cincinnati. Milford Parkway is the main connection from I-275 to the City of Milford. US 50 is not only the main road into Milford, it is also a main route to eastern Clermont County from the west. SR 131 connects Milford and I-275 to several towns including Newtonsville. *Figure 1* shows a vicinity map and aerial photograph of the intersection.

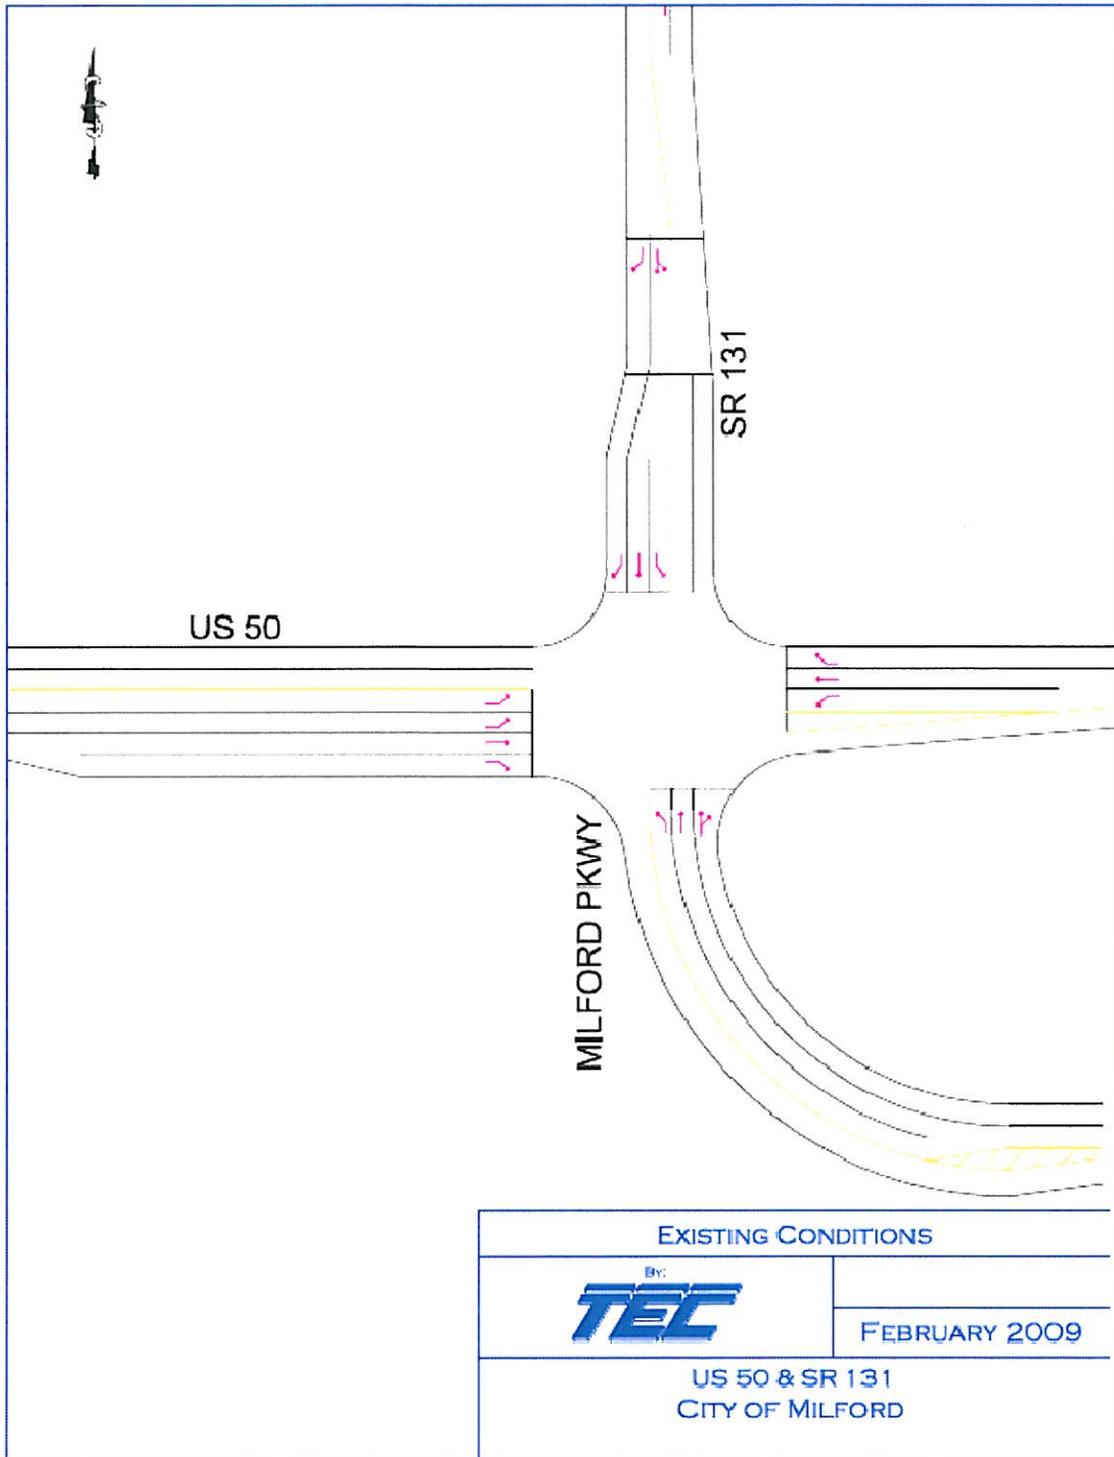
Figure 2: Existing Conditions

All approaches have both left and right turn lanes, with dual left turn lanes on eastbound US 50. The pavement markings and signage near the intersection are in good condition. **Figure 2** shows the existing lane configuration. Intersection pictures are provided in **Appendix A**.

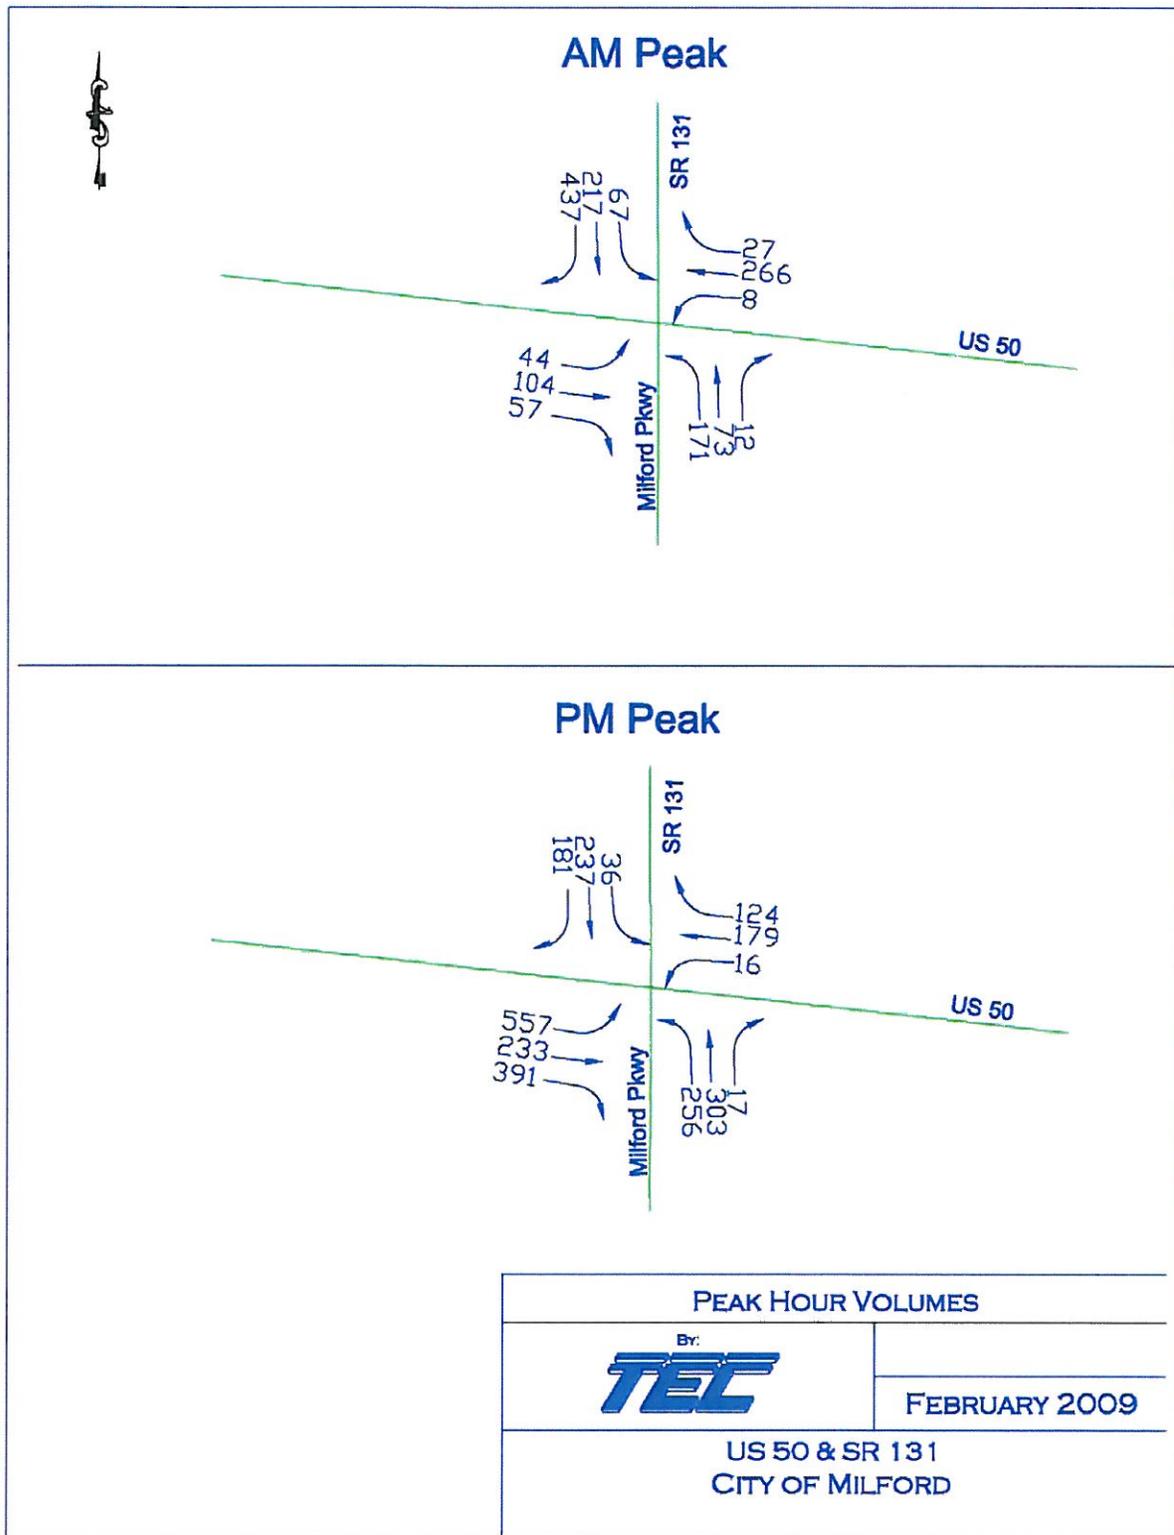
Figure 3: Peak Hour Volumes

The traffic pattern varies greatly from the AM Peak to the PM peak. During the AM Peak a higher number of vehicles are traveling from the north and east to the west. During the PM peak a higher number of vehicles are traveling from the west to the north and from the south to the west and north. **Figure 2** shows the peak hour turning movement volumes at the intersection. Full traffic count data is provided in **Appendix B**.

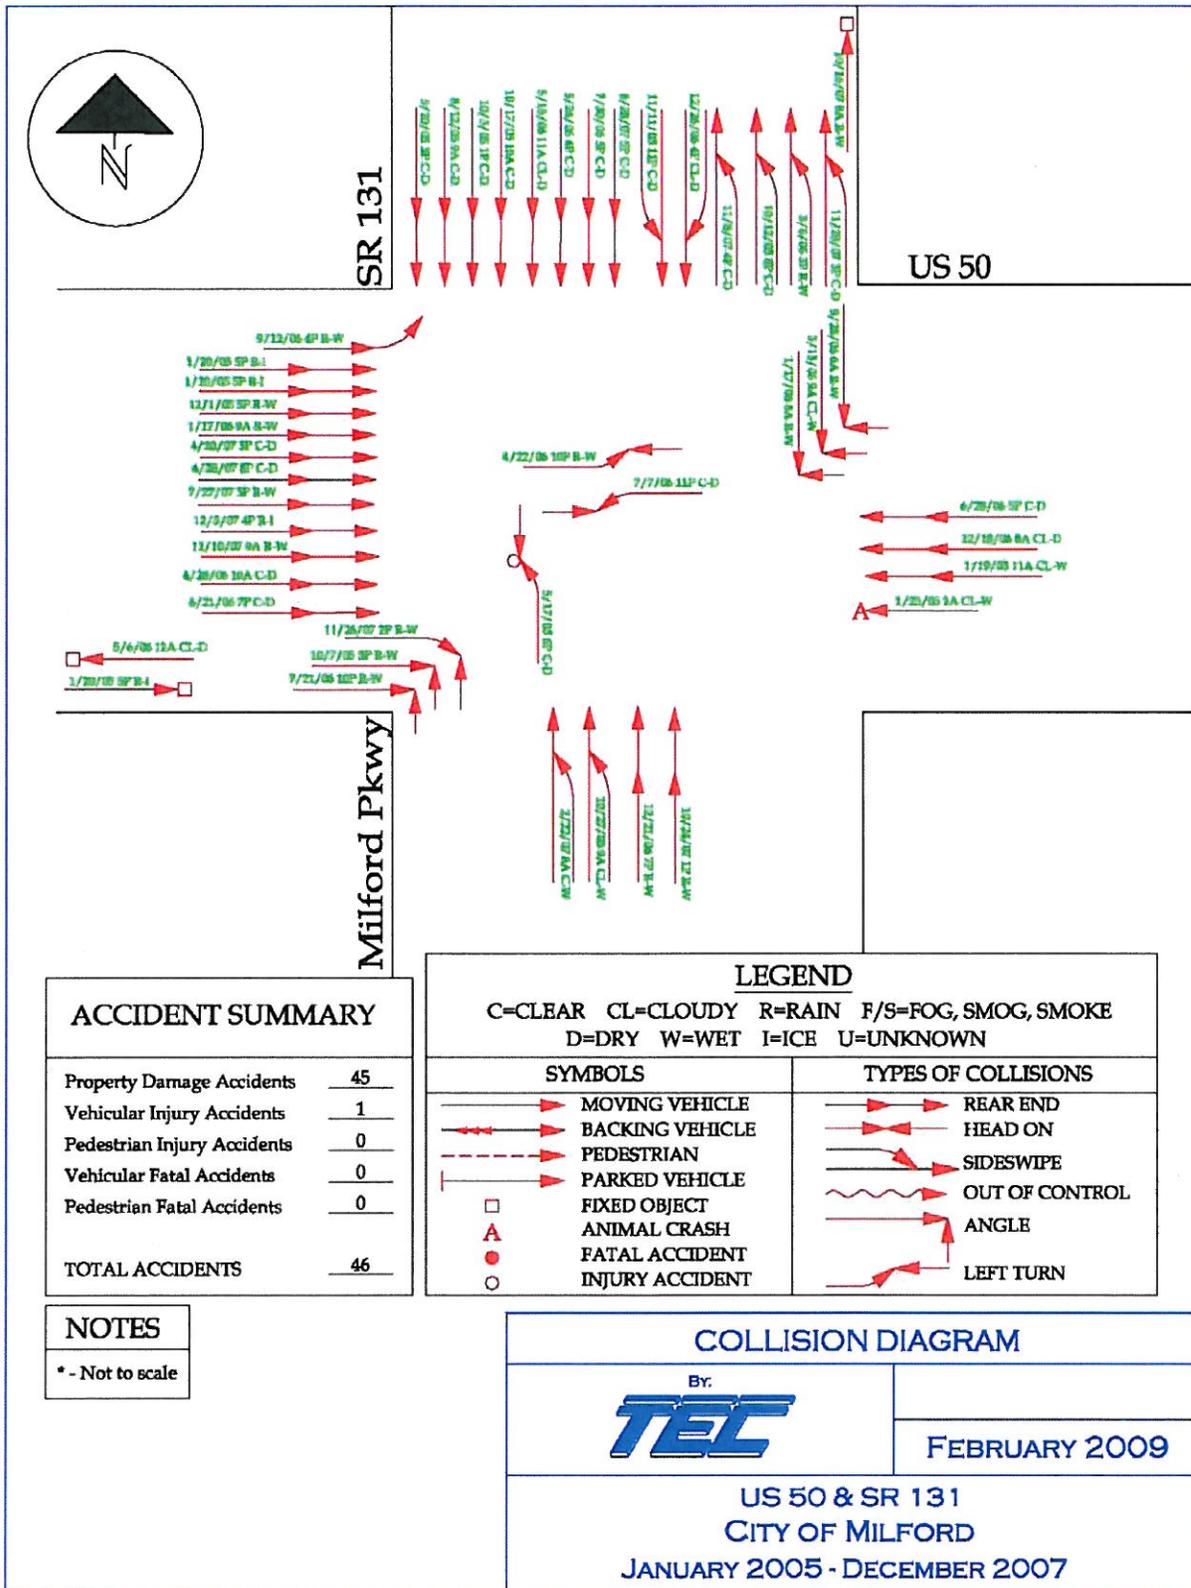
Figure 5: Collision Diagram

The crash reports were grouped using several different criteria, including crash type, severity and environmental conditions among others. Collision diagrams were created to provide a visual depiction of the accidents. The crash summaries are provided in *Figure 4* and the collision diagrams are shown in *Figure 5*. More comprehensive crash data is presented in *Appendix C*.

Several of the rear end accidents occurred after a lane change. This was especially true for southbound vehicles and is most likely due to inadequate lane signage and the jog in the lane.

Another common type of accident near this intersection is the sideswipe/passing accident. Several of these accidents occur on SR 131 north of the intersection. There are eastbound dual left turn lanes, which merge into one northbound lane a short distance from the intersection. This was the location of several accidents where drivers did not leave enough room to merge, or did not see the vehicle in the other lane.

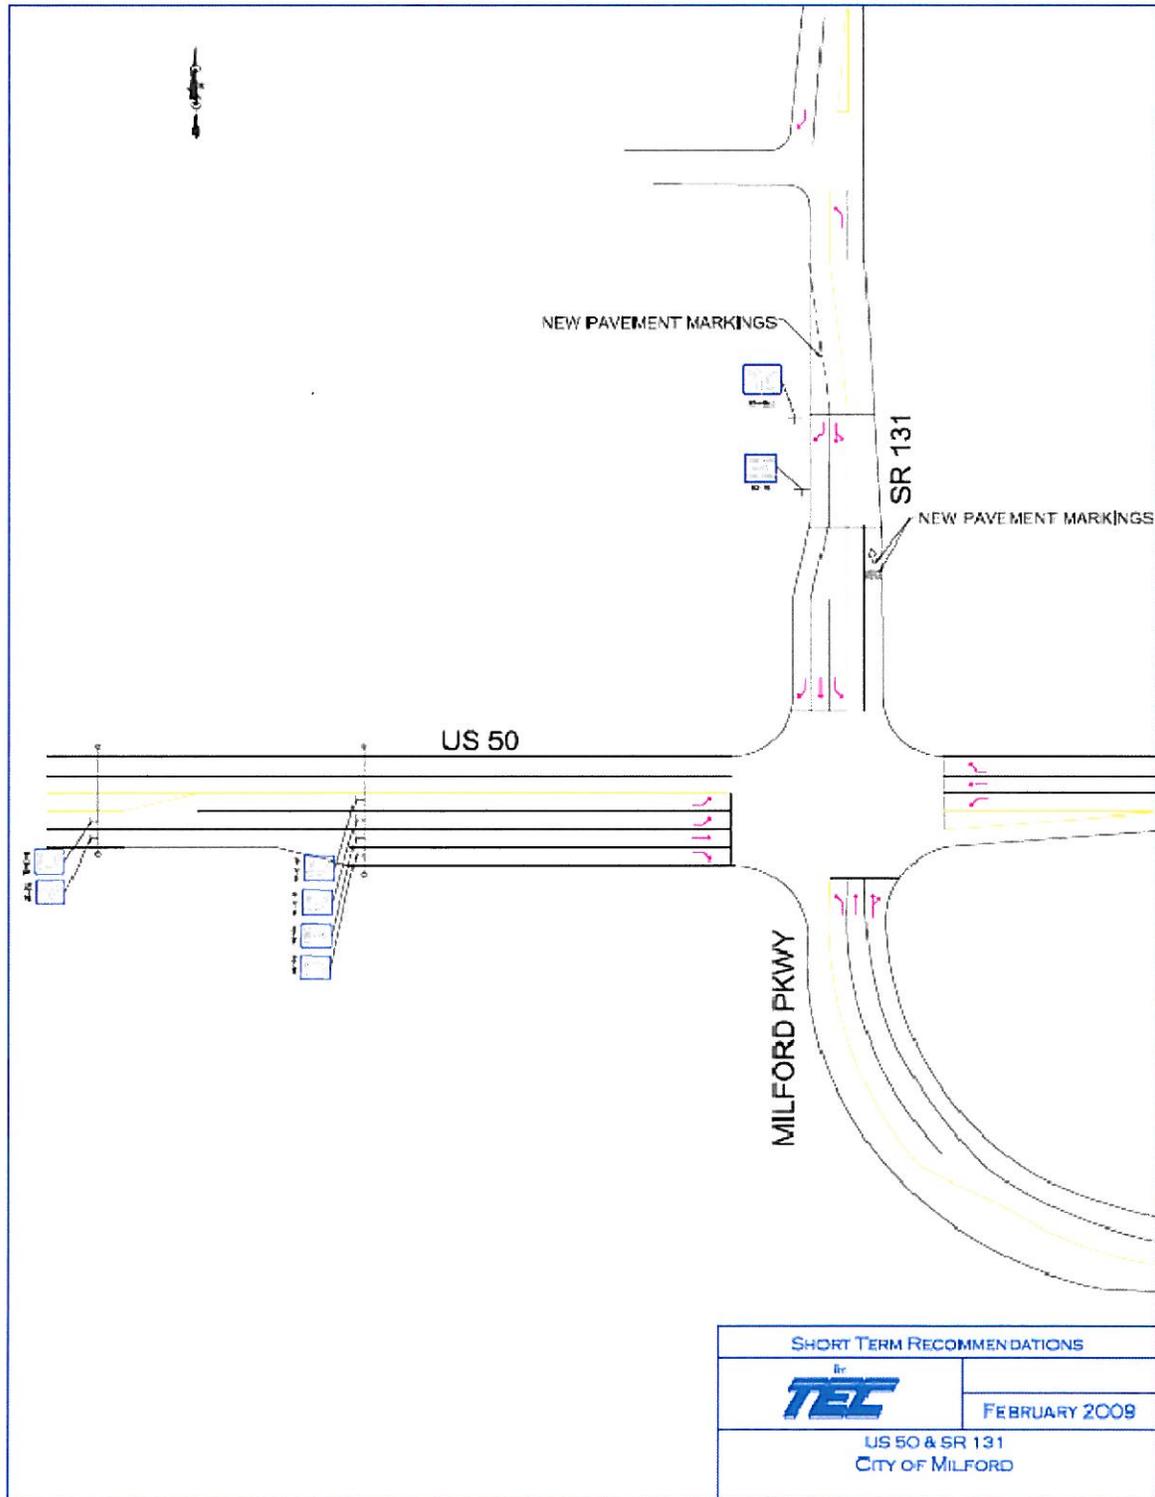
Figure 6: Short Term Recommendations

The third short term recommendations is to modify the pavement markings at the intersection. The following pavement marking modifications should be made for SB SR 131:

- Extend the channelize lane line
- Add a dotted line delineating the right turn lane to ensure drivers stay in the thru lane
- Add a “MERGE” warning and arrow to the pavement on the north side of the intersection

Figure 6 is a schematic of the short term recommendations. The cost for this improvement is approximately \$1,000. The total cost for the short term solutions, including a 20% contingency, is \$15,500 as shown in *Table 6*. The rate of return for the short term recommendations is 385%. See *Section 5* for additional rate of return discussion.

The second short term recommendation is to improve the signage. The eastbound approach should have overhead signage. There are currently two through lanes prior to the intersection. One of these through lanes becomes a left turn lane at the intersection. It is important that drivers are aware of this well before the intersection so they can maneuver into the correct lane. The overhead signage should be installed approximately 450 feet to the west of the intersection. The cost for this improvement is approximately \$11,500.

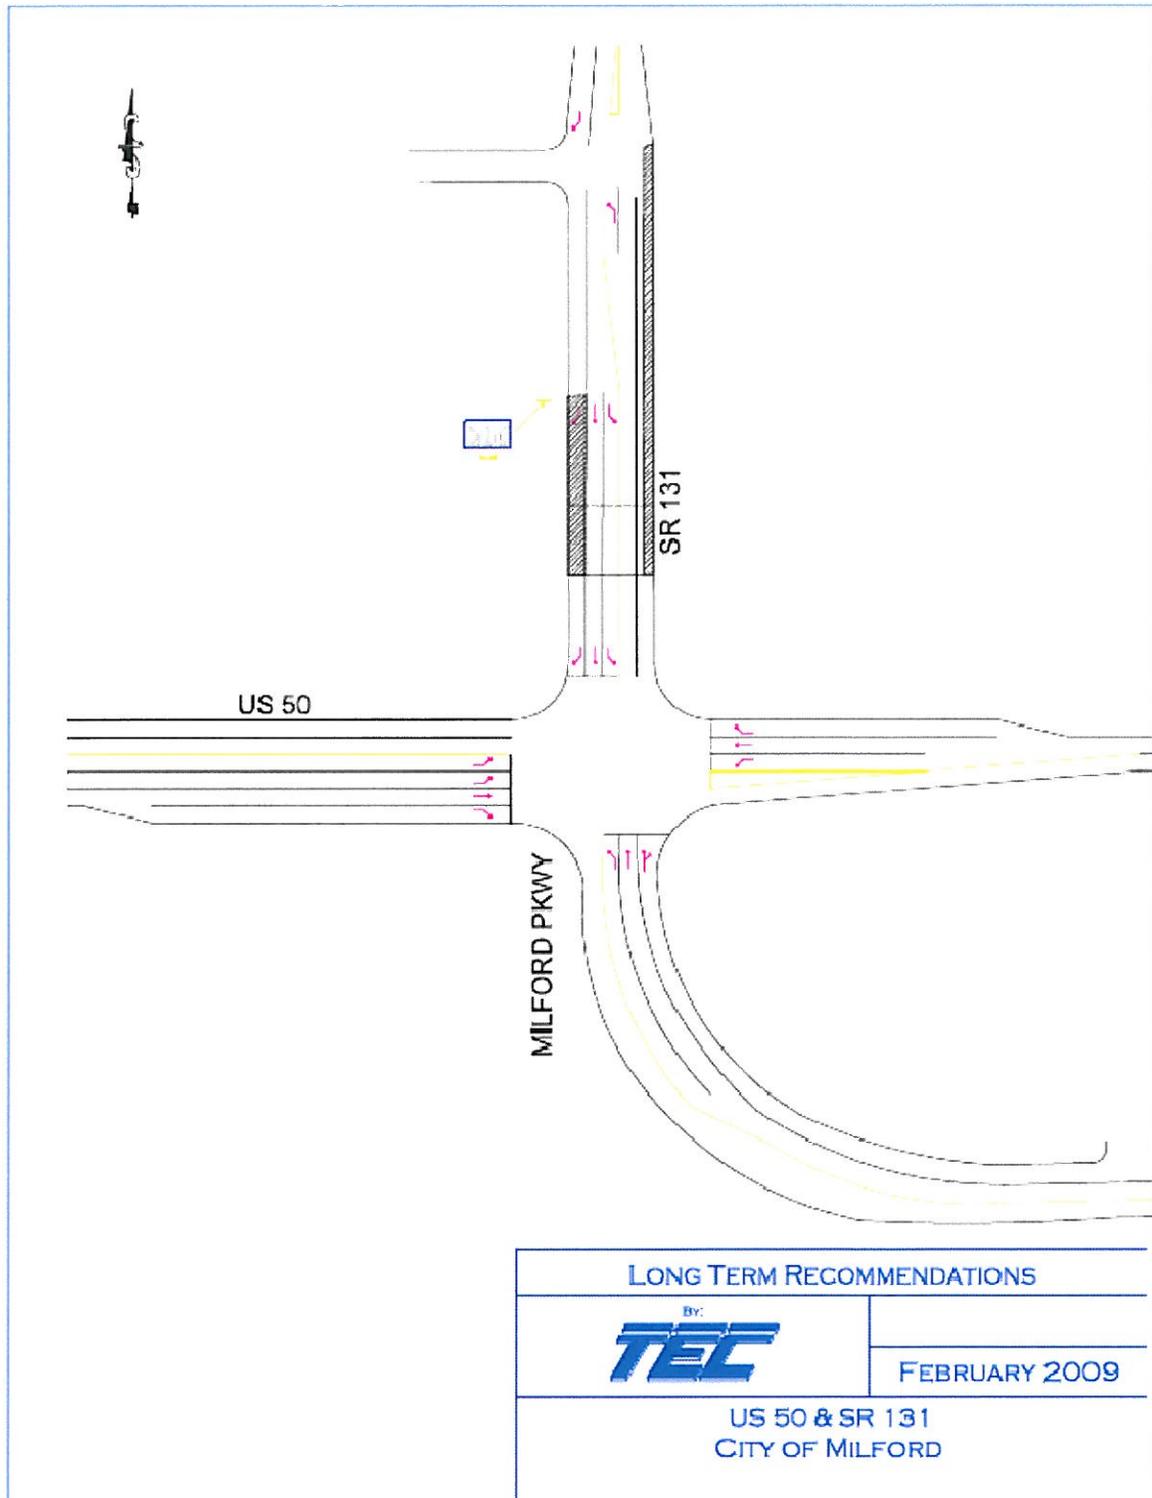
Figure 7: Long Term Recommendations

Widen the small bridge north of the intersection to better align the lanes. The road should also be widened north of the bridge to lengthen the merge or the two northbound lanes turning vehicles. This improvement will reduce the number of southbound rear end accidents, which can be caused by the abrupt lane changes as well as sideswipes from lane changes. This will also improve the conditions for the northbound traffic as it will increase the distance before the two inbound lanes merge to one lane which caused several sideswipe accidents during the study period. *Figure 7* is a schematic of the long term recommendations. The cost for this improvement is approximately \$1,422,000. *Table 7* shows the cost estimate for this improvement. The rate of return for the short term recommendations is -29%. See *Section 5* for additional rate of return discussion.
