Hall Run, Salt Run and Lower East Fork Little Miami River Preservation and Restoration Opportunities Inventory Report Clermont County, Ohio

January 2006

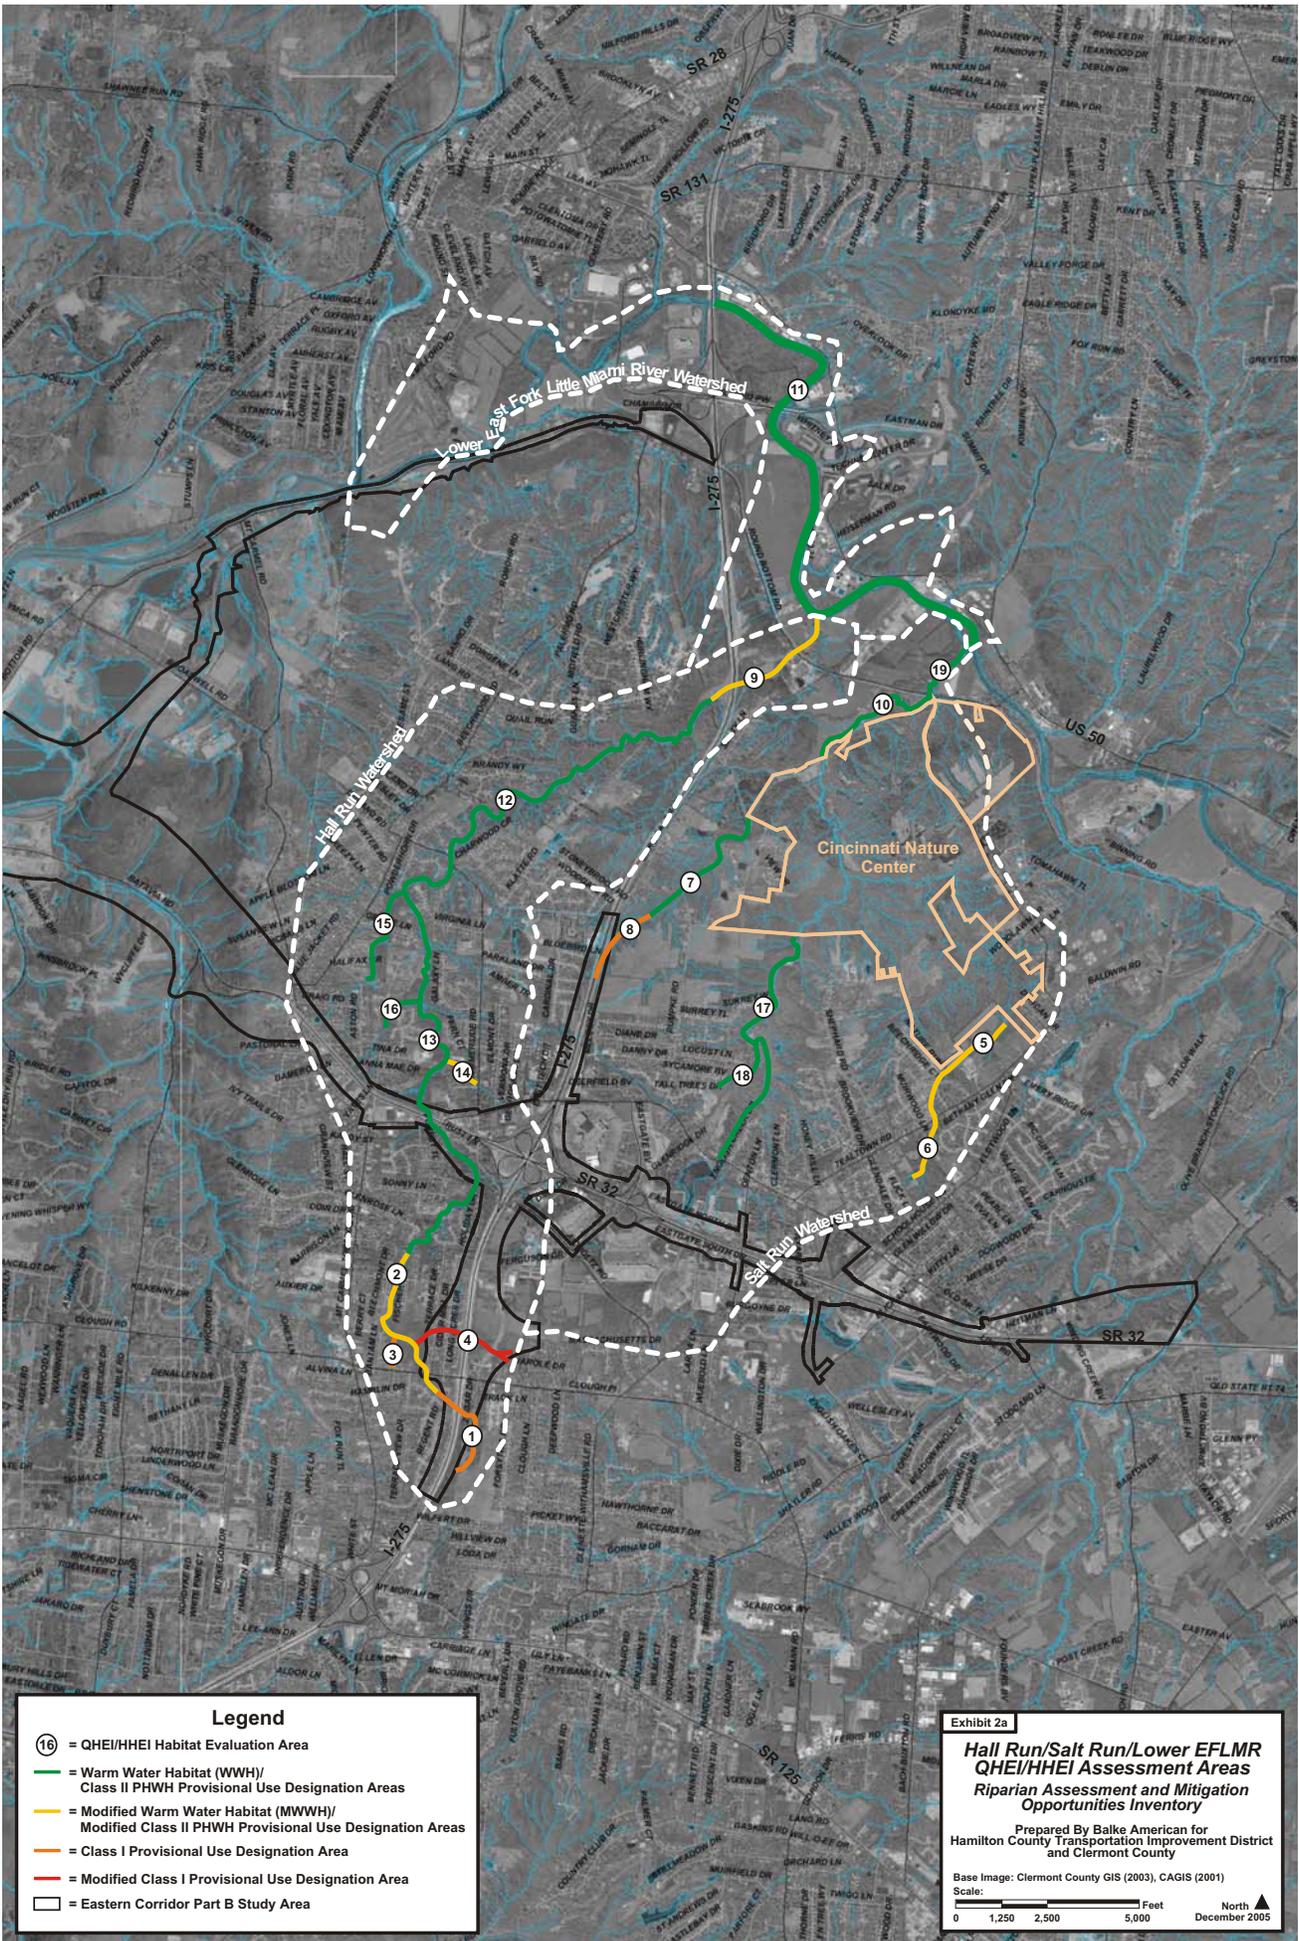
- ⑬ = QHEI/HHEI Habitat Evaluation Area
- = Warm Water Habitat (WWH)/ Class II PHWH Provisional Use Designation Areas
- = Modified Warm Water Habitat (MWWH)/ Modified Class II PHWH Provisional Use Designation Areas
- = Class I Provisional Use Designation Area
- = Modified Class I Provisional Use Designation Area
- = Eastern Corridor Part B Study Area

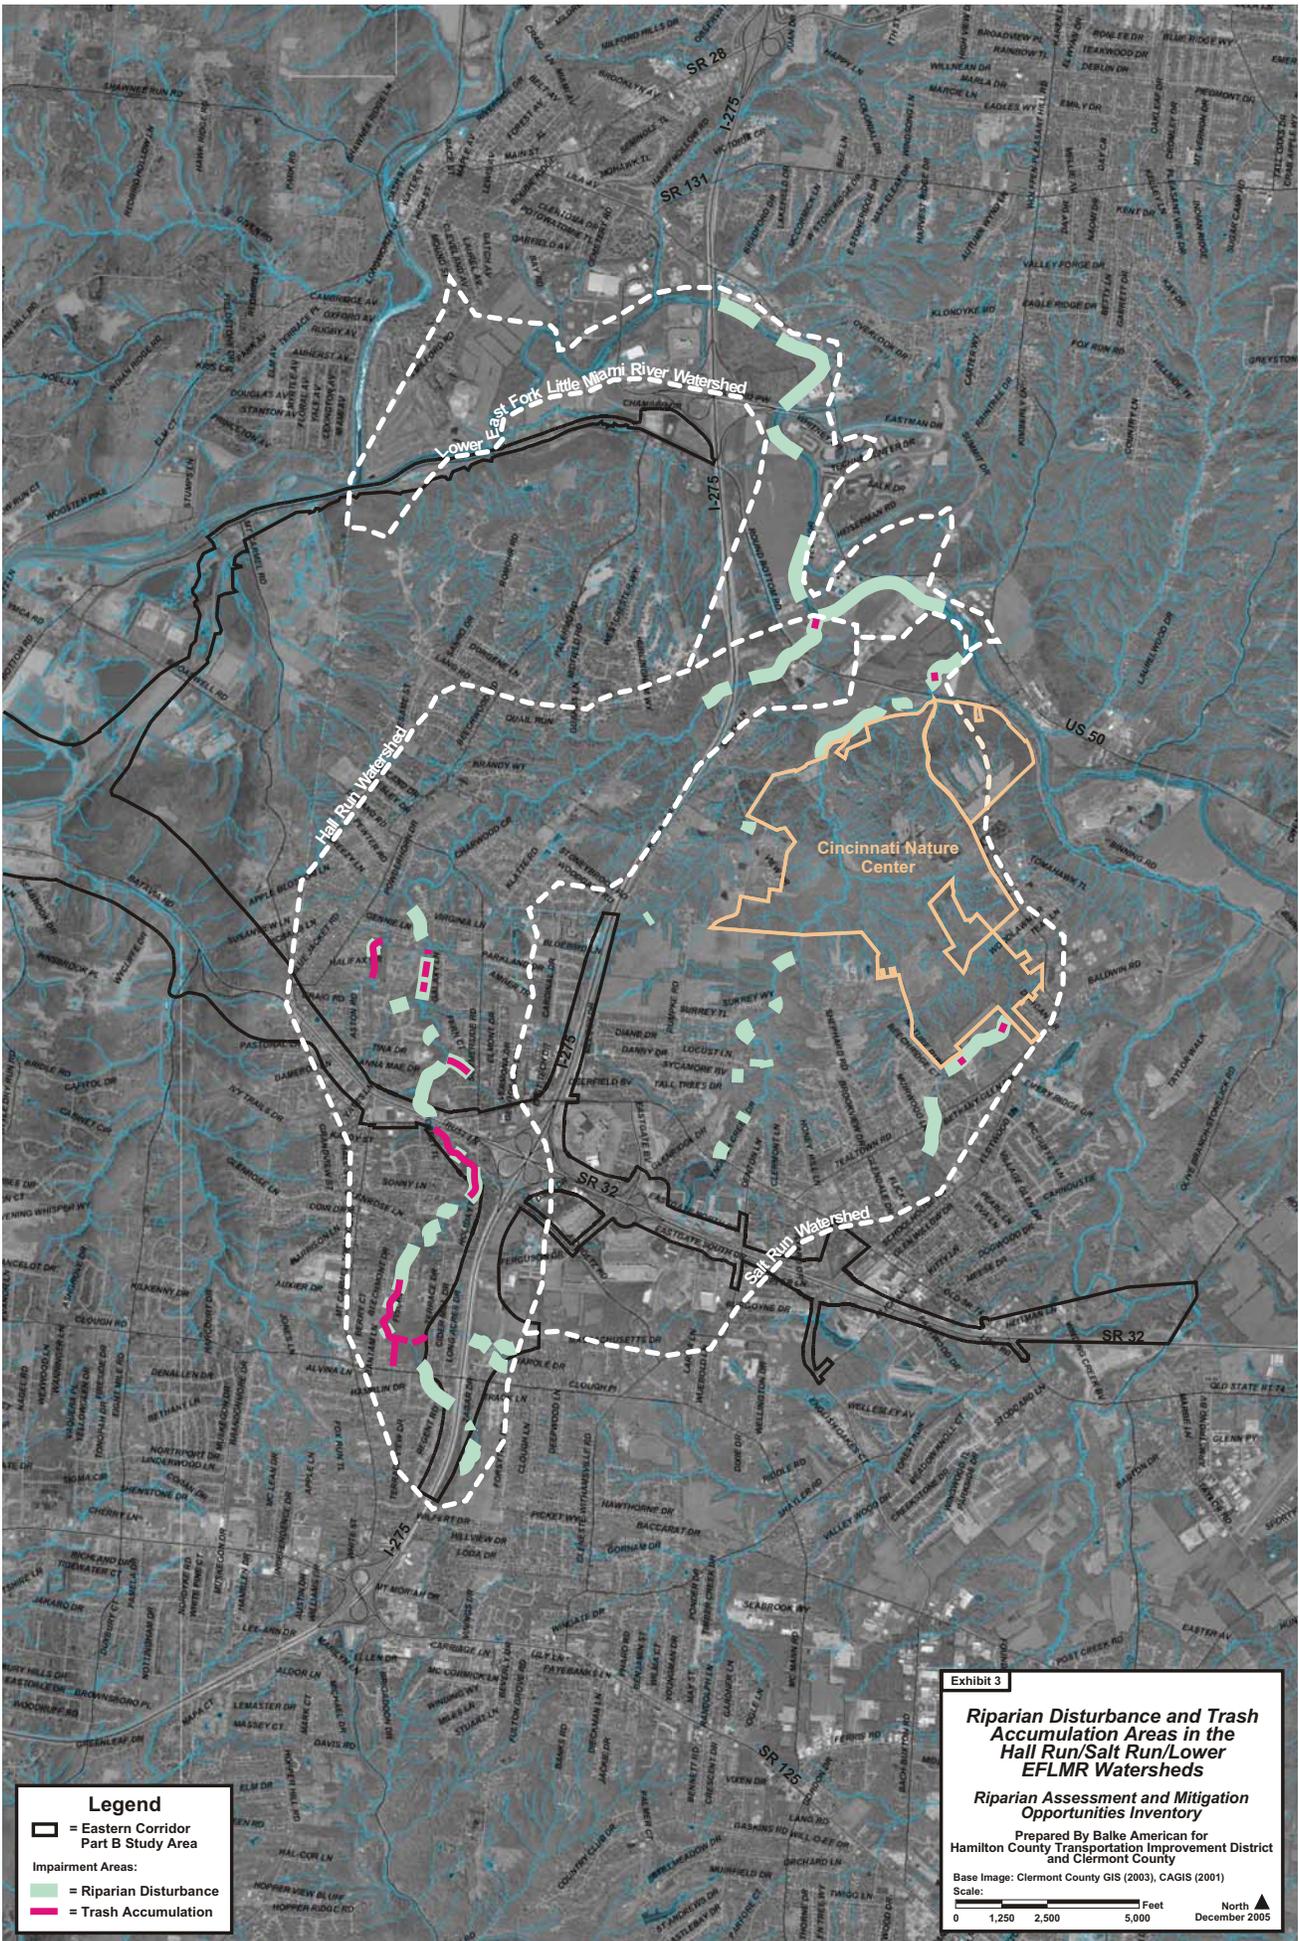
- = Eastern Corridor Part B Study Area
- Impairment Areas:**
- = Riparian Disturbance
- = Trash Accumulation

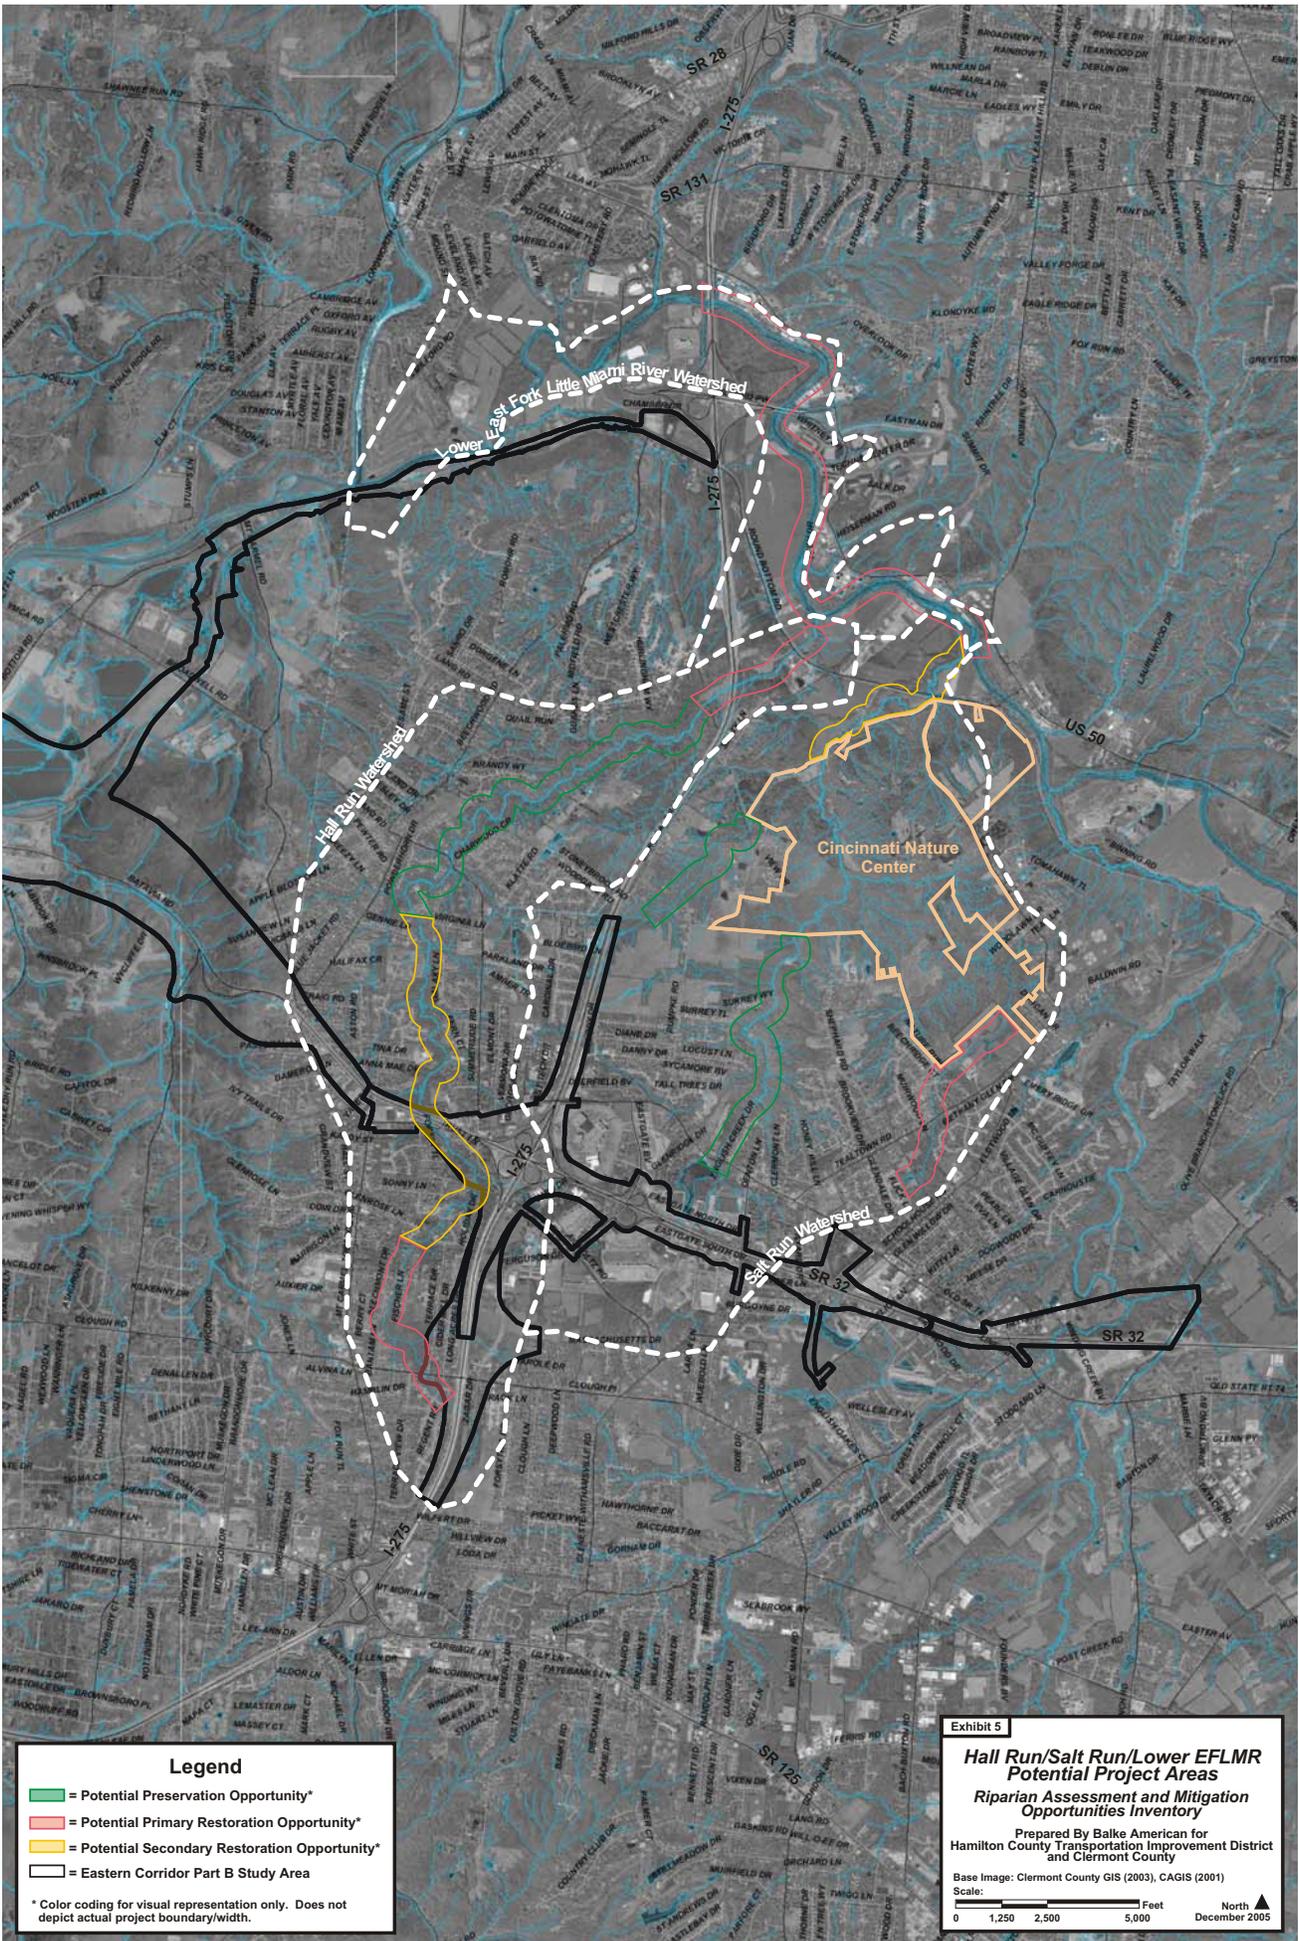
- █ = Potential Preservation Opportunity*
- █ = Potential Primary Restoration Opportunity*
- █ = Potential Secondary Restoration Opportunity*
- = Eastern Corridor Part B Study Area

A total of four potential projects (one preservation, two primary restoration and one secondary restoration) were identified for the Hall Run watershed based on existing conditions, and data gathered through walkover surveys, and QHEI/HHEI assessments (see Exhibit 5).

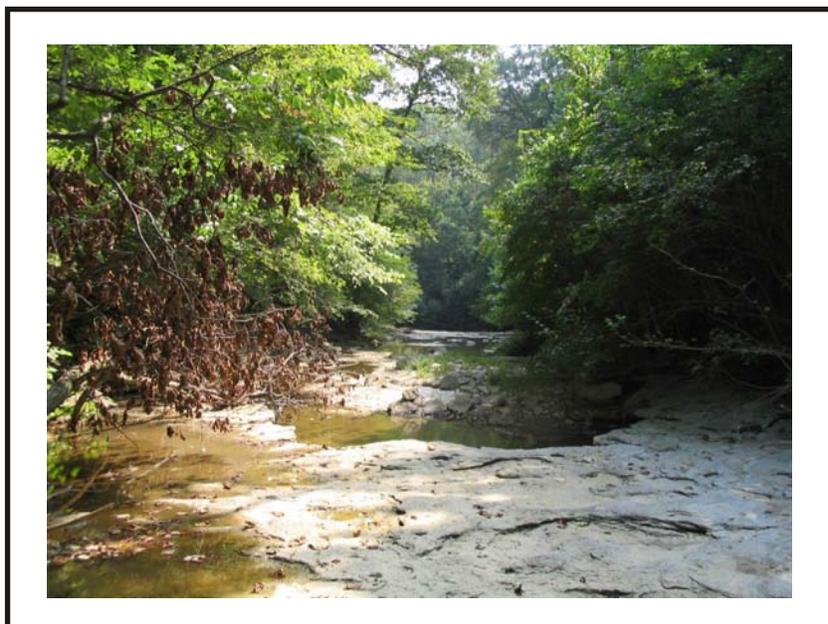
Photo 1: Hall Run Mainstem (middle lower portion); view downstream showing natural bedrock/boulder/slabs cascade section and complete, wide, steep sloped wooded riparian corridor.

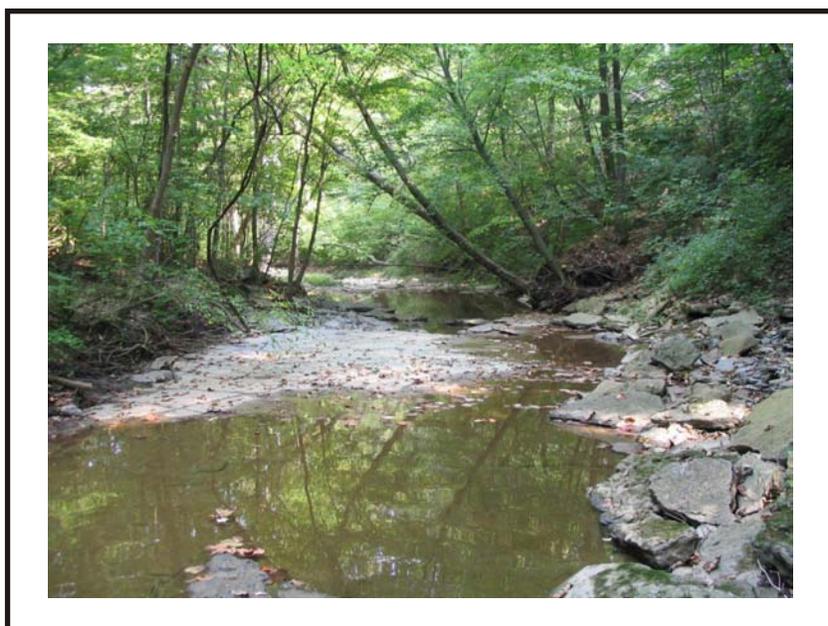
Photo 2: Hall Run Mainstem (middle lower portion); view downstream showing bedrock dominated substrate with glide, small riffle and pool habitat and steep sloped, wide wooded riparian corridor on both banks.

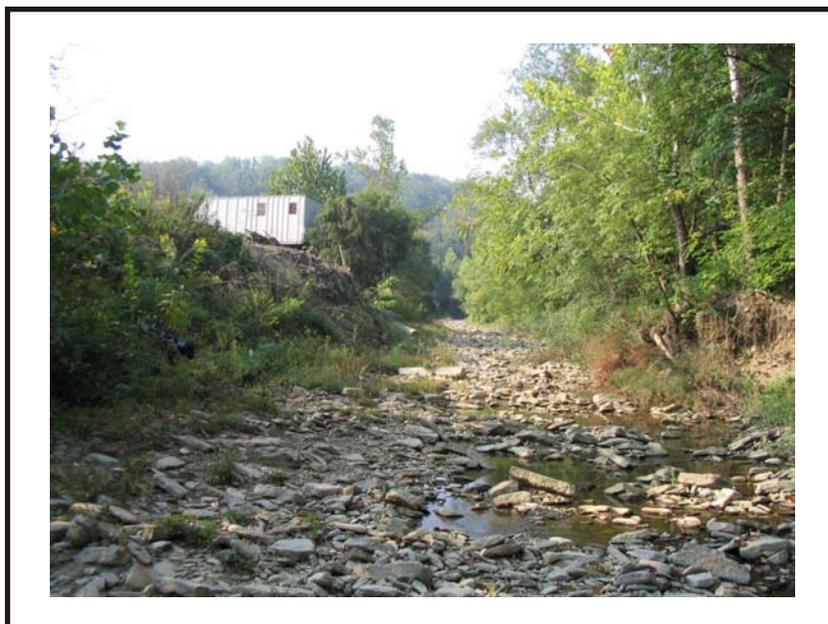
Photo 1: Hall Run Mainstem (lower portion); view upstream showing denuded riparian corridor on RDB and scrubby narrow riparian corridor on LDB through channelized section of stream.

- Establishment of conservation easements to prevent degradation or development in floodplain or riparian areas of this portion of Hall Run Mainstem.
- Replanting of native species in areas of riparian vegetation removal.
- Creation of an “OEPA recommended” vegetated buffer in the riparian area that is 50-100 feet wide on either side of the stream, using native species to protect and enhance current conditions. According to the OEPA a vegetated buffer of 50-120 feet on both sides of the bankfull channel is a “rule of thumb” minimum necessary to maintain a high quality aquatic ecosystem (OEPA, 2005). The

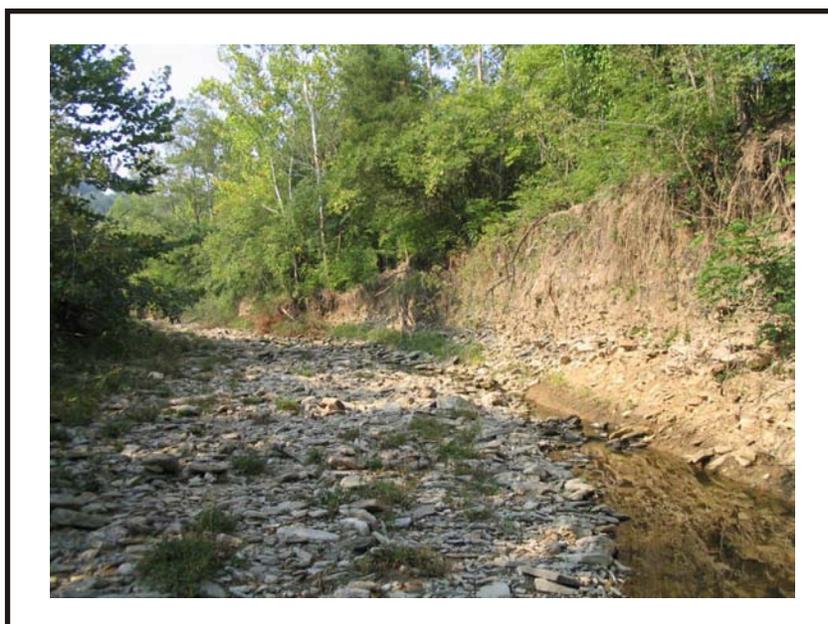
Photo 2: Hall Run Mainstem (lower portion); view upstream showing unstable, eroding bank and narrow, scrubby wooded riparian corridor on LDB.

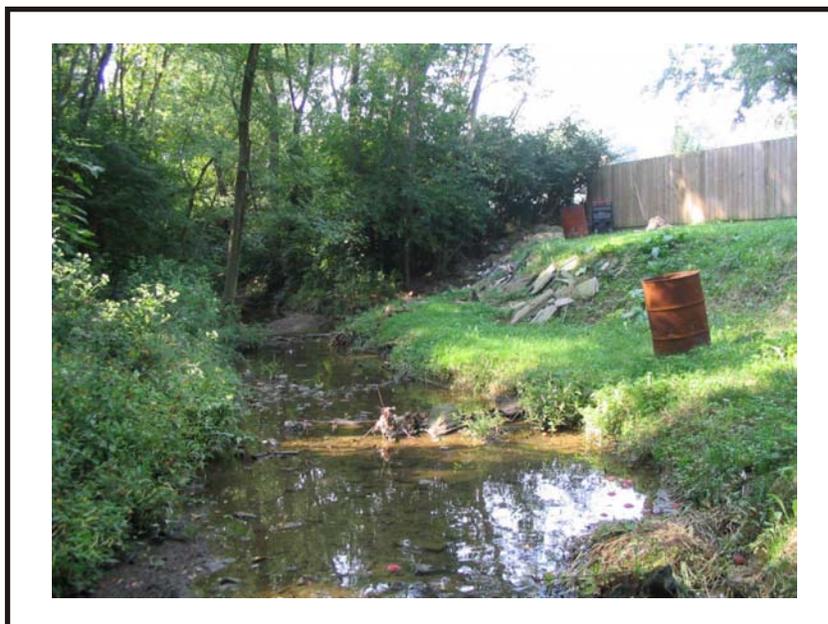
Photo 1: Hall Run Headwater; view upstream showing encroachment of residential development and section of cleared riparian corridor.

- Establishment of conservation easements to prevent degradation or development in floodplain or riparian areas of this portion of Hall Run Headwater.
- Replanting of native species in areas of riparian vegetation removal and areas of ATV traffic.
- Creation of an "OEPA recommended" vegetated buffer in the riparian area that is 50-100 feet wide on either side of the stream, using native species to protect and enhance current conditions. According to the OEPA a vegetated buffer of 50-120 feet on both sides of the bankfull channel is a "rule of thumb" minimum necessary to maintain a high quality aquatic ecosystem (OEPA, 2005). The actual final buffer widths would be identified during further planning and with input from regulatory agencies, local stakeholders/landowners, and consideration of stream/watershed attributes and quality.

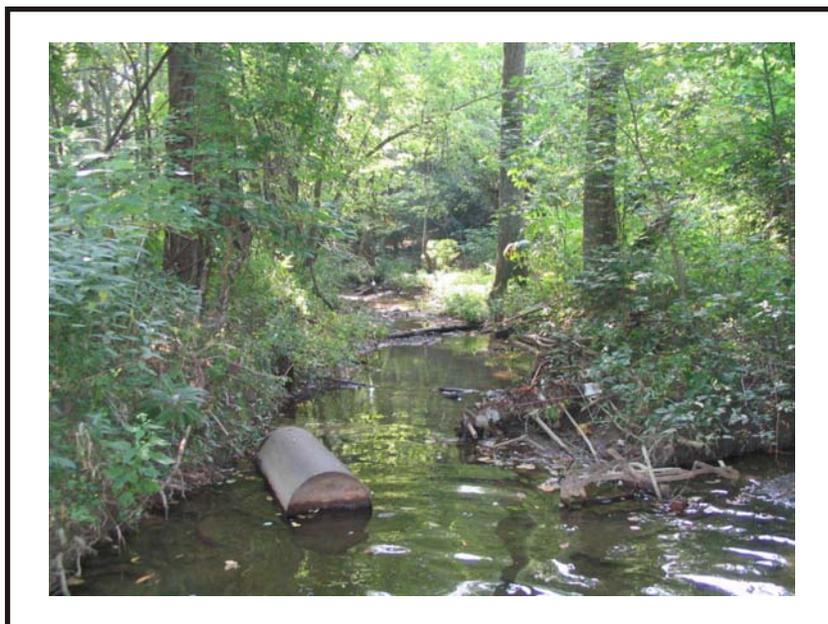
Photo 2: Hall Run Headwater; view upstream showing examples of trash within the channel and adjacent scrubby wooded riparian corridor.

- Removal of trash and yard wastes from stream channel through periodic voluntary "Stream Sweeps".
- Prevention of open dumping of yard and other wastes into the stream through periodic patrol of impairment areas and enforcement of local litter control and clean water act dredge and fill laws, and through creation of educational materials to encourage adjacent residents to keep the stream clean.
- Limitation of ATV use in floodplain and riparian areas through establishment of conservation easements.
- Repair failing household septic systems discharging into stream channels to improve overall conditions for water quality and biological organisms.

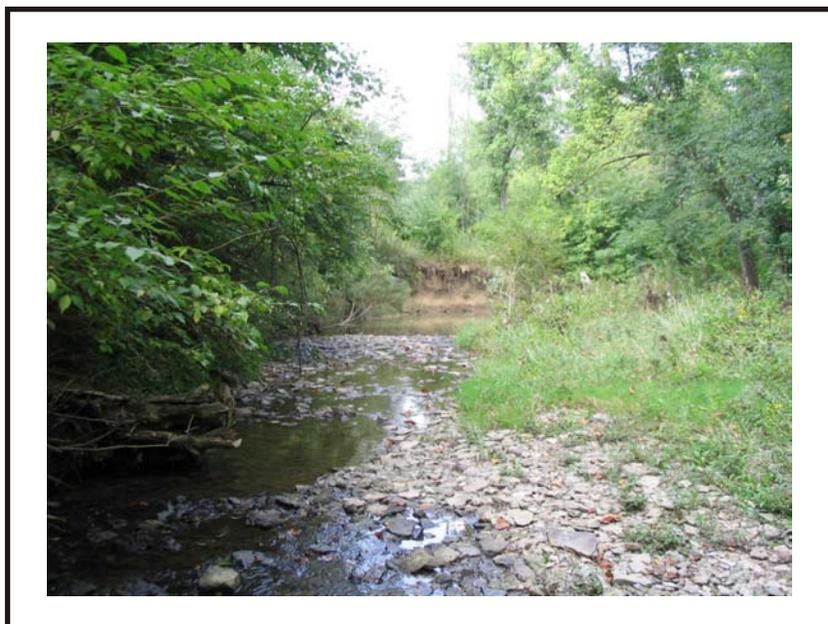
Photo 1: Hall Run Mainstem (middle upper portion); view downstream showing mix of good substrate (cobble/gravel) and heavy silt (downstream pool at eroding bank) and incomplete, narrow to completely open riparian corridor.

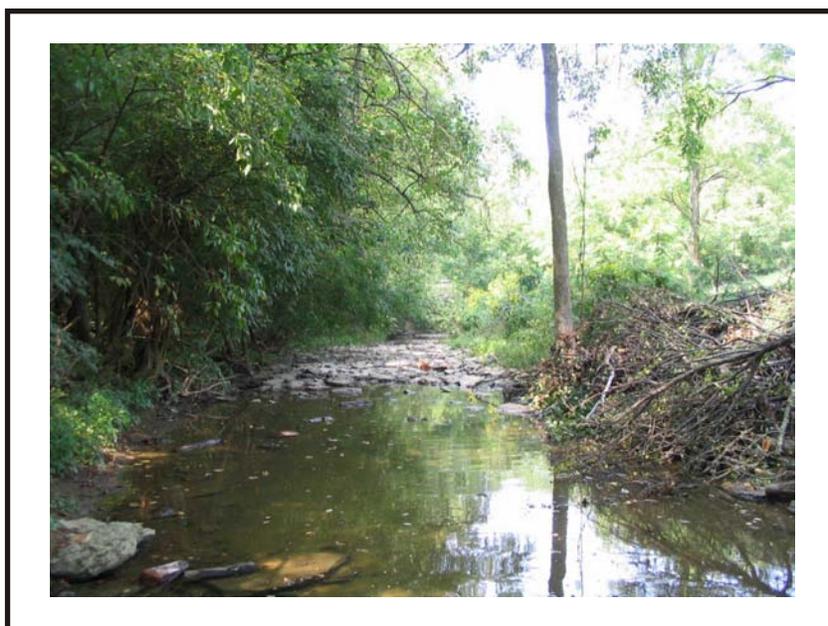
Photo 2: Hall Run Mainstem (middle upper portion); view downstream showing bedrock/boulder slab dominated substrate and complete, but scrubby wooded corridor (LDB) and mostly open corridor (RDB) with residential encroachment, dumped yard waste, and trash.

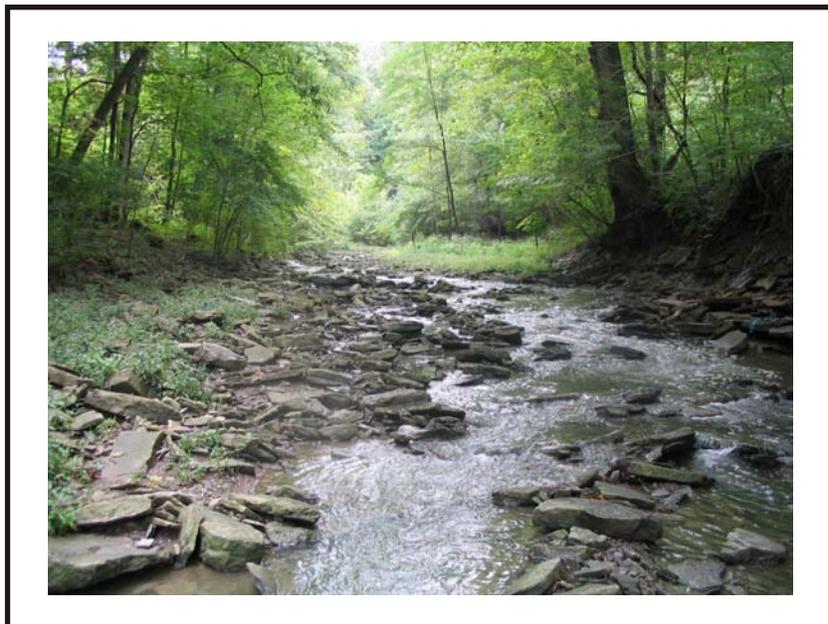
Photo 1: Salt Run Headwater; view upstream showing natural wider channel with boulder/slabs/cobble dominated substrates and mostly complete steep sloped wooded riparian corridor.

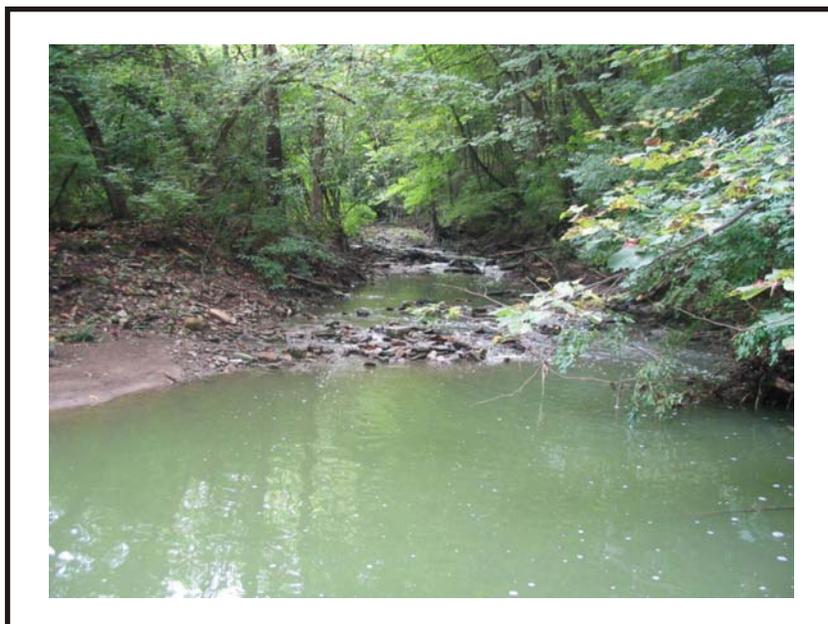
Photo 2: Salt Run Headwater; view upstream showing narrower natural channel with deep pools and shallow riffles and mostly complete steep sloped wooded riparian corridor.

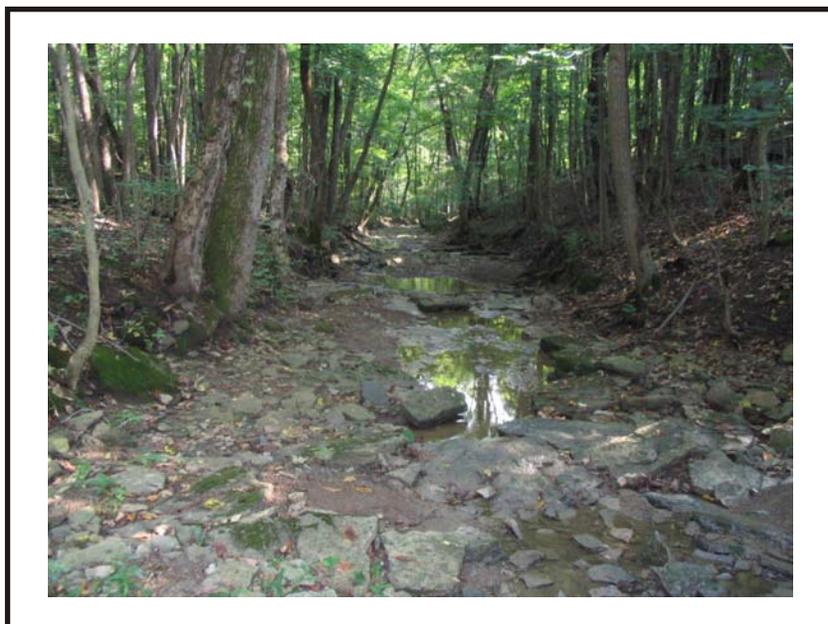
Photo 1: Salt Run Headwater Tributary (west branch); view downstream showing natural wider channel with boulder/slabs/cobble and sand dominated substrates and mostly complete steep sloped wooded riparian corridor.

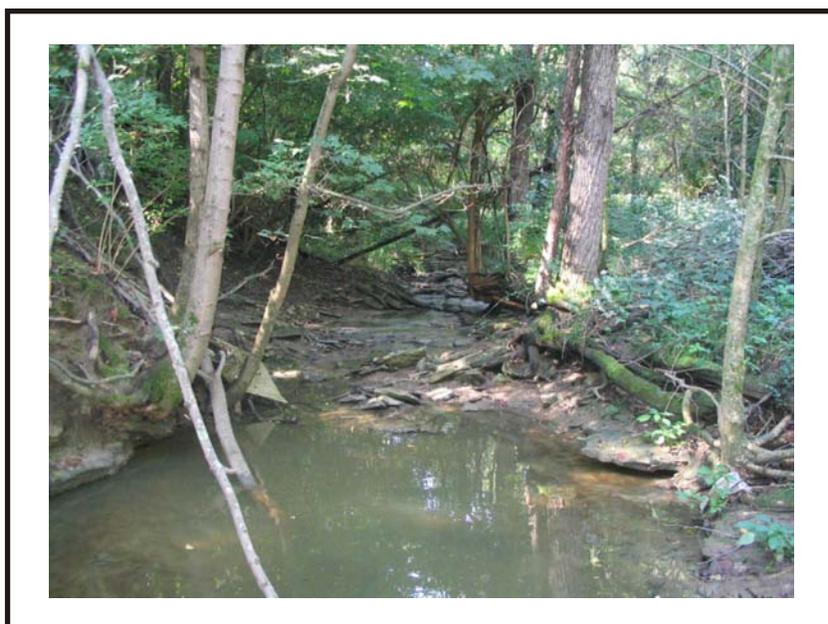
Photo 2: Salt Run Headwater Tributary (west branch); view upstream showing narrower natural channel with deep pools and shallow riffles and slightly more scrubby sloped wooded riparian corridor.

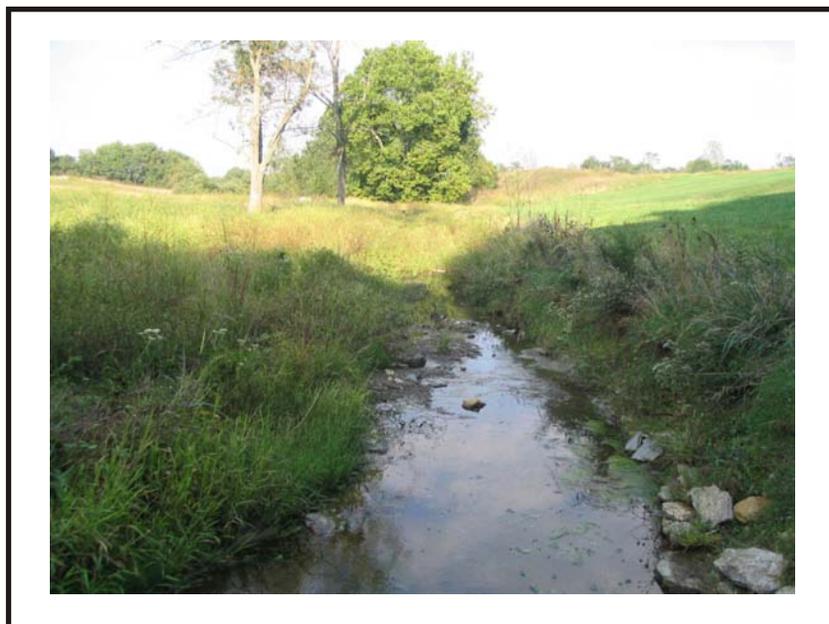
Photo 1: Salt Run Headwater Tributary (east branch); view downstream showing channelized section with open riparian corridor and narrow scrubby wooded riparian corridor further downstream (background of photo).

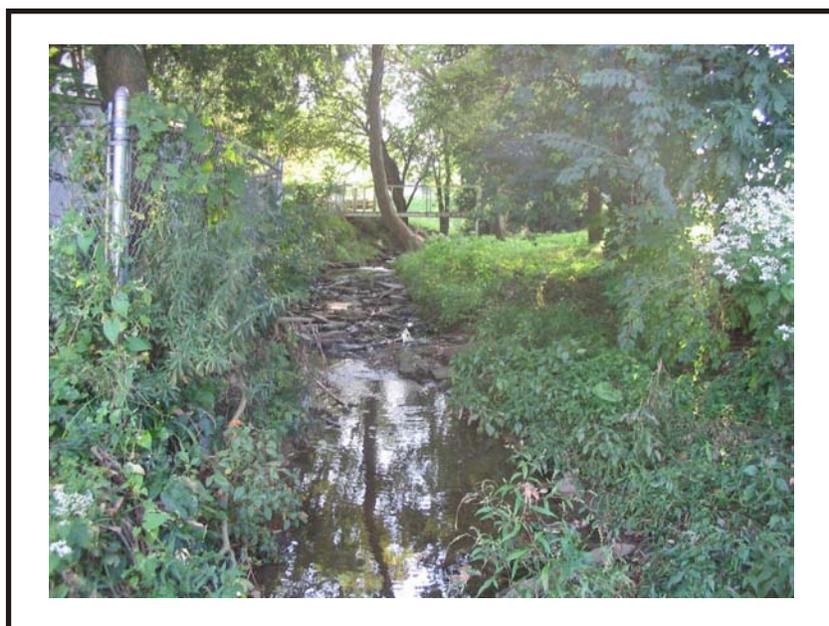
Photo 2: Salt Run Headwater Tributary (east branch); view upstream showing encroachment from residential development and incomplete scrubby wooded riparian corridor.

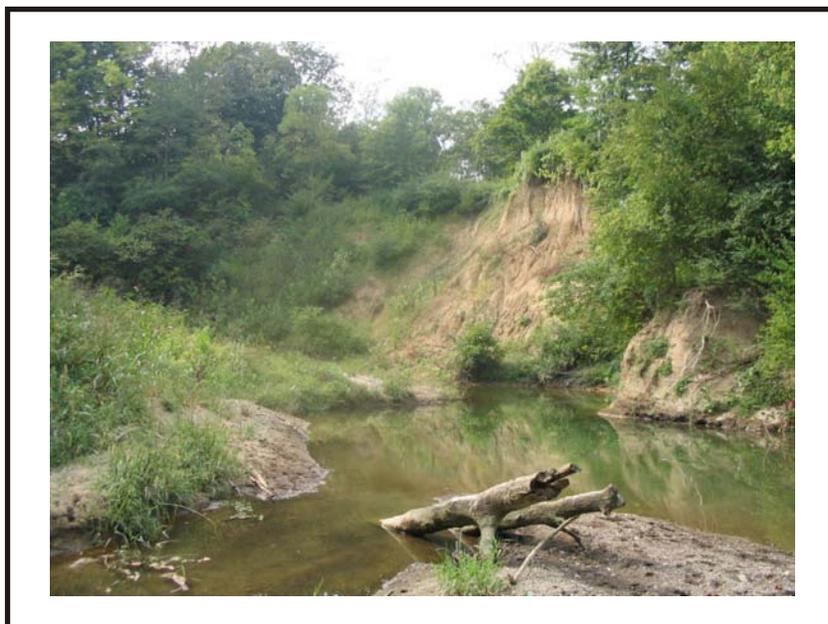
Photo 1: Salt Run Mainstem (lower portion); view upstream showing sand/silt dominated portion and open riparian corridor with heavy bank erosion/slumping.

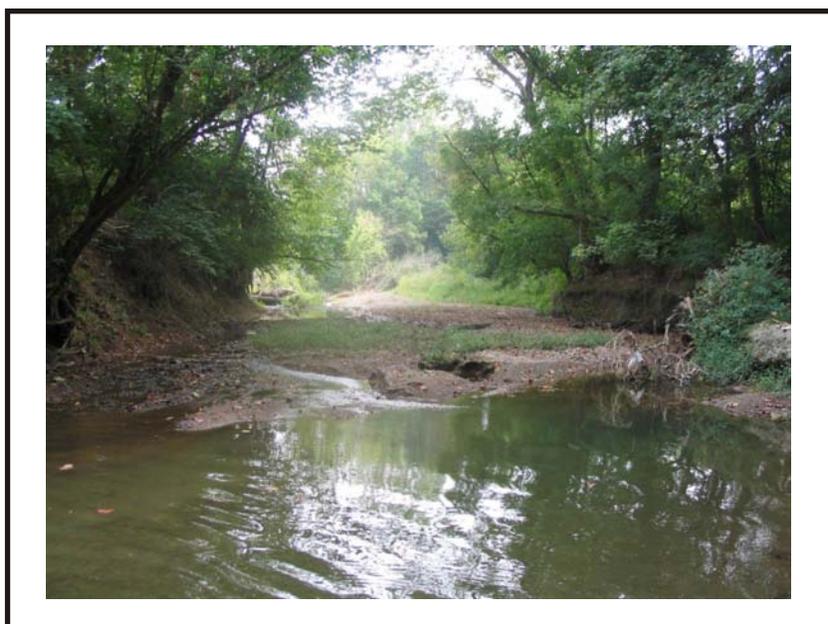
Photo 2: Salt Run Mainstem (lower portion); view upstream showing natural channel with pool/riffle/pool sequence, sand/gravel dominated substrate and section of open riparian corridor in background on both LDB and RDB.

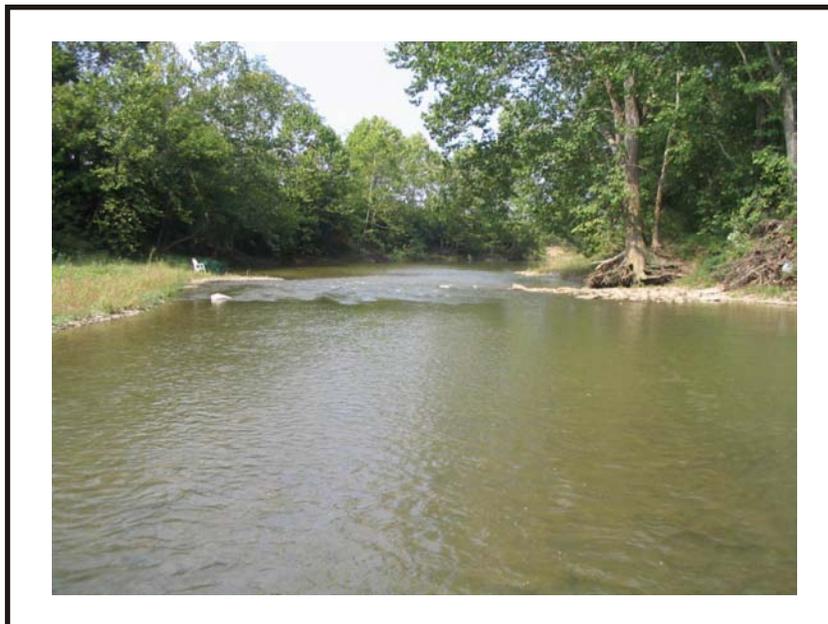
Photo 1: Lower East Fork Little Miami River; view downstream showing glide/riffle/pool sequence and mostly narrow wooded riparian corridor on LDB and moderately wide wooded riparian corridor on RDB.

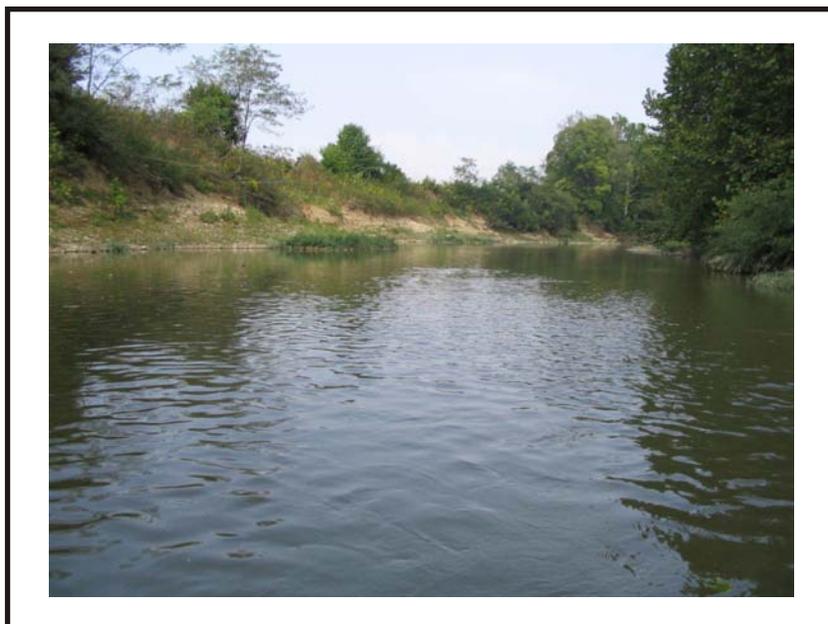
Photo 2: Lower East Fork Little Miami River; view downstream showing a section of denuded riparian corridor on the LDB.
