Environmental Red Flag Summary

Phase I - SR 32 Afton Corridor Clermont County, Ohio

July 2006

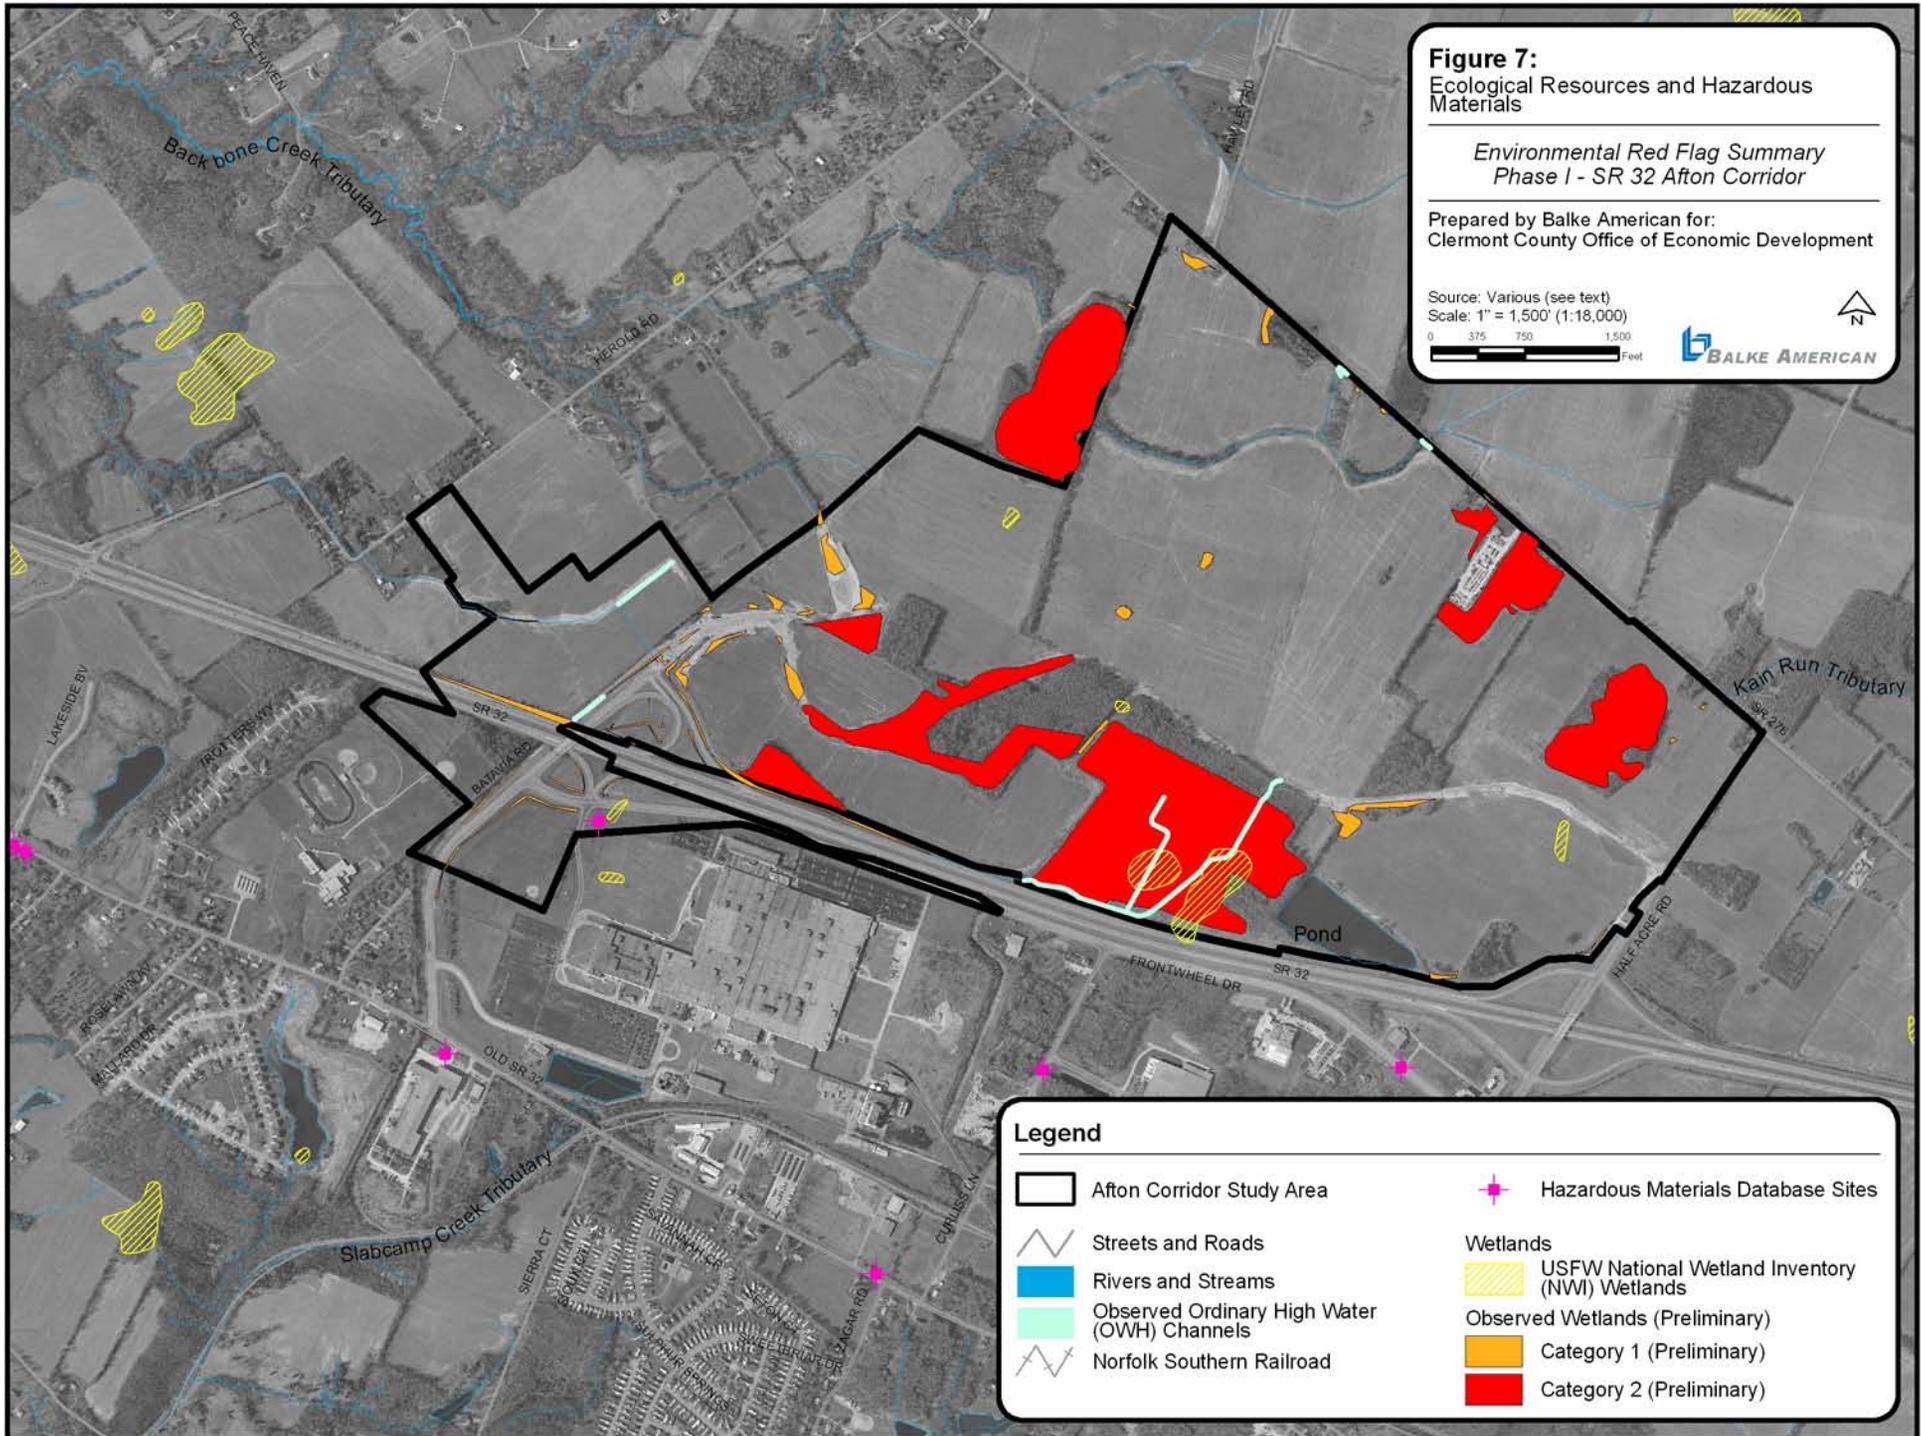
Figure 7:
 Ecological Resources and Hazardous Materials

Based on reconnaissance field survey, nine OHW features were observed within the project study area, including three USGS intermittent streams and six other minor channels/ditches (see Figure 7). Preliminary assessment indicates that all nine features are likely OEPA Modified Class I or II Primary Headwater features (limited quality streams).

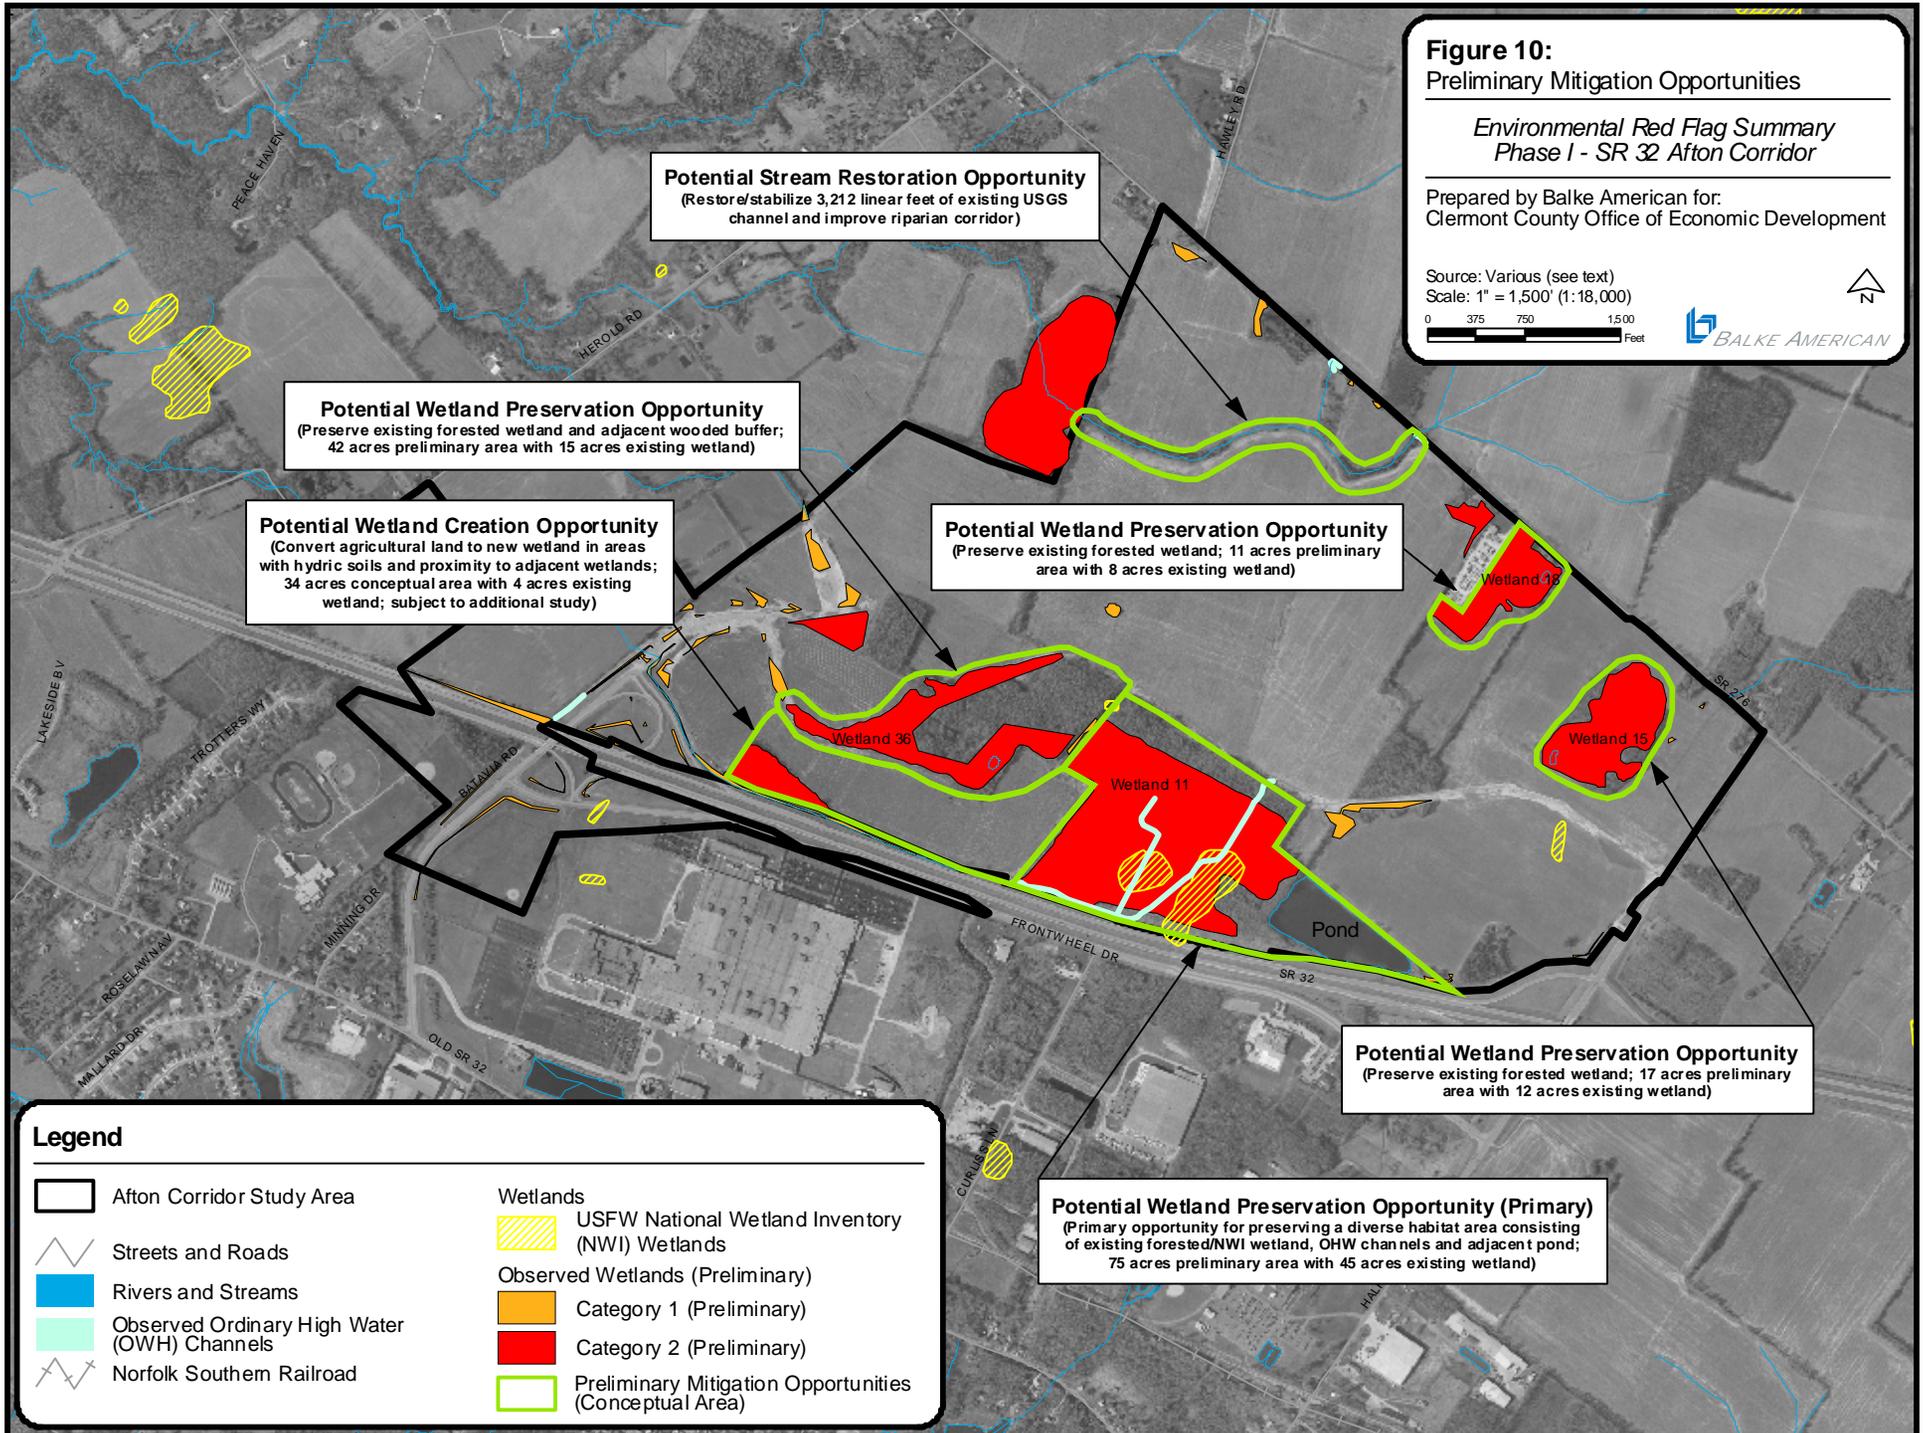
Potential Stream Restoration Opportunity
(Restore/stabilize 3,212 linear feet of existing USGS channel and improve riparian corridor)

Potential Wetland Preservation Opportunity
(Preserve existing forested wetland and adjacent wooded buffer; 42 acres preliminary area with 15 acres existing wetland)

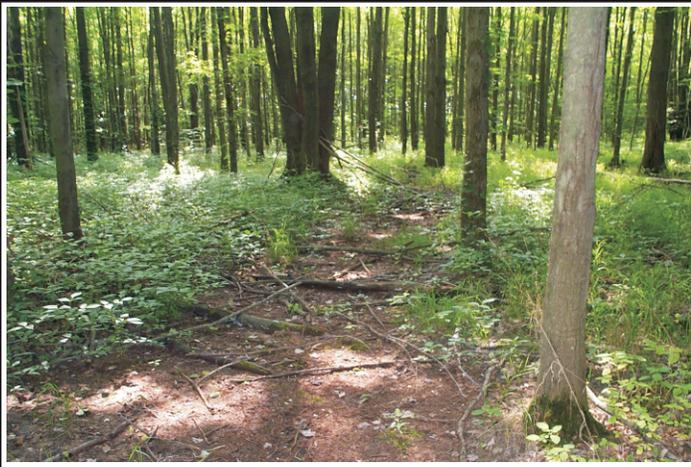
Photo 7: Typical forested wetland in SR 32 Afton Corridor study area showing multi-stemmed red maple canopy (hydrology indicator).

The better quality wetlands identified in the area (8 total) are natural features associated with large woodland tracts, mapped hydric soils, and NWI-mapped wetlands. Typical vegetation consists of a red maple canopy and a clear understory due to early-season extended periods of standing water or saturation. Old, man-made channels were observed in several of the

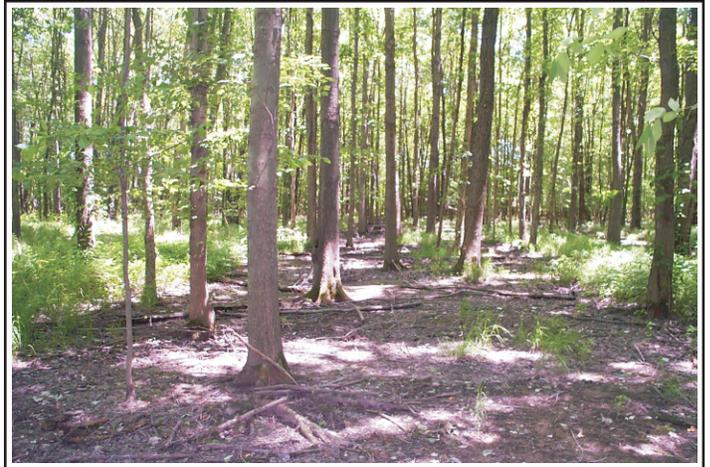
Photo 8: Typical forested wetland showing bare groundcover from extended early season standing water or saturated conditions.

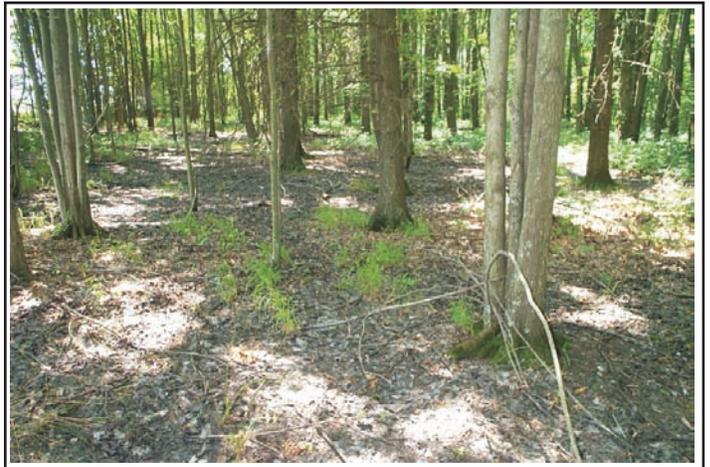
Photo 10: Typical forested wetland showing multi-stemmed canopy trees, buttressed bases and water marks (hydrology indicators).

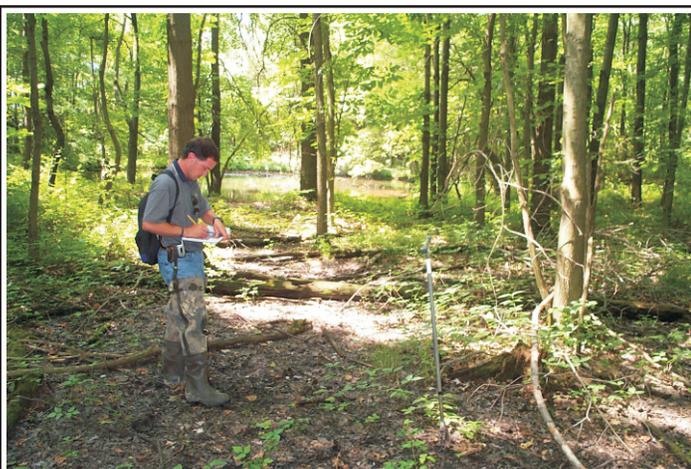
Photo 11: Forested wetland showing depressional area (old pond in background) with standing water.

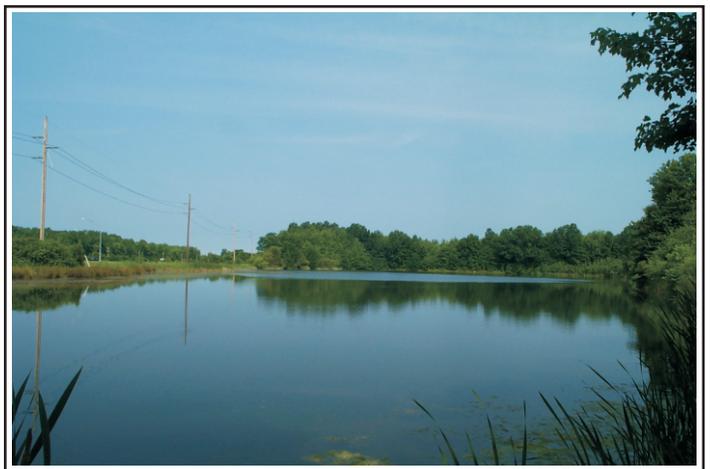
Photo 12: Existing man-made pond adjacent to forested wetland (combined habitats offer primary wetland preservation opportunity).

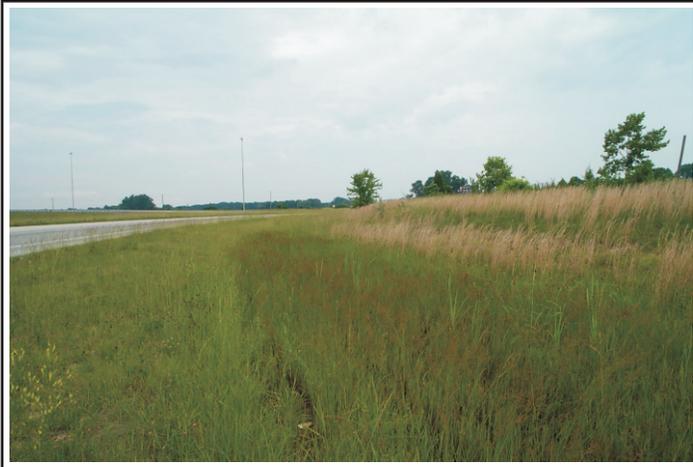
Photo 13: Emergent wetland formed in roadway ditch along south edge SR 32 Afton Corridor study area.

The smaller, limited quality wetlands observed in the study area (42 total) are mostly emergent features formed in man-made drainage ditches, such as along existing SR 32 and interchange ramps, or are associated with ponds and depressional areas in fields. These are typically narrow, linear wetlands dominated by cattails, sedges and other common emergent plants.

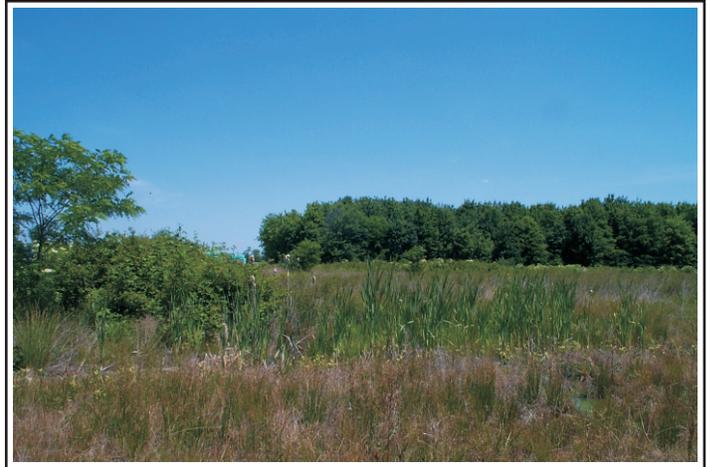
Photo 14: Typical emergent wetland swale in SR 32 Afton Corridor study area (cattail dominance).

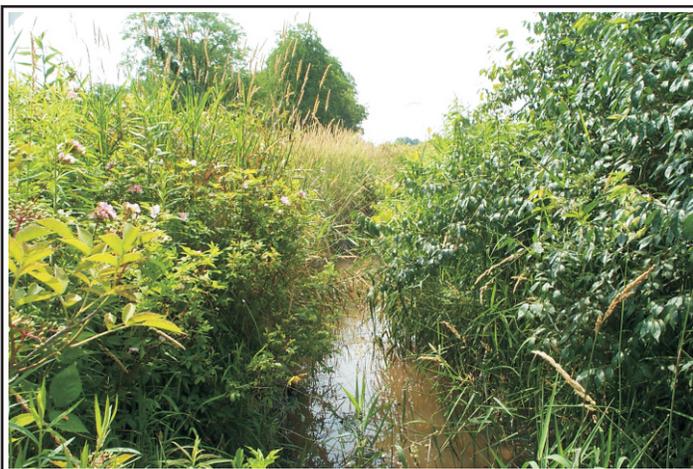
Photo 17: USGS stream in northwest corner of SR 32 Afton study area showing silted bottom and scrubby riparian corridor (limited stream mitigation [restoration] opportunity).

within the study area boundaries), combined with channel restoration and stabilization and improvement of the riparian corridor. However, for the level of work required and limited ecological benefit is anticipated, *this opportunity is considered secondary to the wetland opportunities that exist on the site.*

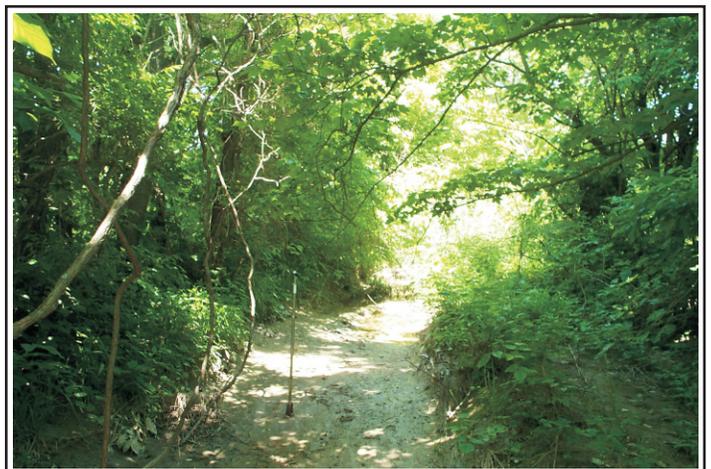
Photo 18: Typical non-USGS Ordinary High Water (OHW) channel in the SR 32 Afton Corridor study area boundaries.

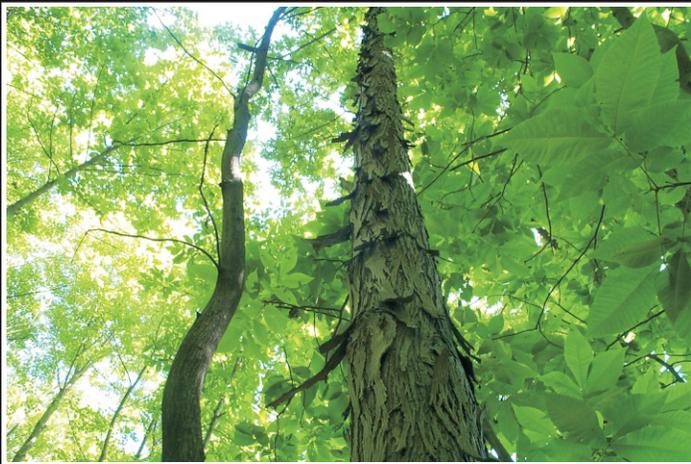
Photo 19: Typical potential habitat for Federal endangered Indiana bat in SR 32 Afton study area - peeling bark of shagbark hickory.

None of the four federal listed species are known from the immediate project study area, although potential summer roosting habitat for Indiana bat was noted during reconnaissance field surveys conducted for this project. Potential summer habitat consists of trees with exfoliating bark and dead limbs/trunks with cavities. All of the woodlands in the study area possess some trees with suitable Indiana bat roosting habitat.

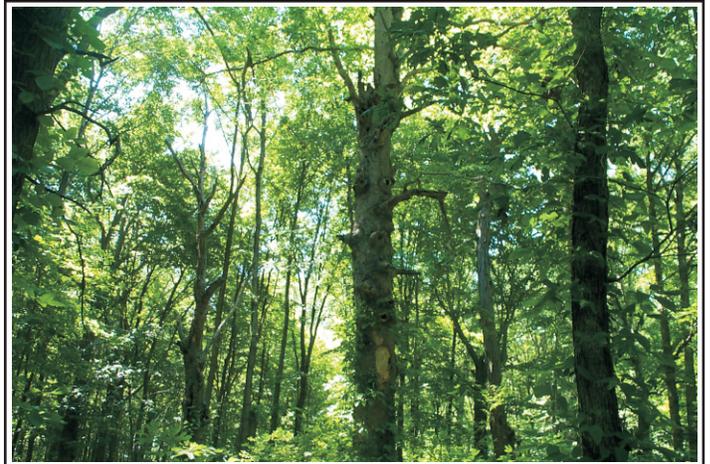
Photo 20: Typical potential habitat for Federal endangered Indiana bat in SR 32 Afton study area - dead snags, holes, and peeling bark.

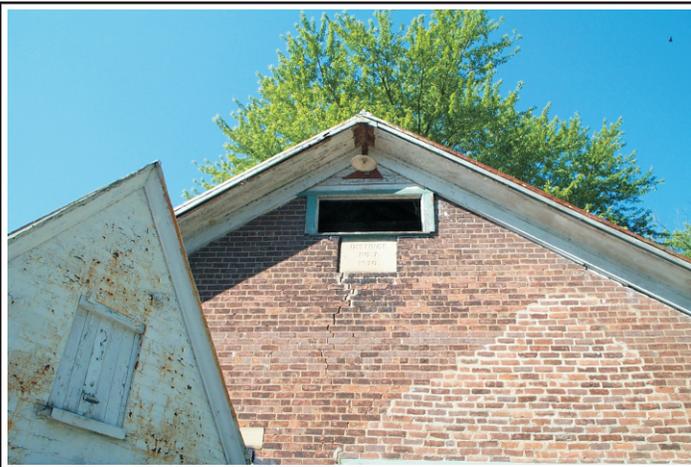
Photo 21: Potential historic property noted during reconnaissance field survey (building dated 1870; significance not determined).

During reconnaissance field survey conducted for this red flag study, several old (> 50 years) residences and agricultural outbuildings were noted along SR 276 and Half Acre Road. The historic significance of these structures has not been determined.

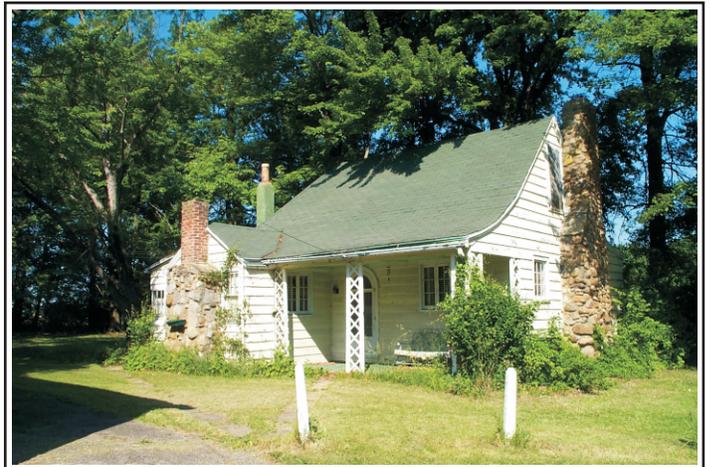
Photo 22: Potential historic property noted during reconnaissance field survey (age and significance not determined).

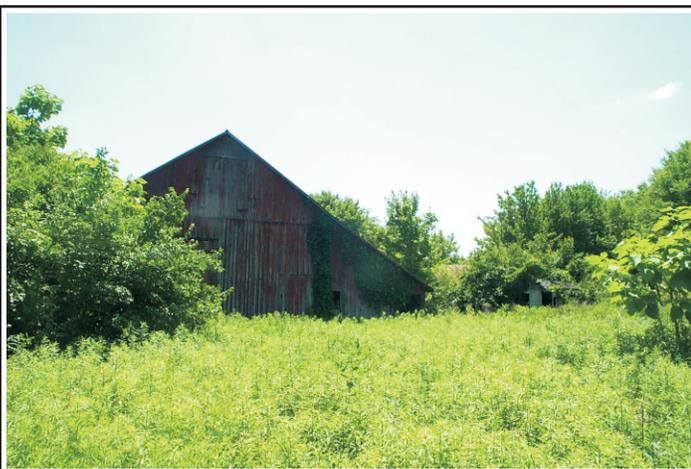
Photo 23: Agricultural outbuildings noted during reconnaissance field surveys (age and significance not determined).
