**East Fork Little Miami River
Watershed Action Plan**

Lower East Fork Watershed Management Plan 2003

December 2003

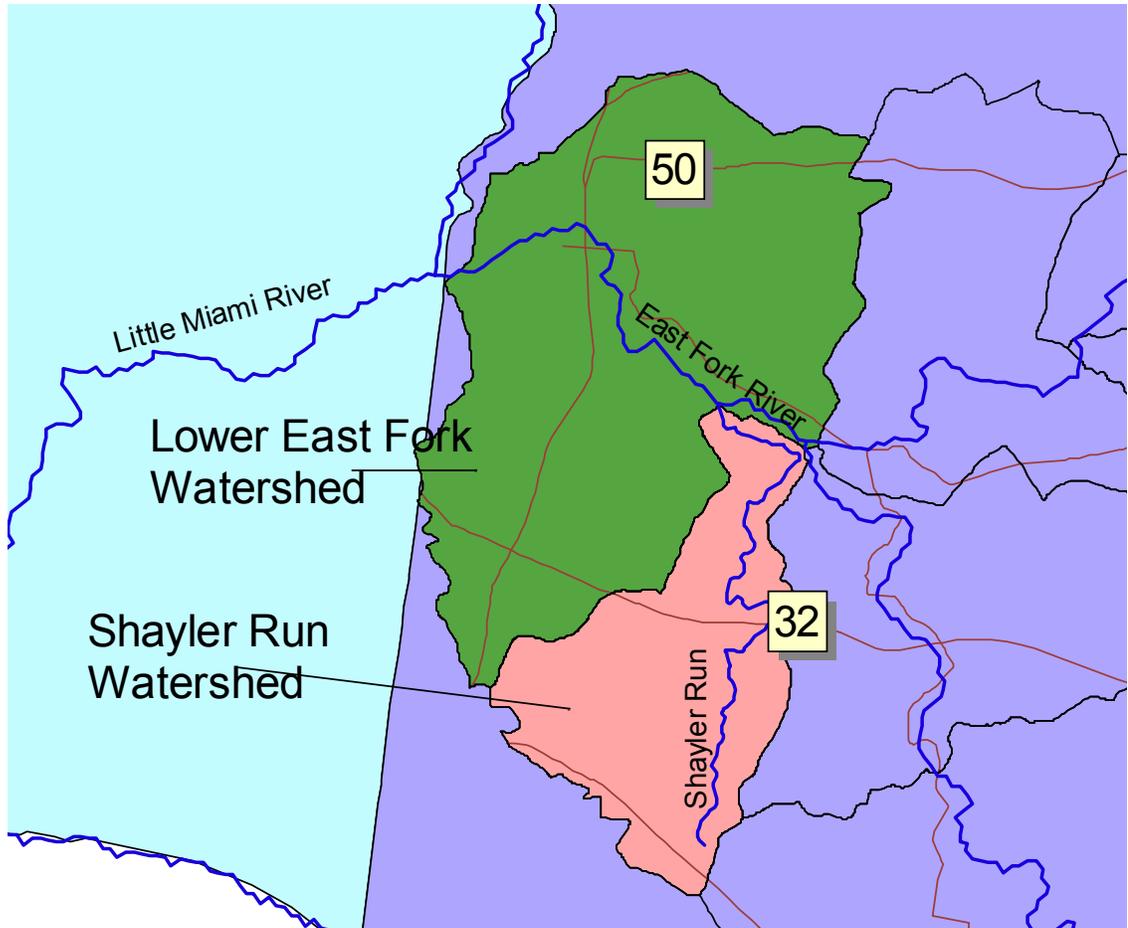
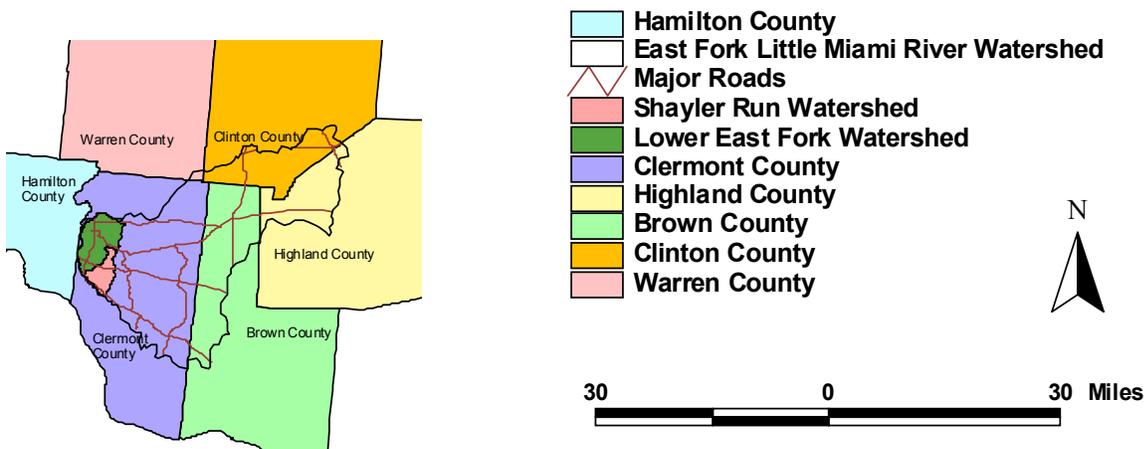
Figure 1: Location of Lower East Fork and Shayler Run watersheds in relation to Little Miami River. Inset shows location of watersheds within East Fork basin.

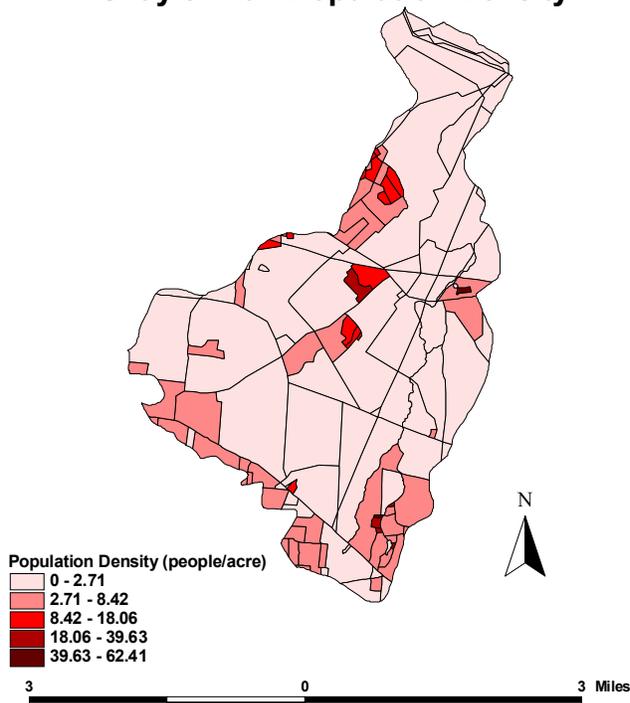
Figure 2: Population density within Shayler Run watershed for the year 2000.

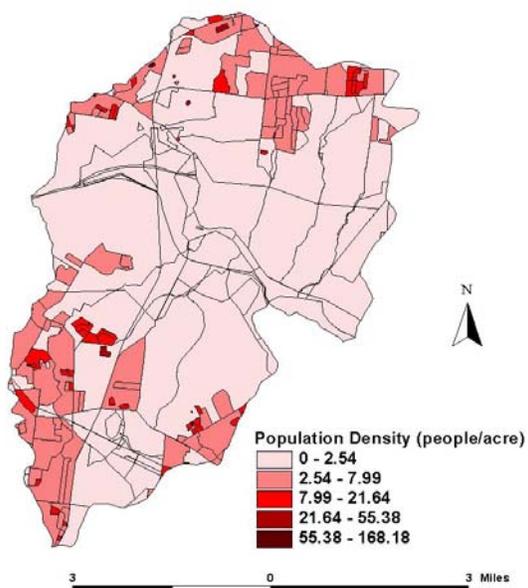
Figure 3: Population density within Lower East Fork watershed for the year 2000.

acre. The Eastgate area in Union Township, located at the western edge of the watershed, is also heavily populated, with an average of 5.88 people per acre. The average population density for the Lower East Fork sub-watershed is 5.26 people per acre (Figure 3).

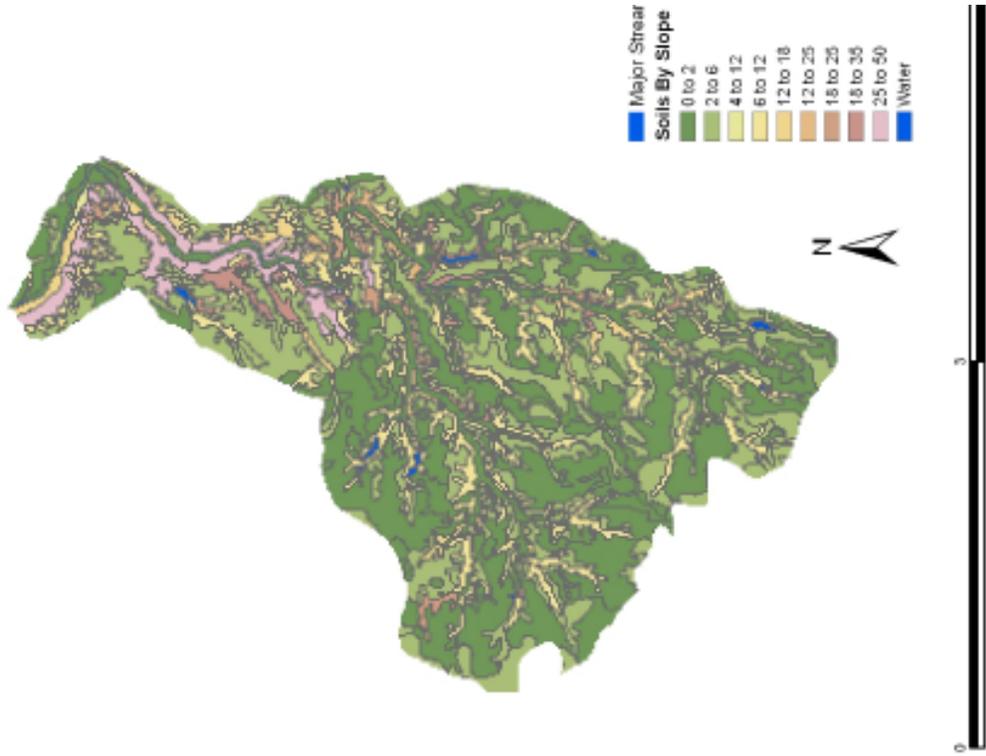
Figure 5: Soil slopes within the Shayler Run subwatershed.

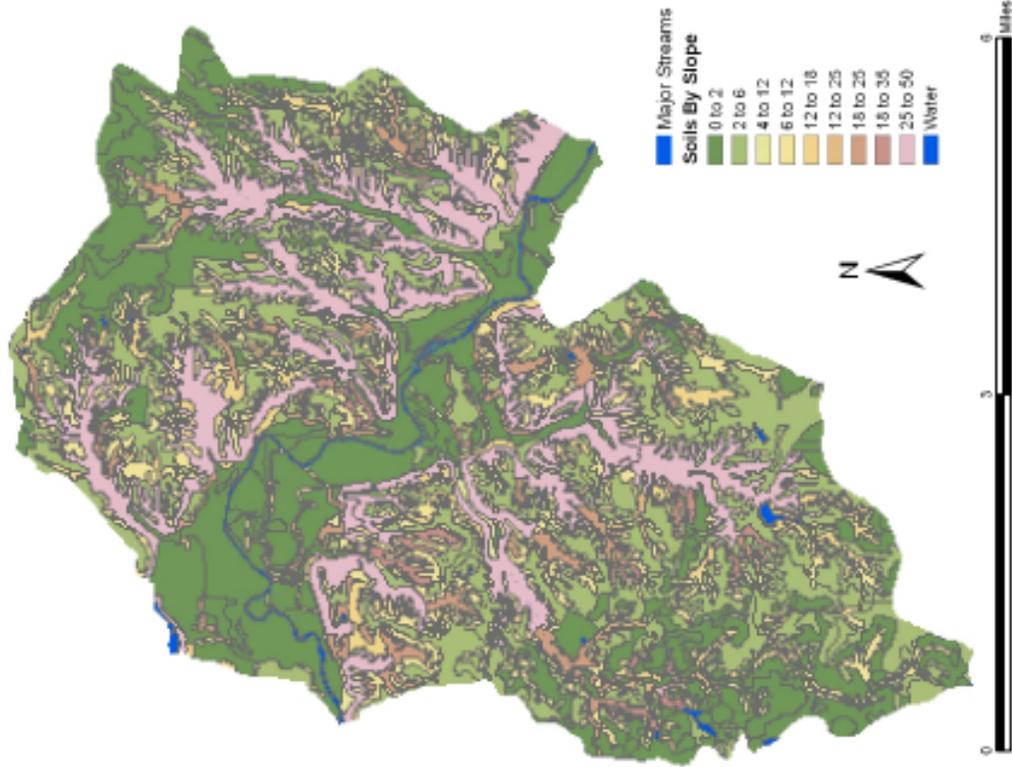
Figure 6: Soil slopes within the Lower East Fork subwatershed.

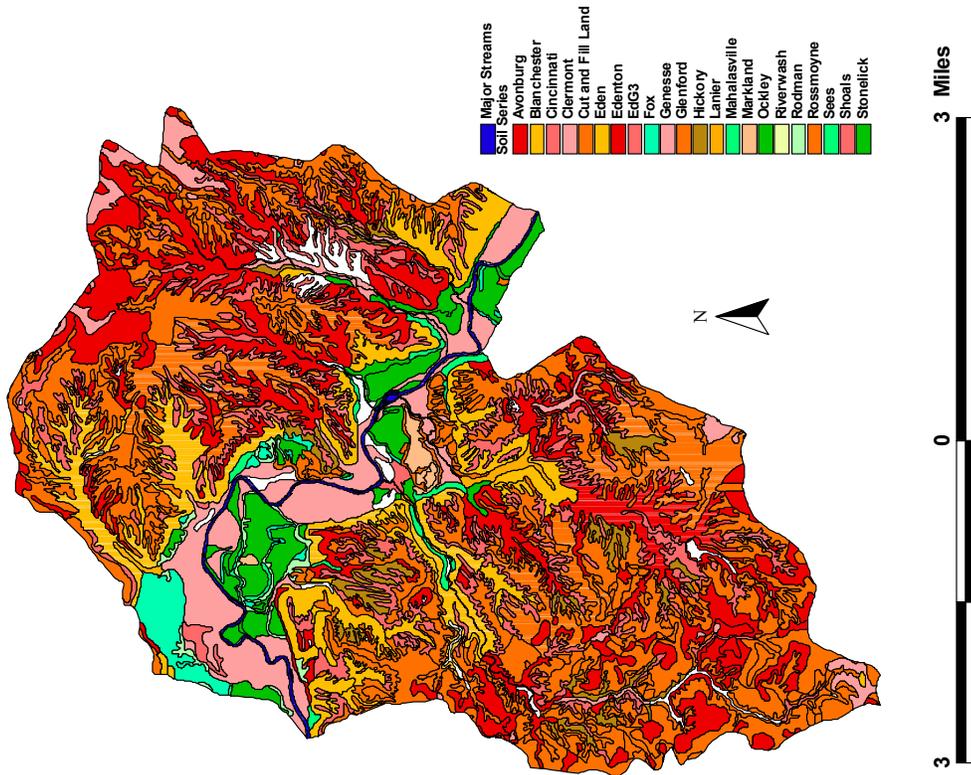
Lower East Fork Watershed Soil Profile

Figure 8: Distribution of soils within the Lower East Fork subwatershed.

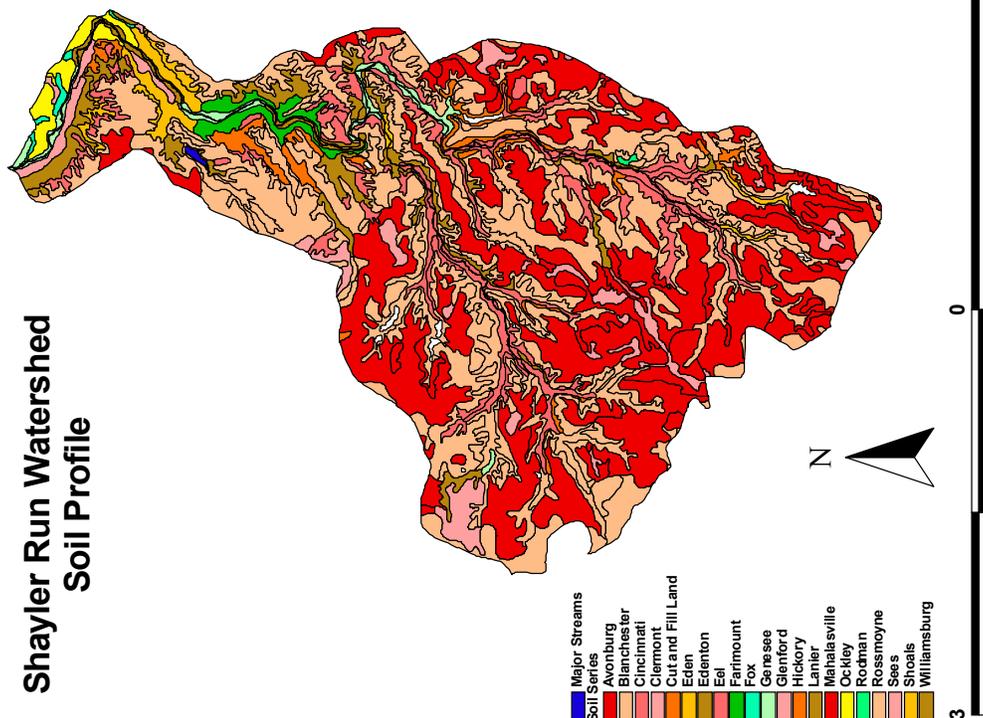
Shayler Run Watershed Soil Profile

Figure 7: Distribution of soil types within the Shayler Run subwatershed.

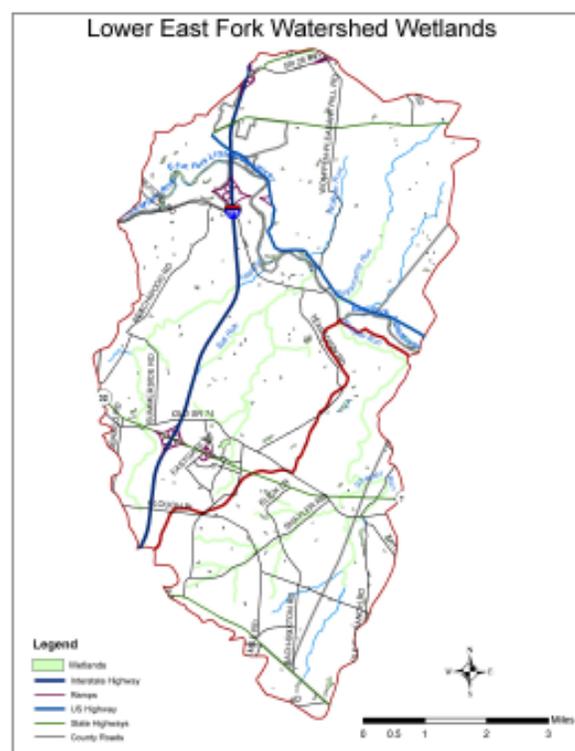
Figure 9: Location of wetlands in Lower East Fork watershed.

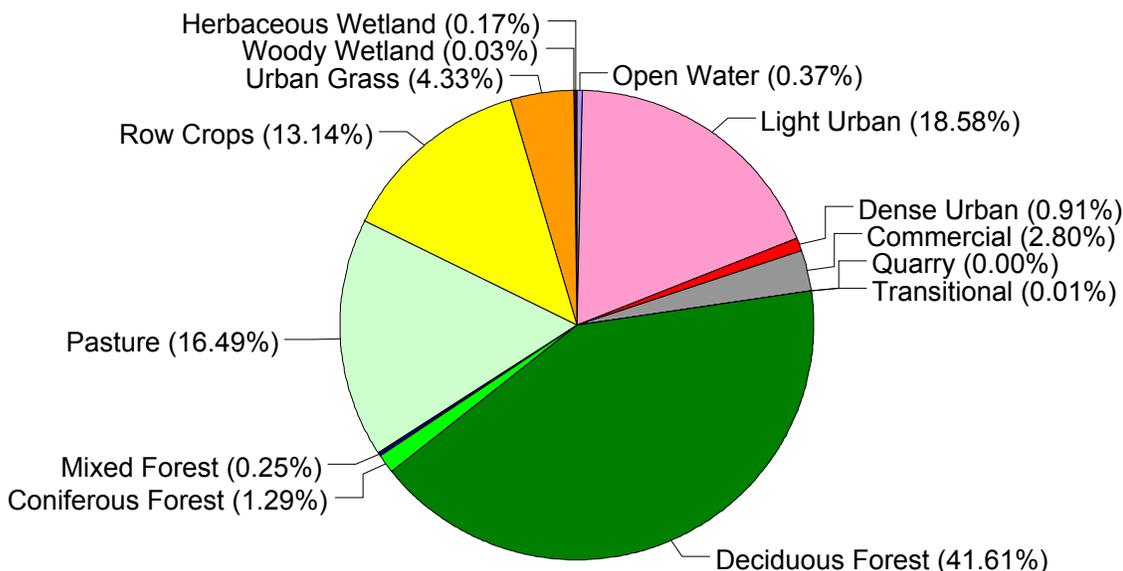
Figure 10: Percent distribution of land use within the Shayler Run subwatershed.

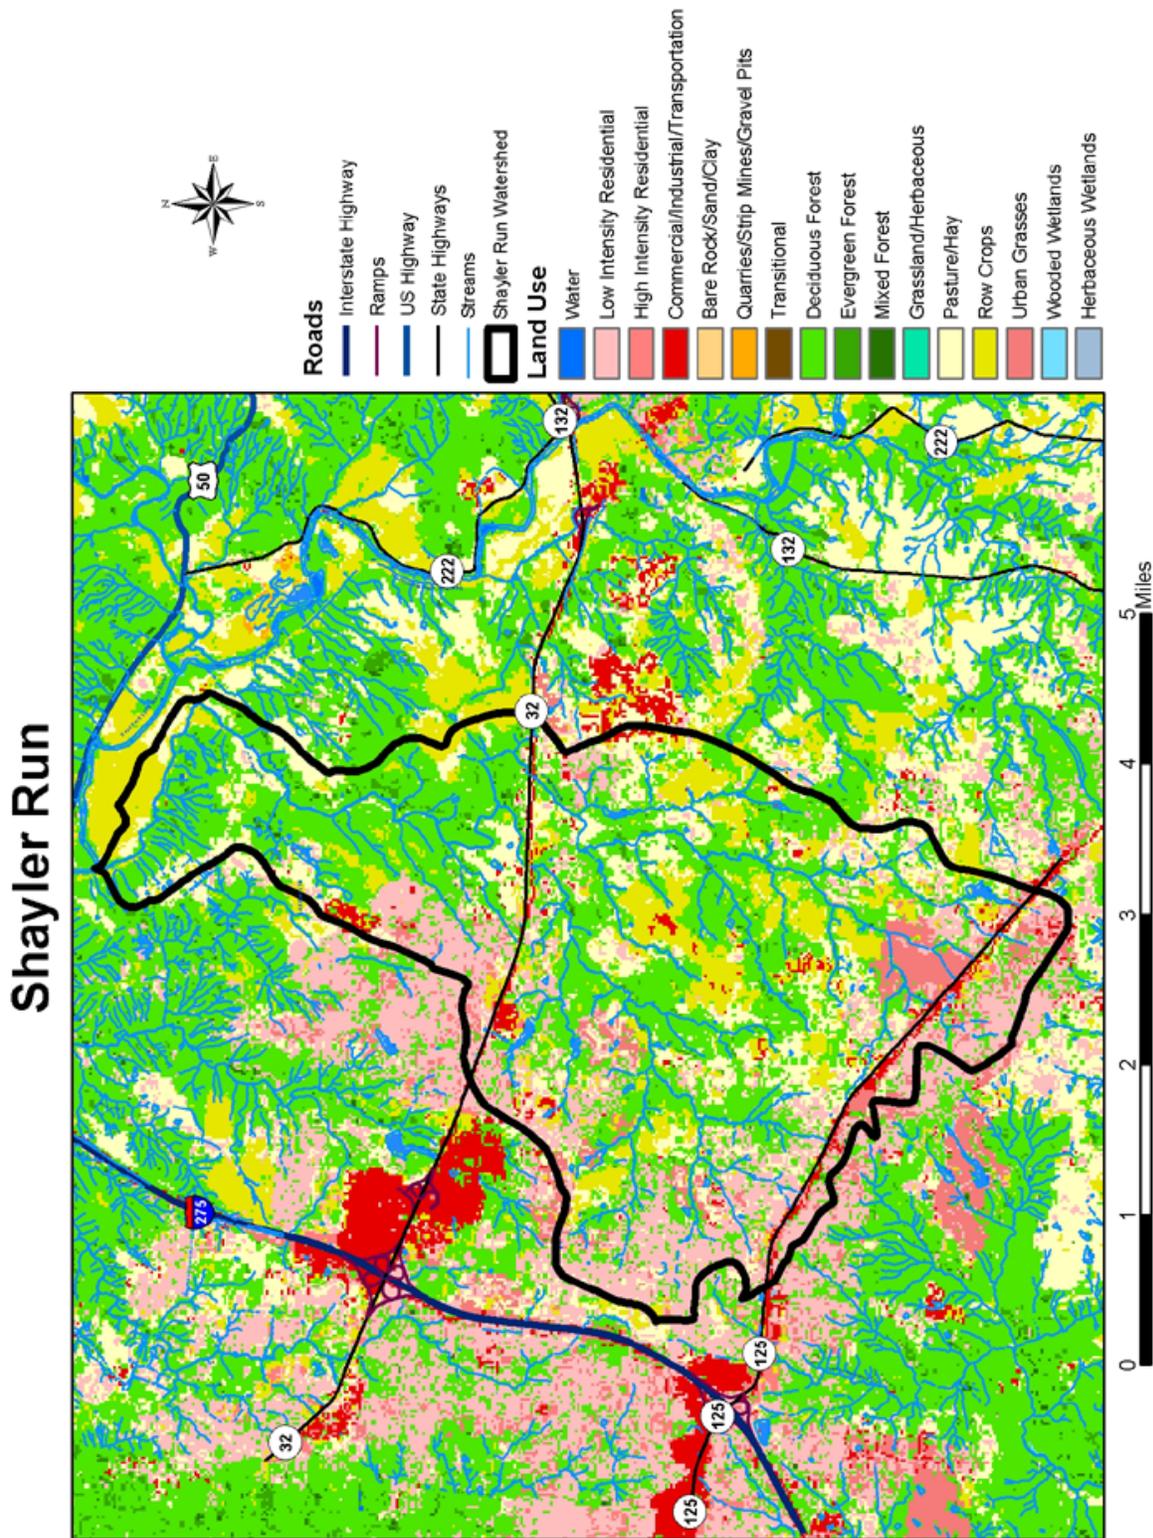
Figure 11: Distribution of land use within the Shayler Run subwatershed. (Data from National Land Use Database, 1992)

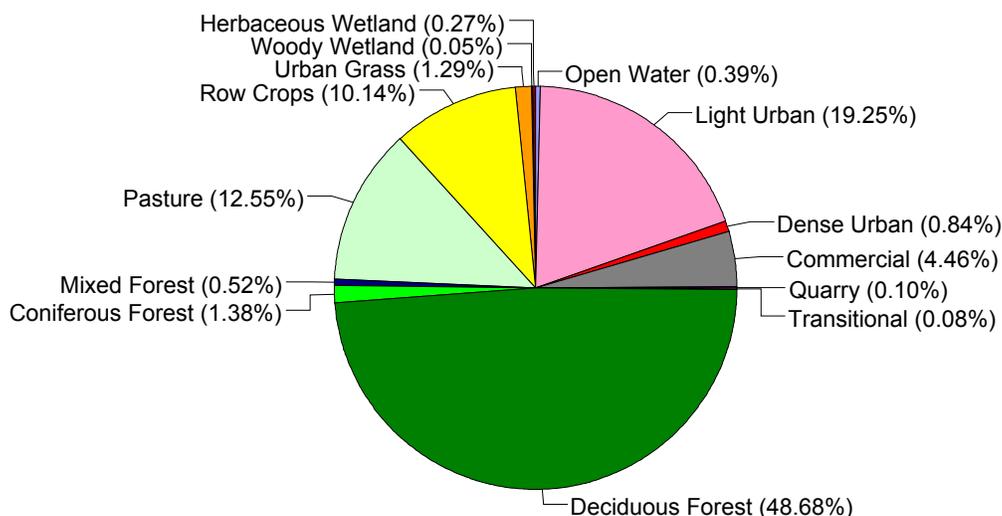
Figure 12: Percent distribution of land uses within the Lower East Fork subwatershed.

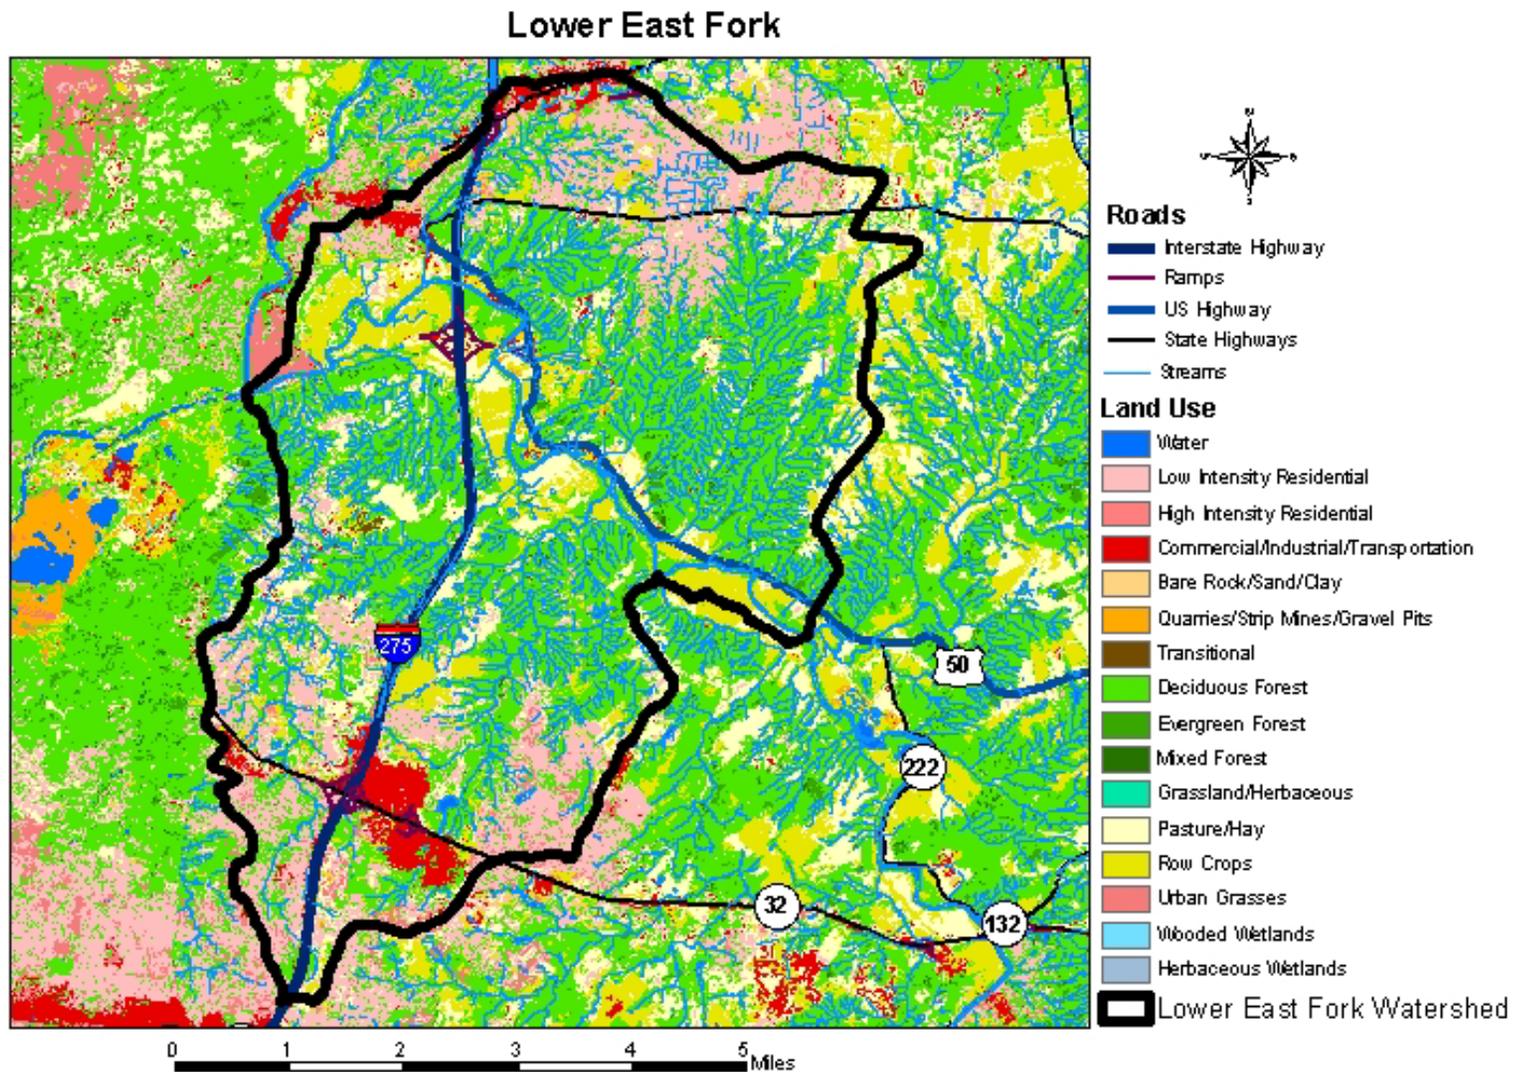
Figure 13: Distribution of land uses within the Lower East Fork subwatershed, based on the 1992 land use data.

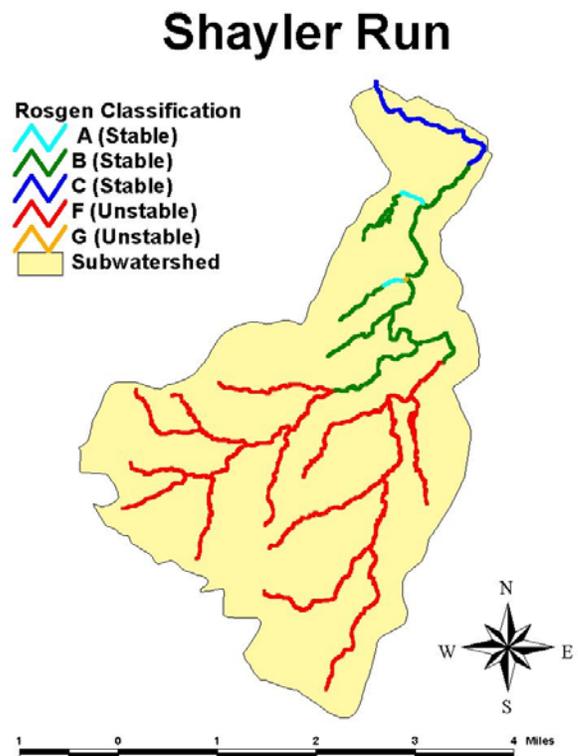
Figure 14: Map depicting stream type in Shayler Run subwatershed based on the Rosgen Level 1 classification scheme.

Results of the Level 1 assessment show a sharp differentiation in stream types in the upper and lower Shayler Run watershed. In the headwater tributaries and upper reaches of Shayler Run, F-type streams are

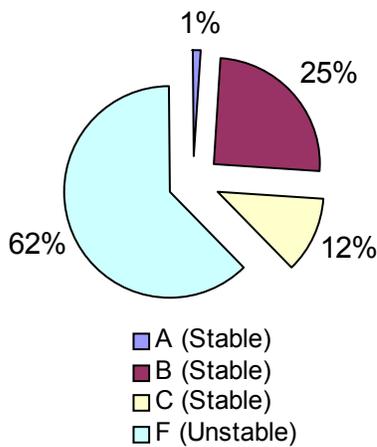
Figure 15: Percent distribution of stream type based on the Rosgen analysis, Shayler Run subwatershed.

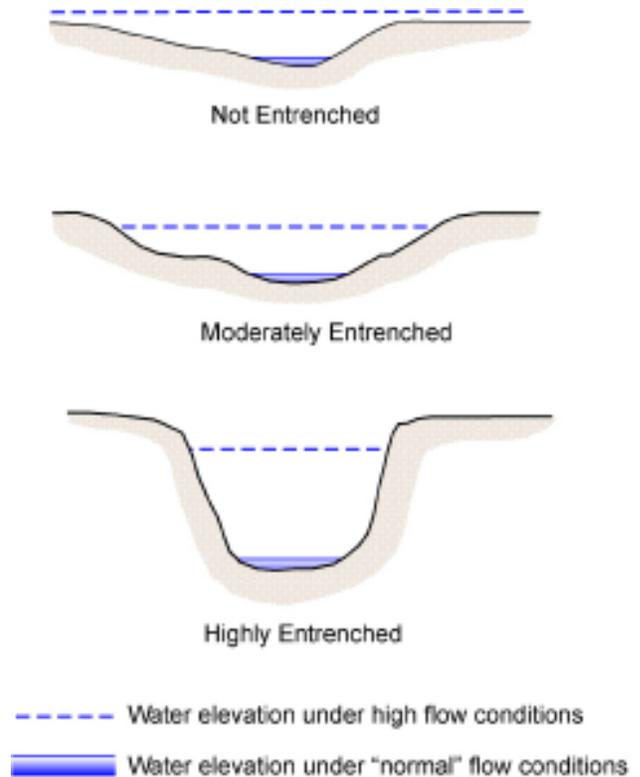
Figure 16: Examples of stream cross-sections depicting various degrees of channel entrenchment.

Entrenchment describes a stream's ability to access its floodplain under high flow conditions (see Figure 16). Streams that are not entrenched have the ability to rapidly overflow their banks during high flows, thereby dissipating much of the erosive energy of those high flows. Highly entrenched streams cannot access a floodplain during most high flows, thereby containing and concentrating the erosive energy of the high flows within the stream channel.

A significant amount of F-type (unstable) streams (23.9%) were found in the Eastgate area, including the upper reaches of Hall Run and an unnamed tributary to Salt Run. These stream types characteristically have high bank erosion rates, high sediment supply and are very entrenched (Figure 16).

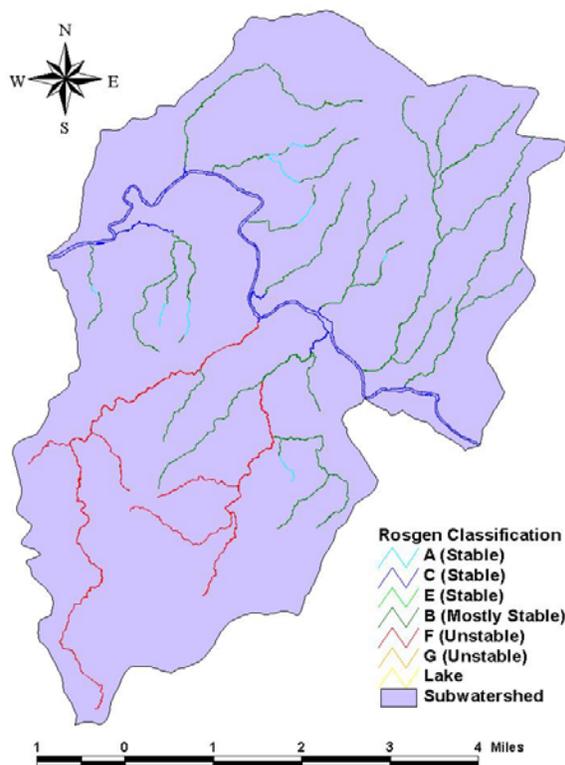
Figure 17: Map depicting stream type in Lower East Fork subwatershed based on the Rosgen Level 1 classification scheme.

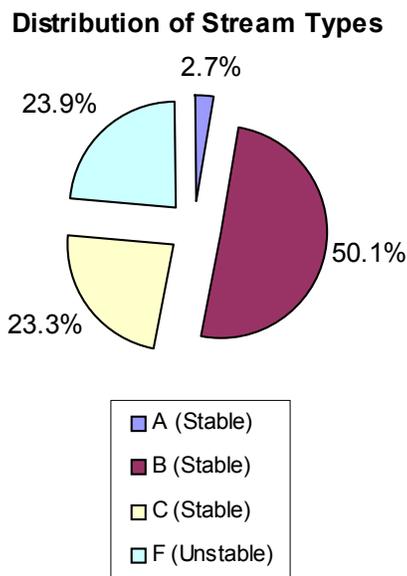
Figure 18: Percent distribution of stream type based on the Rosgen analysis, Lower East Fork subwatershed.

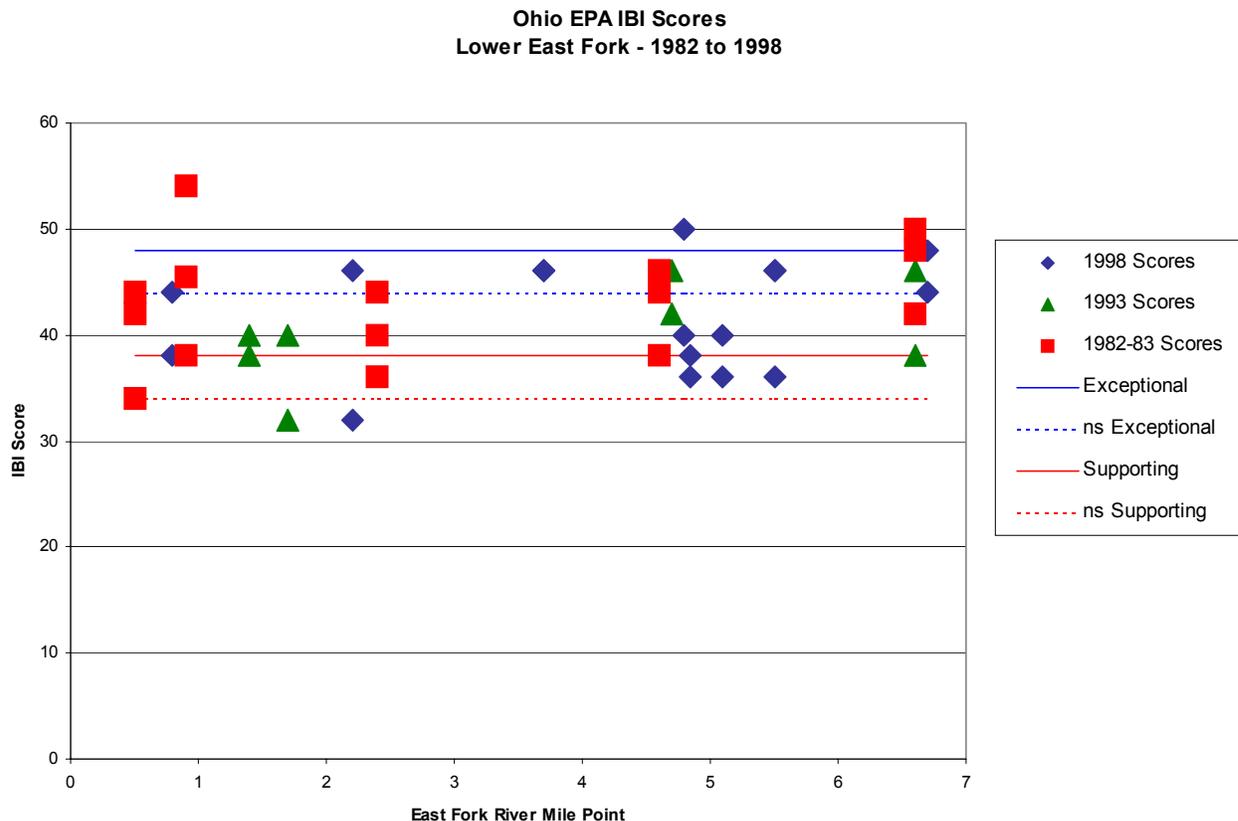
Figure 19: Results from Ohio EPA biological surveys on the Lower East Fork from 1982 to 1998.

Only 12.5 percent of the surveys resulted in index scores that meet the exceptional warmwater habitat criterion of 48. A total of 42.5 percent of surveys had IBI scores equal to or greater than 44, which is within the range of “non-significant departure” from the established criterion. Although few surveys met the EWH

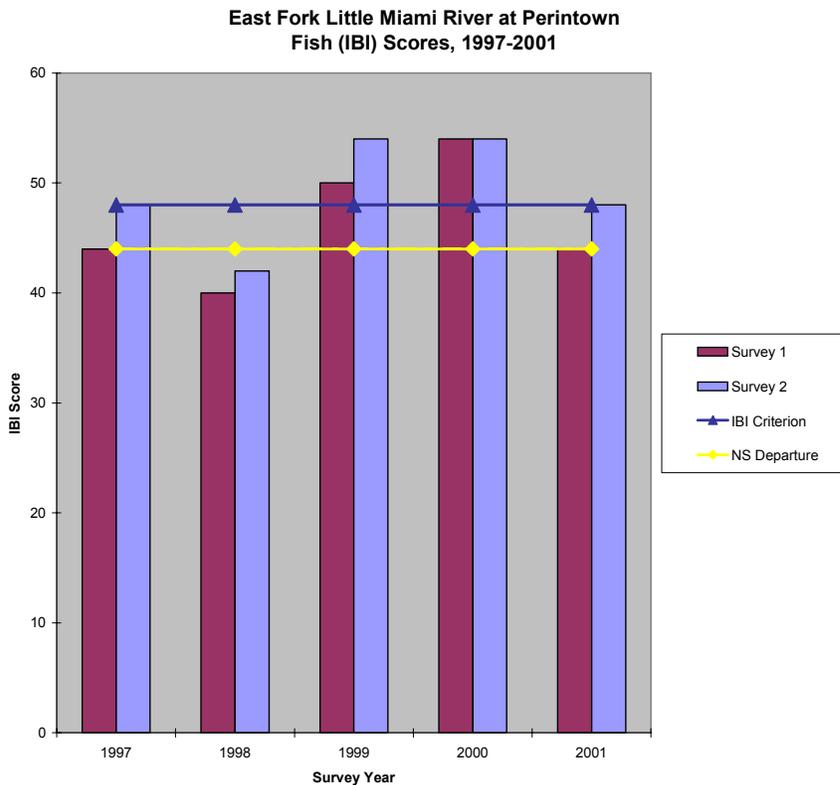
Figure 20: Clermont County fish results from East Fork surveys from 1997 to 2001.

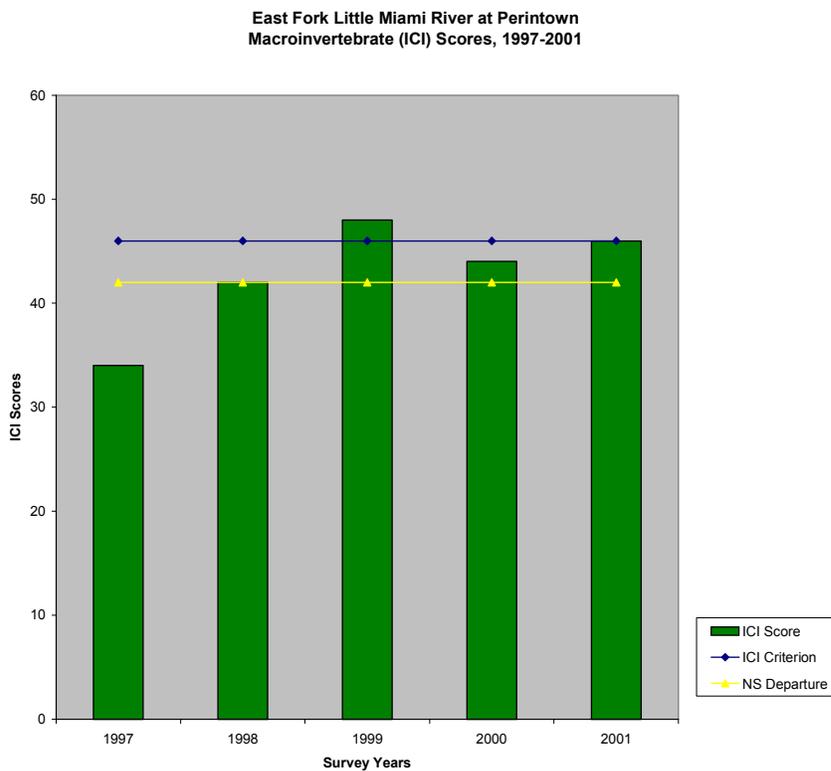
Figure 21: Clermont County macroinvertebrate results from East Fork surveys from 1997 to 2001.

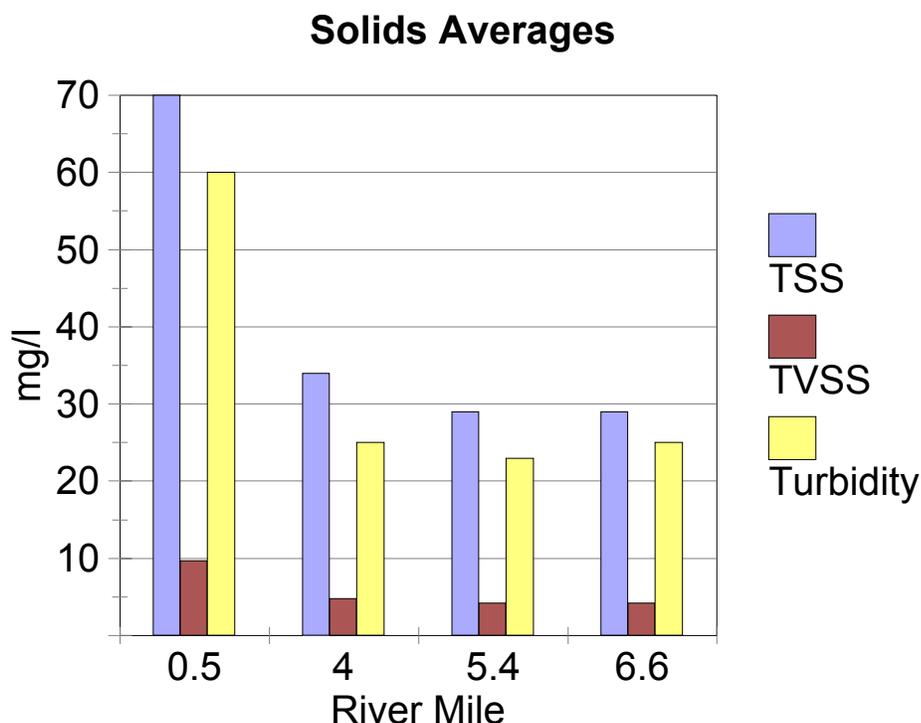
Figure 22: Solids averages at the Lower East Fork sampling locations.

Results indicate that average solids concentrations significantly increase downstream. In particular, average concentrations are very similar for RM 4.0, RM 5.4 and RM 6.6, however, they significantly increase at RM 0.5 (Figure 22).

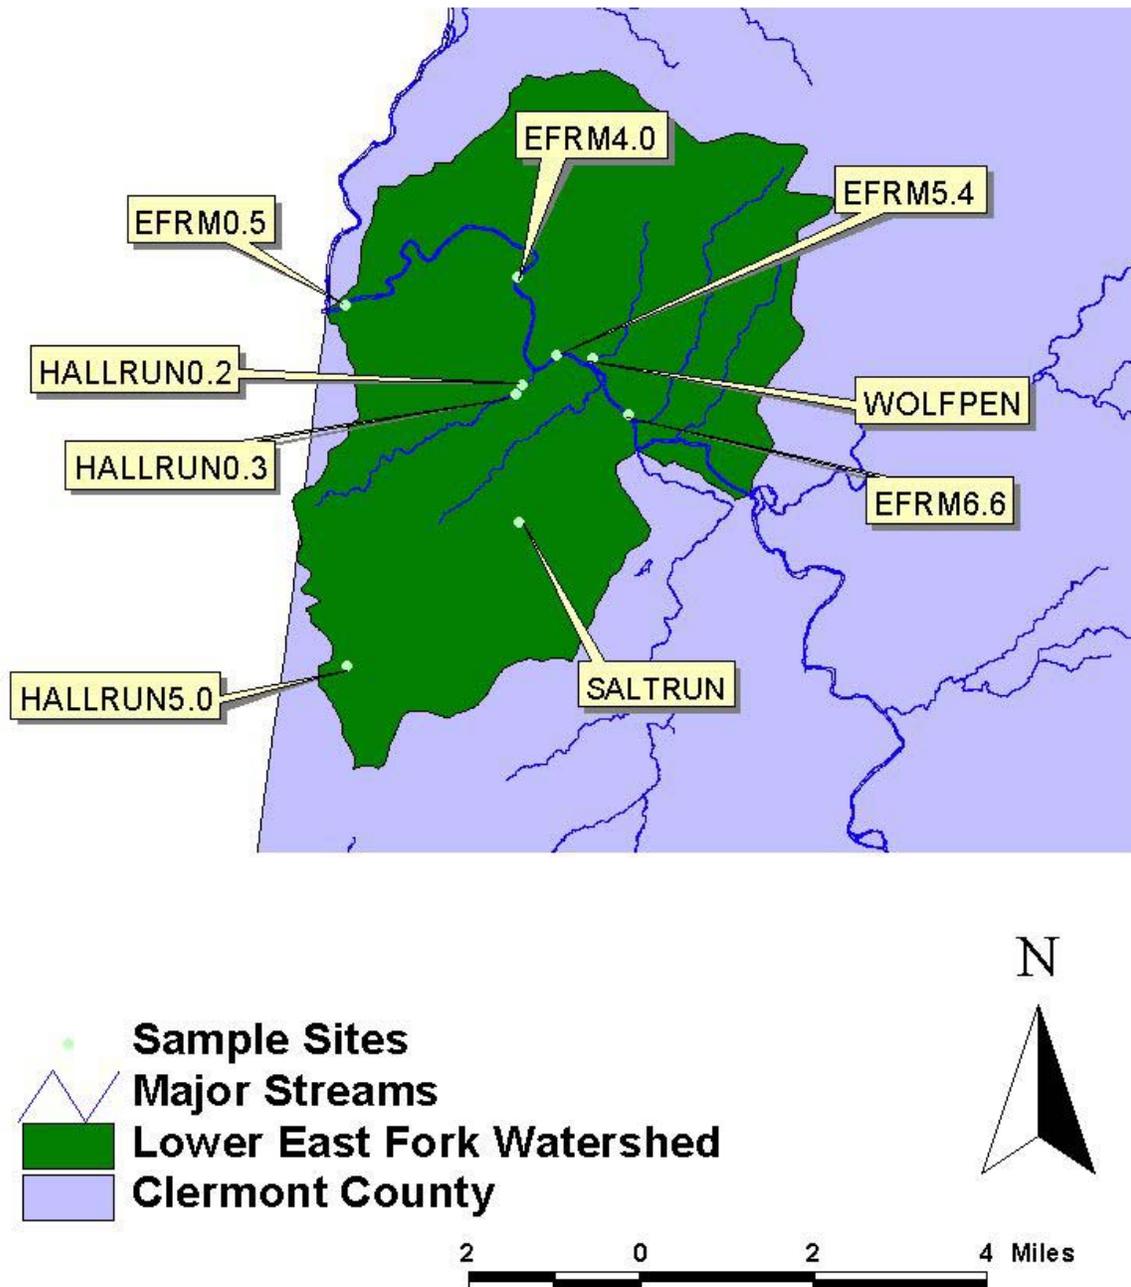
Lower East Fork Sample Sites

Figure 19: Location of sampling sites within Lower East Fork subwatershed.

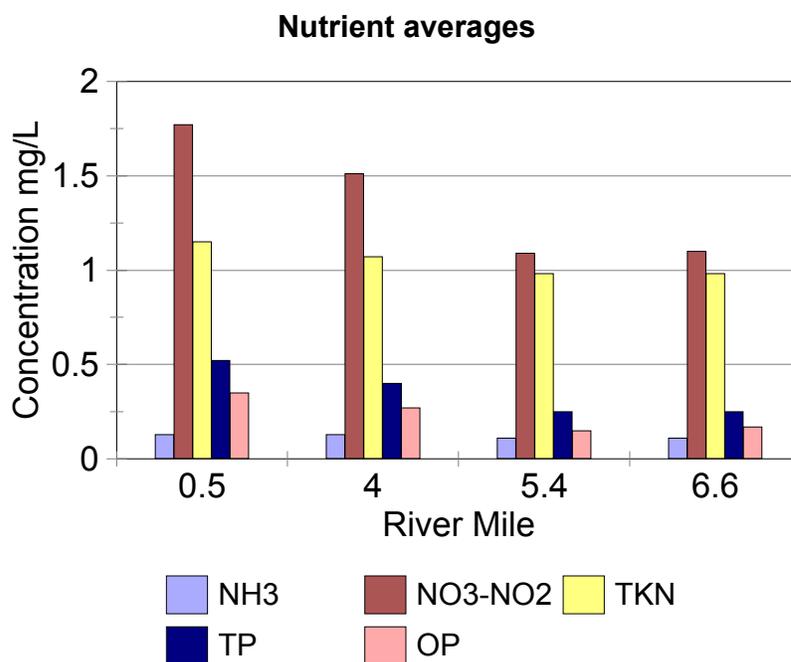
Figure 24: Nutrient averages at the sampling locations along the East Fork River.

Criteria have not yet been established for either orthophosphate or TKN. Average values for TKN on the main stem appear to be relatively steady for all of the sampling years, however, values appear to increase slightly downstream (Figure 24).

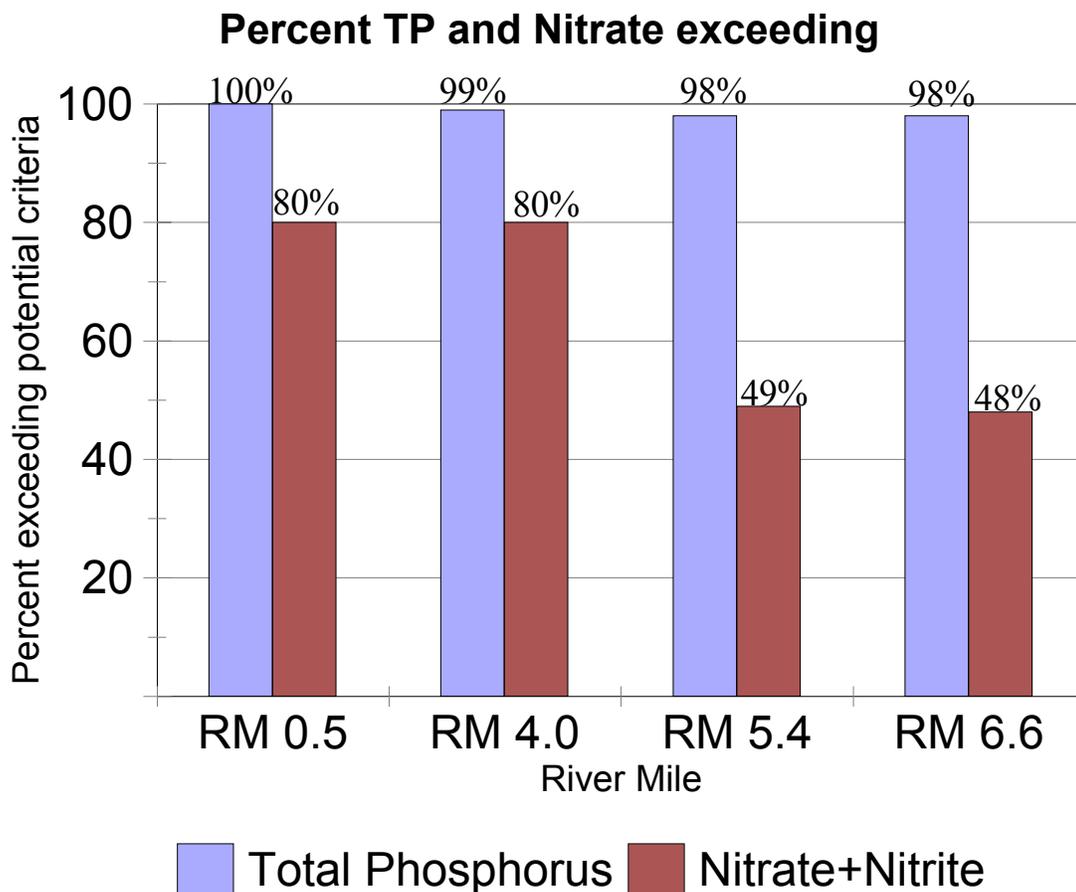
Figure 25: Percent Total Phosphorus and NO₃-NO₂ exceeding Ohio EPA benchmarks at the Lower East Fork sample sites.

The primary pollutant of concern in the lower East Fork main stem is total phosphorus, as 98 percent or greater of the samples collected exceeded the 0.1 mg/L benchmark at all four sampling sites (Figure 25).

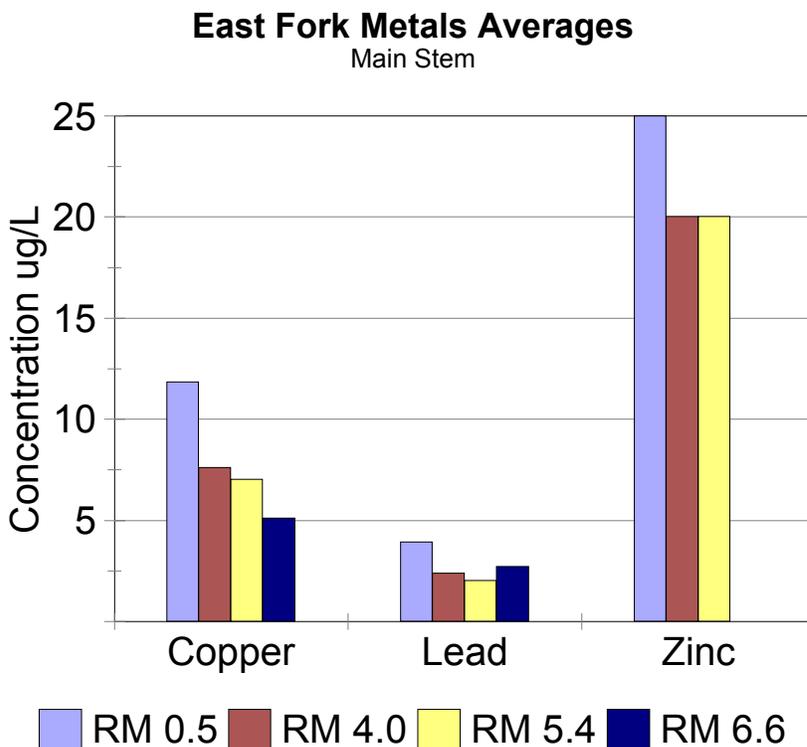
Figure 26. Metals (copper, lead and zinc) averages from the sampling locations along the East Fork River.

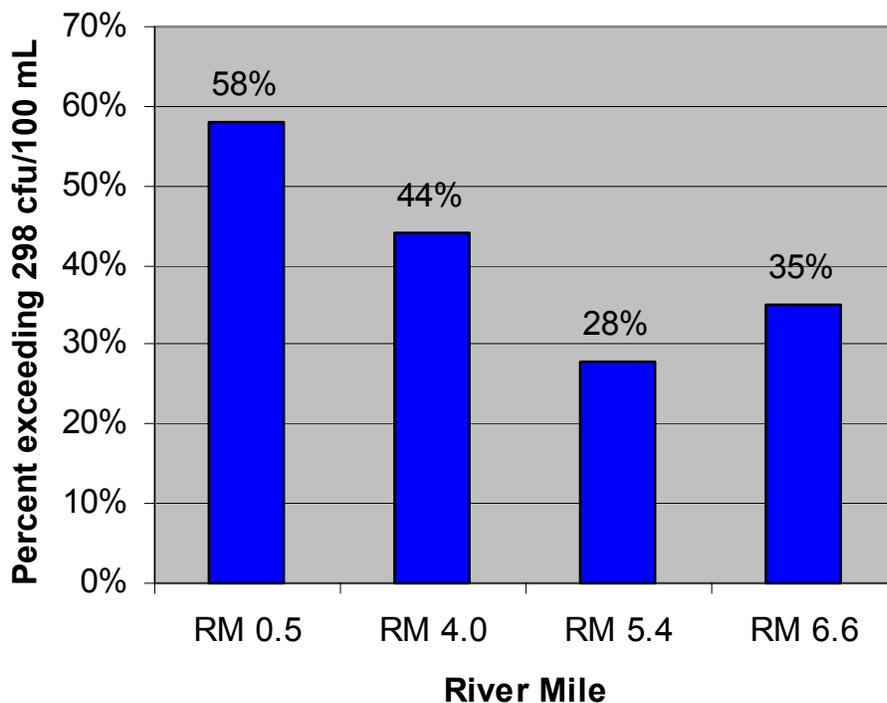
Figure 27: Percent of E. coli samples at lower East Fork sample sites exceeding 298 cfu/100 mL.

While the data collected by Clermont County cannot be directly compared to the criteria due to the frequency of sampling, the data does show concerns with E. coli concentrations at all four sampling sites along the main stem. At RM 0.5, 58 percent of samples exceeded 298 cfu/100 mL with concentrations reaching 18,000 cfu/100 mL. The percentage of samples ex-

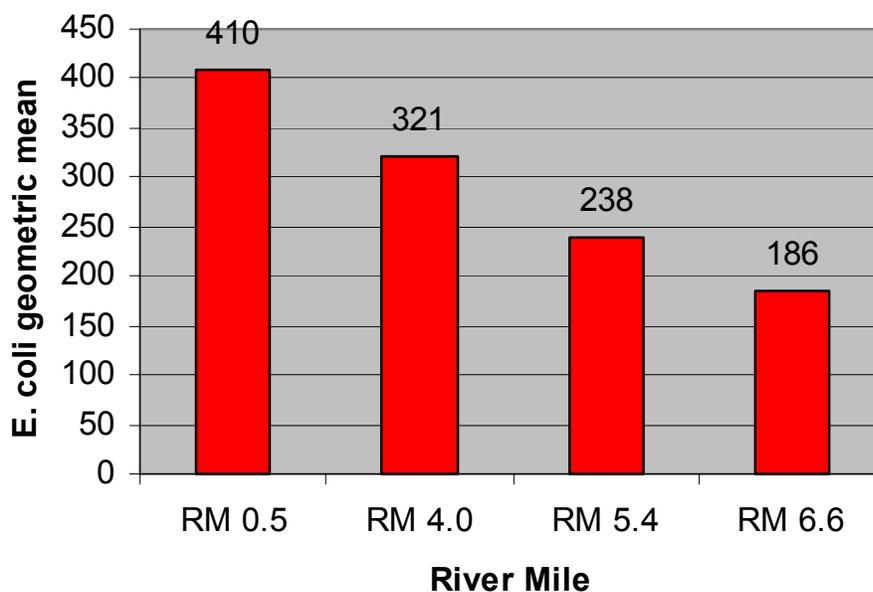
E. coli Geometric Means, 1998-2002

Figure 28: E. coli geometric means for sampling locations along the East Fork River.

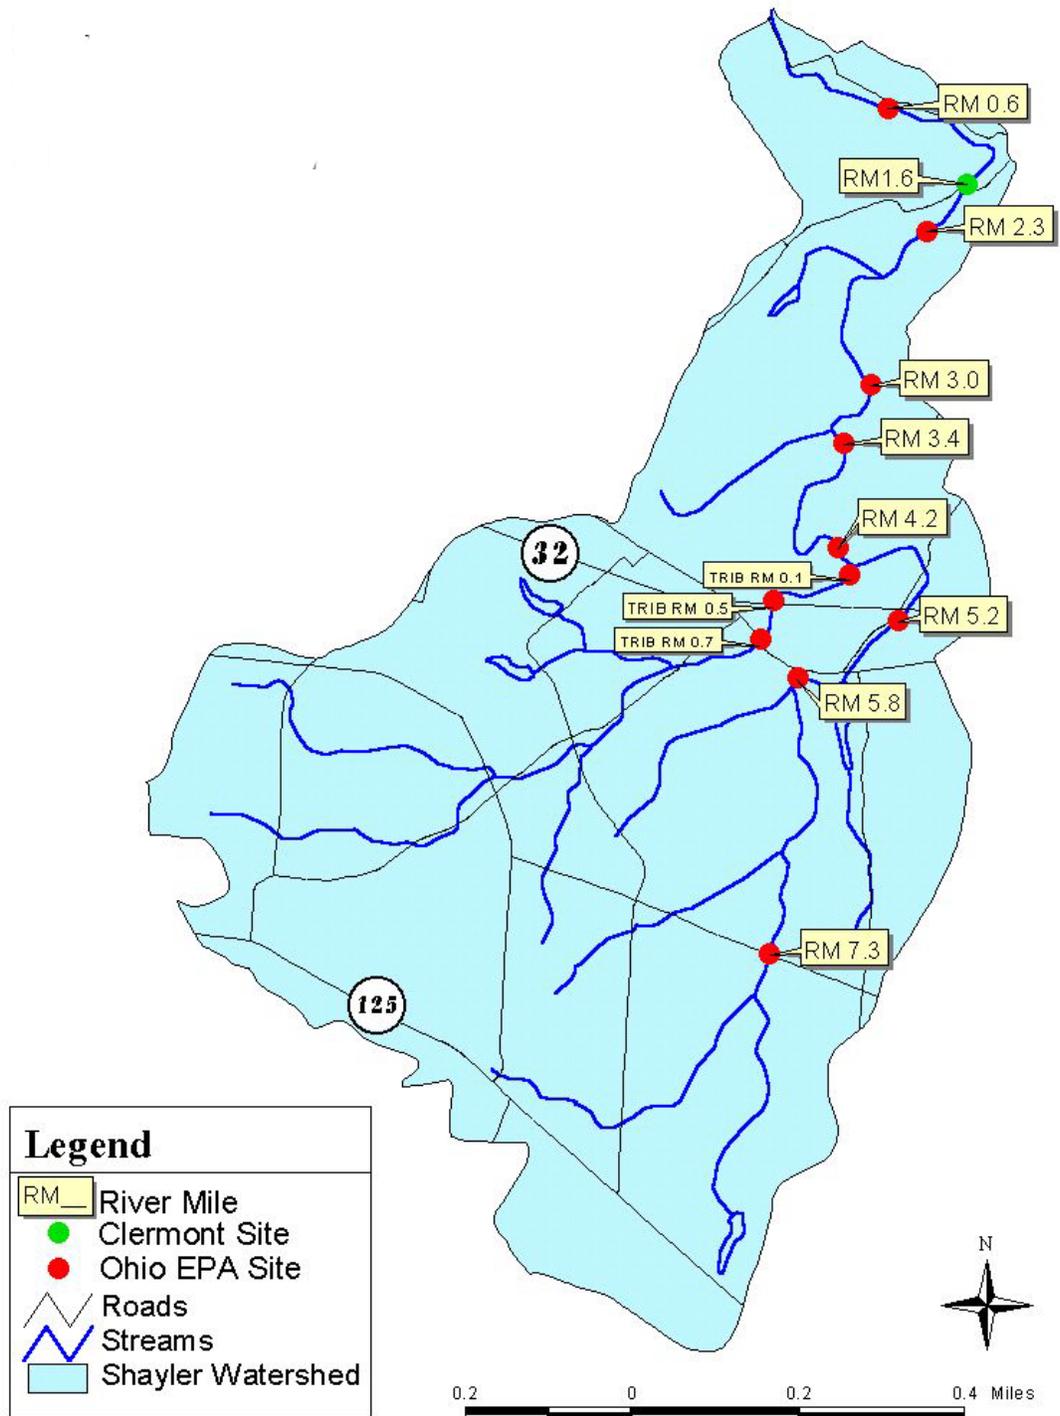
Figure 29: Biological sampling locations in the Shayler Run subwatershed

Each year since 1997, Clermont County has collected water chemistry samples from Shayler Run downstream of the Baldwin Road bridge (river mile 1.6) (Figure 29). From 1997 through 2001, ambient stream samples were collected once every two weeks from May through October. Samples were analyzed for a variety of pollutants, including bacteria, nutrients, metals, solids, dissolved oxygen (DO), biochemi-

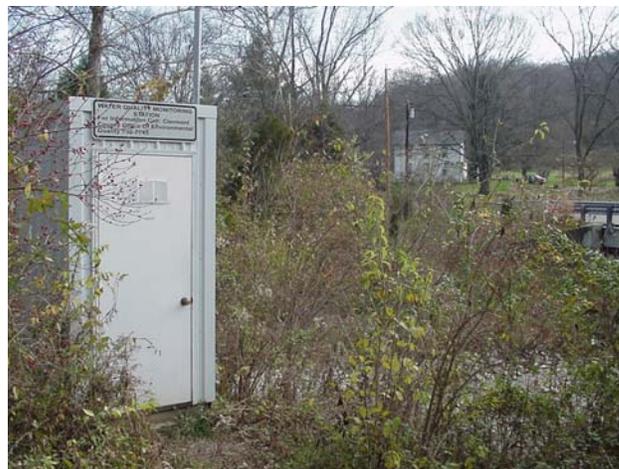
Figure 30: Shayler Run autosampling station, Baldwin Rd.
