**East Fork Little Miami River
Watershed Action Plan**

Lower East Fork Watershed Management Plan 2003

December 2003

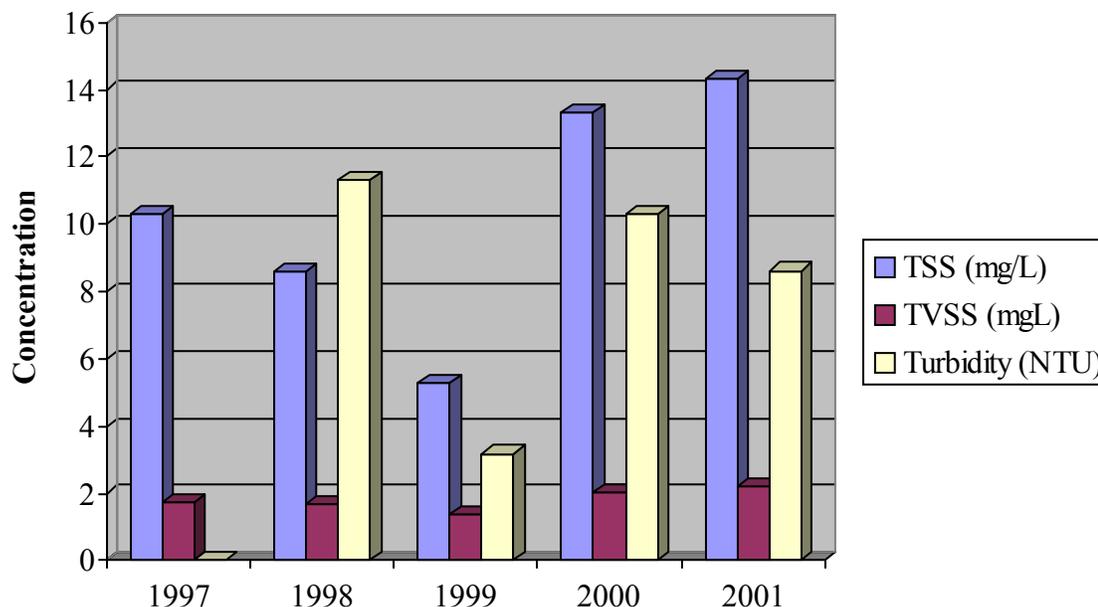
Figure 31: Annual average ambient concentrations of solids and turbidity in Shayler Creek, 1997-2001.

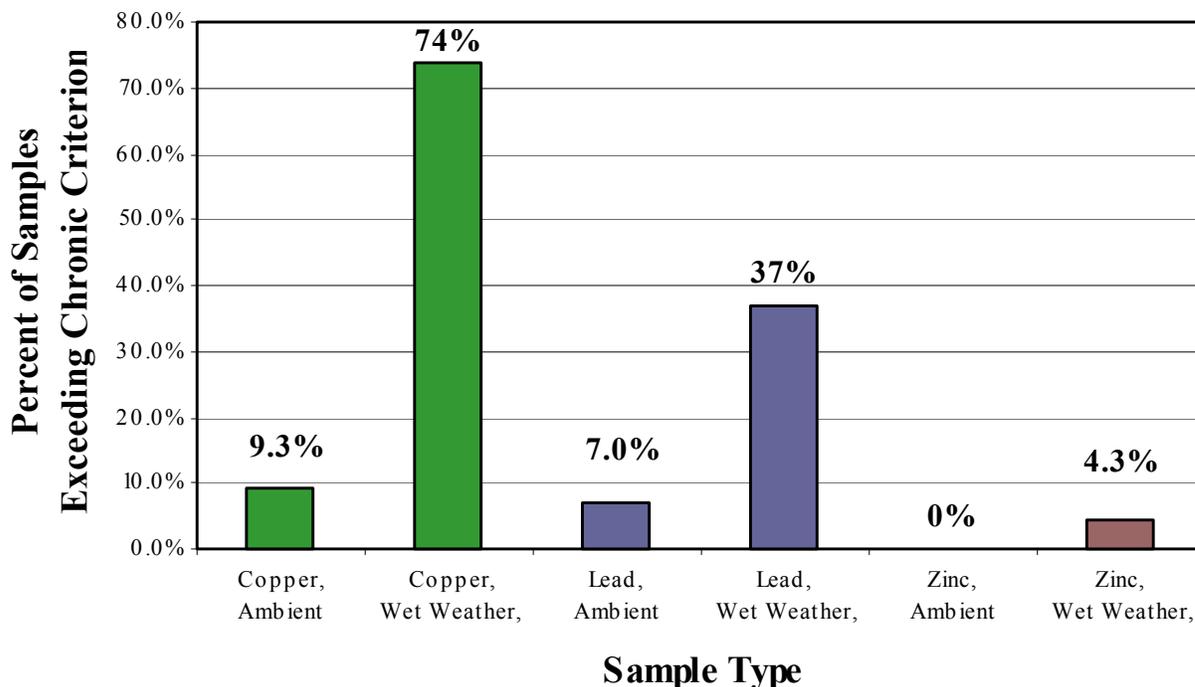
Figure 32: Percent of ambient and wet weather samples that exceed chronic aquatic life criteria established by Ohio EPA for copper, lead and zinc.

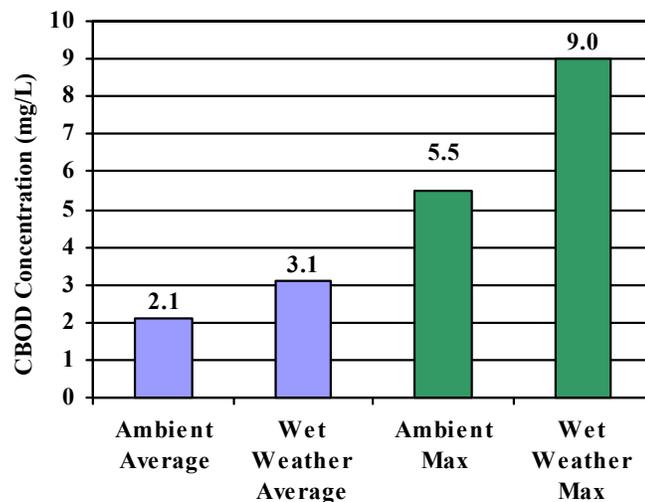
Figure 33: Comparison of ambient and wet weather CBOD₅ concentrations, Shayler Creek at Baldwin Road, 1997-2001

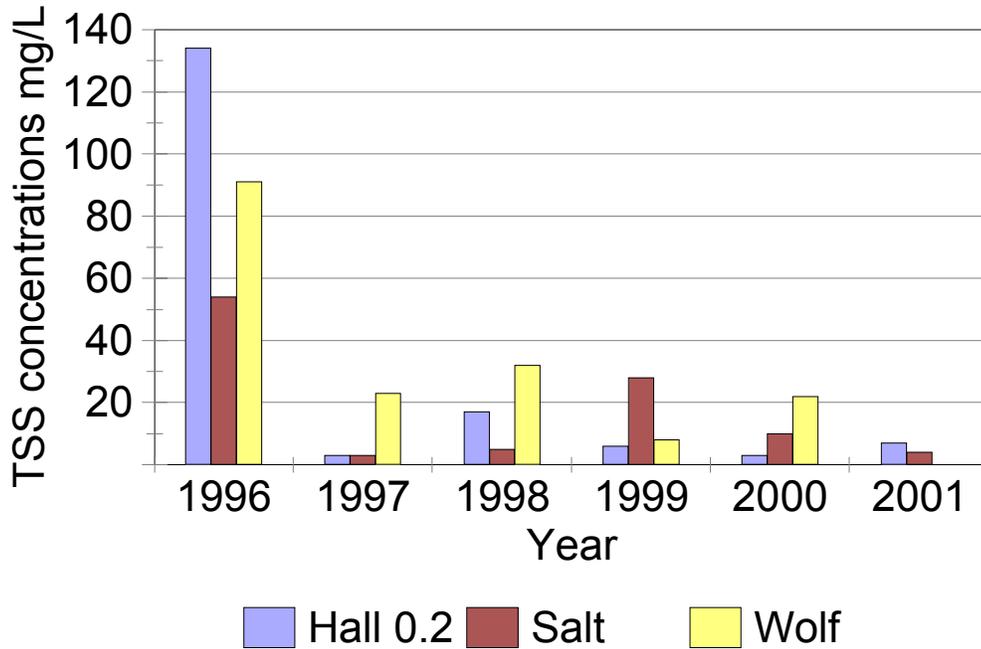
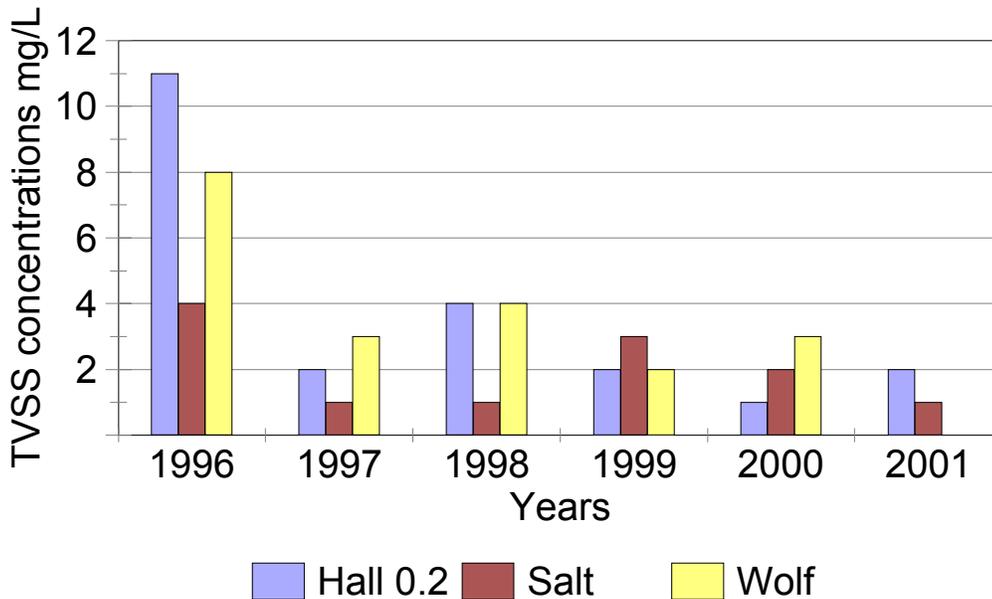
Figure 34: Annual average TSS concentrations (a) and TVSS concentrations (b) at Hall Run RM 0.2, Salt Run and Wolfpen Run.

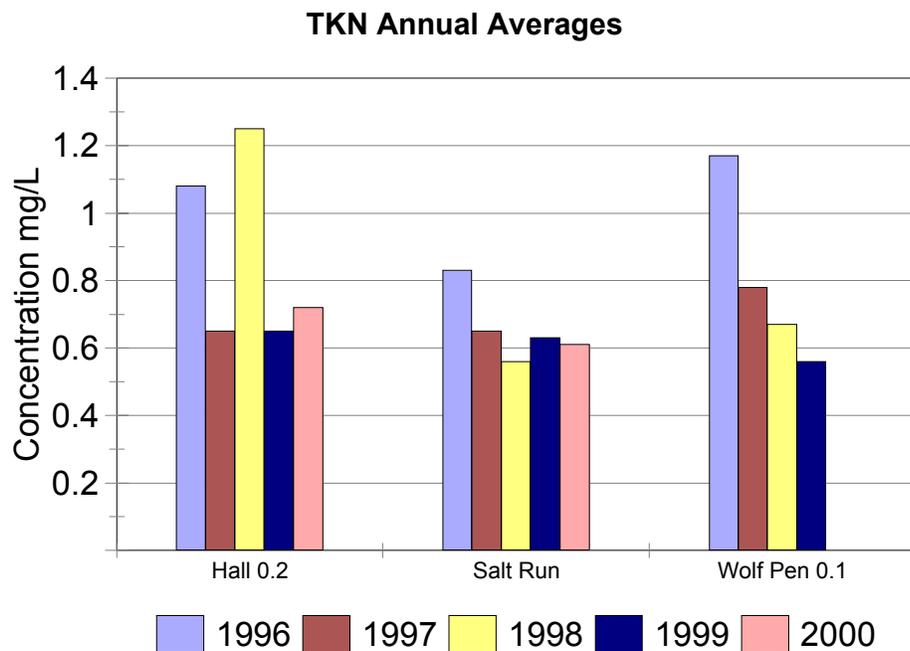
Figure 35: Annual TKN averages for tributaries to the Lower East Fork River.

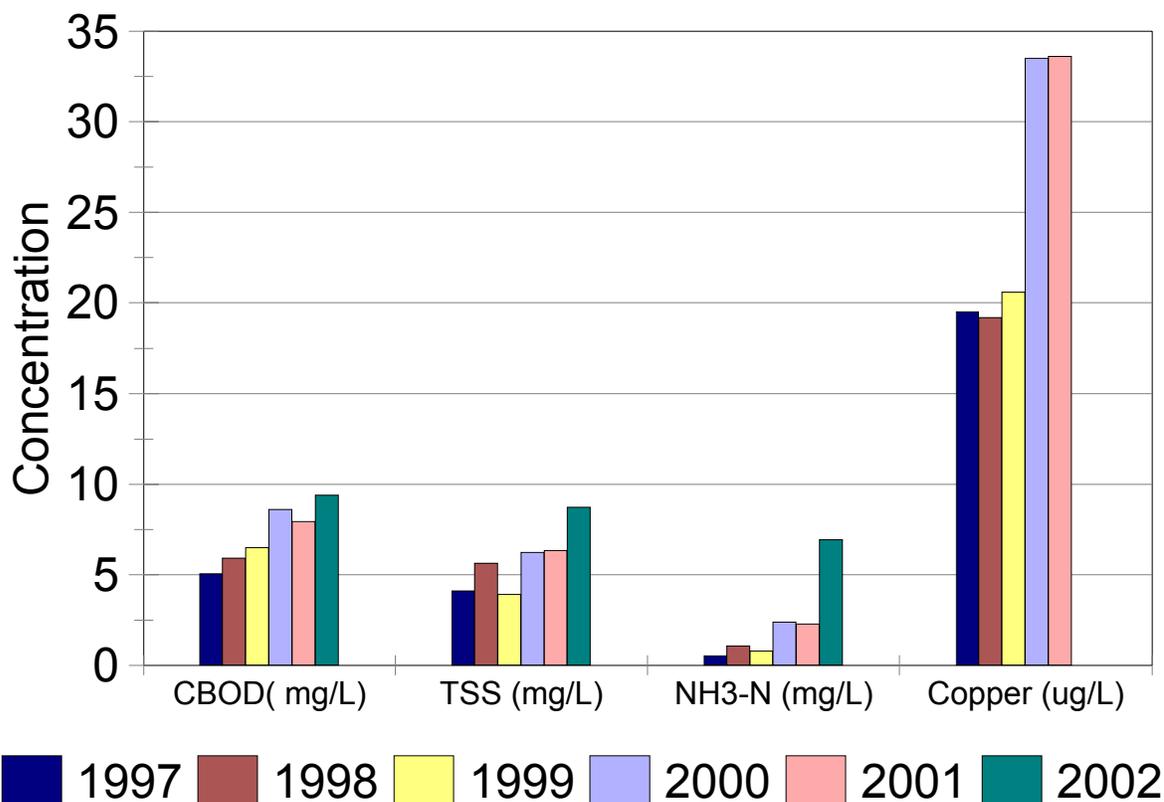
Effluent Concentration Lower East Fork WWTP

Figure 36: Summary of Lower East Fork WWTP effluent concentrations from 1997 to 2002

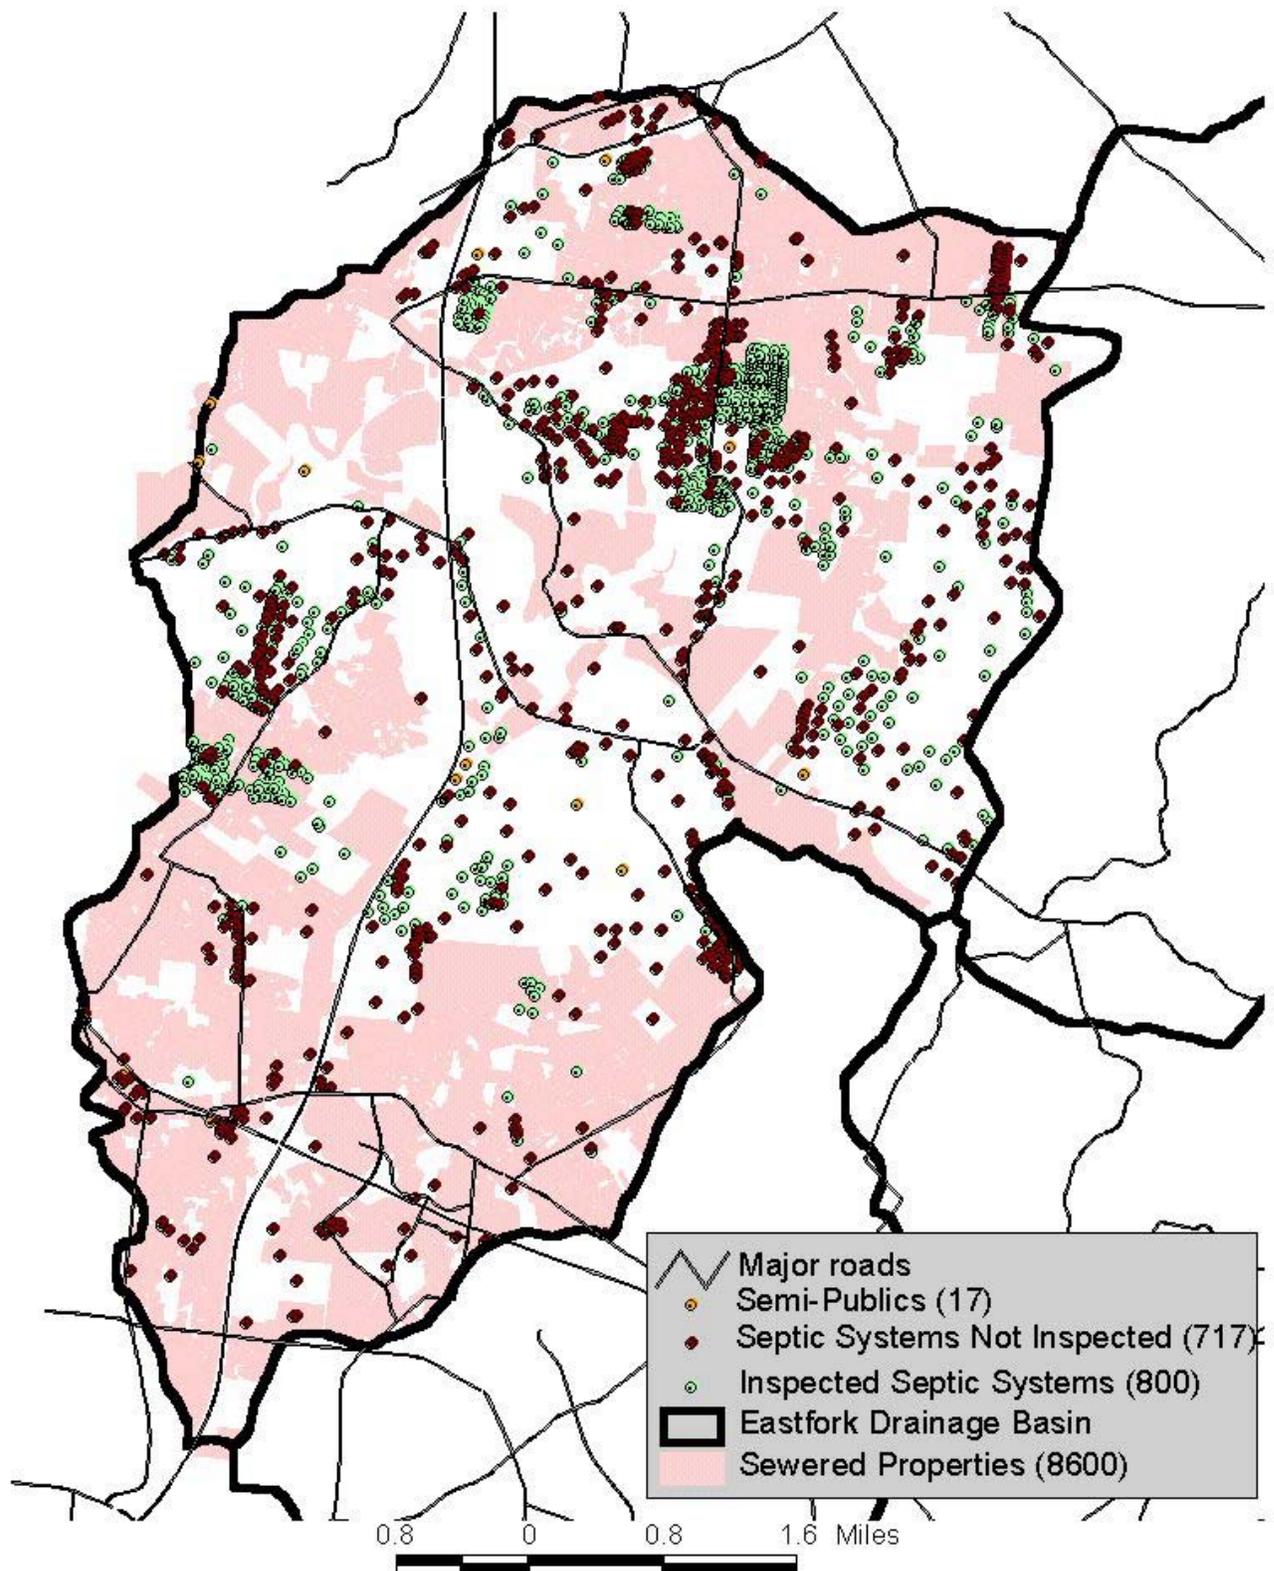
Figure 37: Distribution of residential and semi-public onsite systems within the Lower East Fork subwatershed.

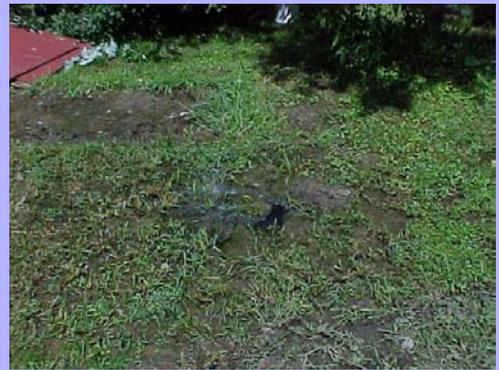
Conventional septic systems typically release wastewater effluent into subsurface drainage tiles to absorb into the surrounding soil. In suitable soils, this effluent will infiltrate into the ground where it causes minimal risk to surface waters.

Having the septic tank pumped out at intervals determined by the scum/sludge accumulation rates in the tank will prolong the life of the secondary treatment component of the septic system.

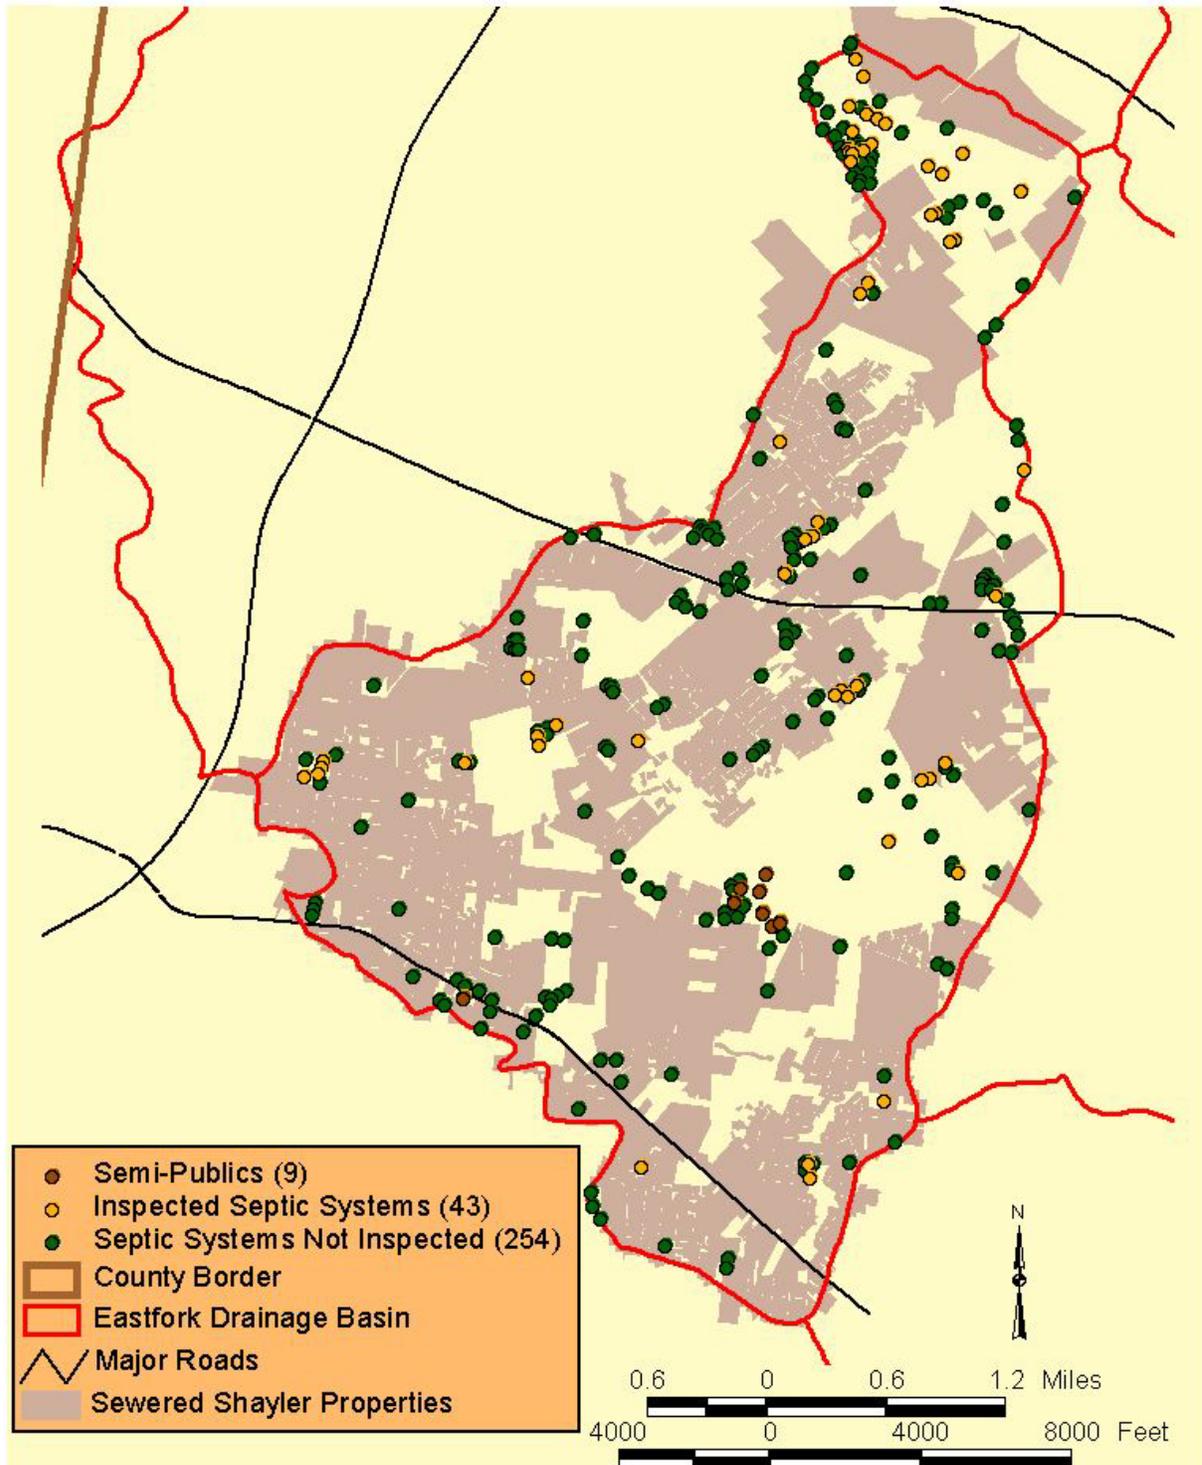
Onsite Sewage Systems In Shayler Run

Figure 38: Distribution of residential and semi-public onsite systems within the Shayler Run subwatershed.

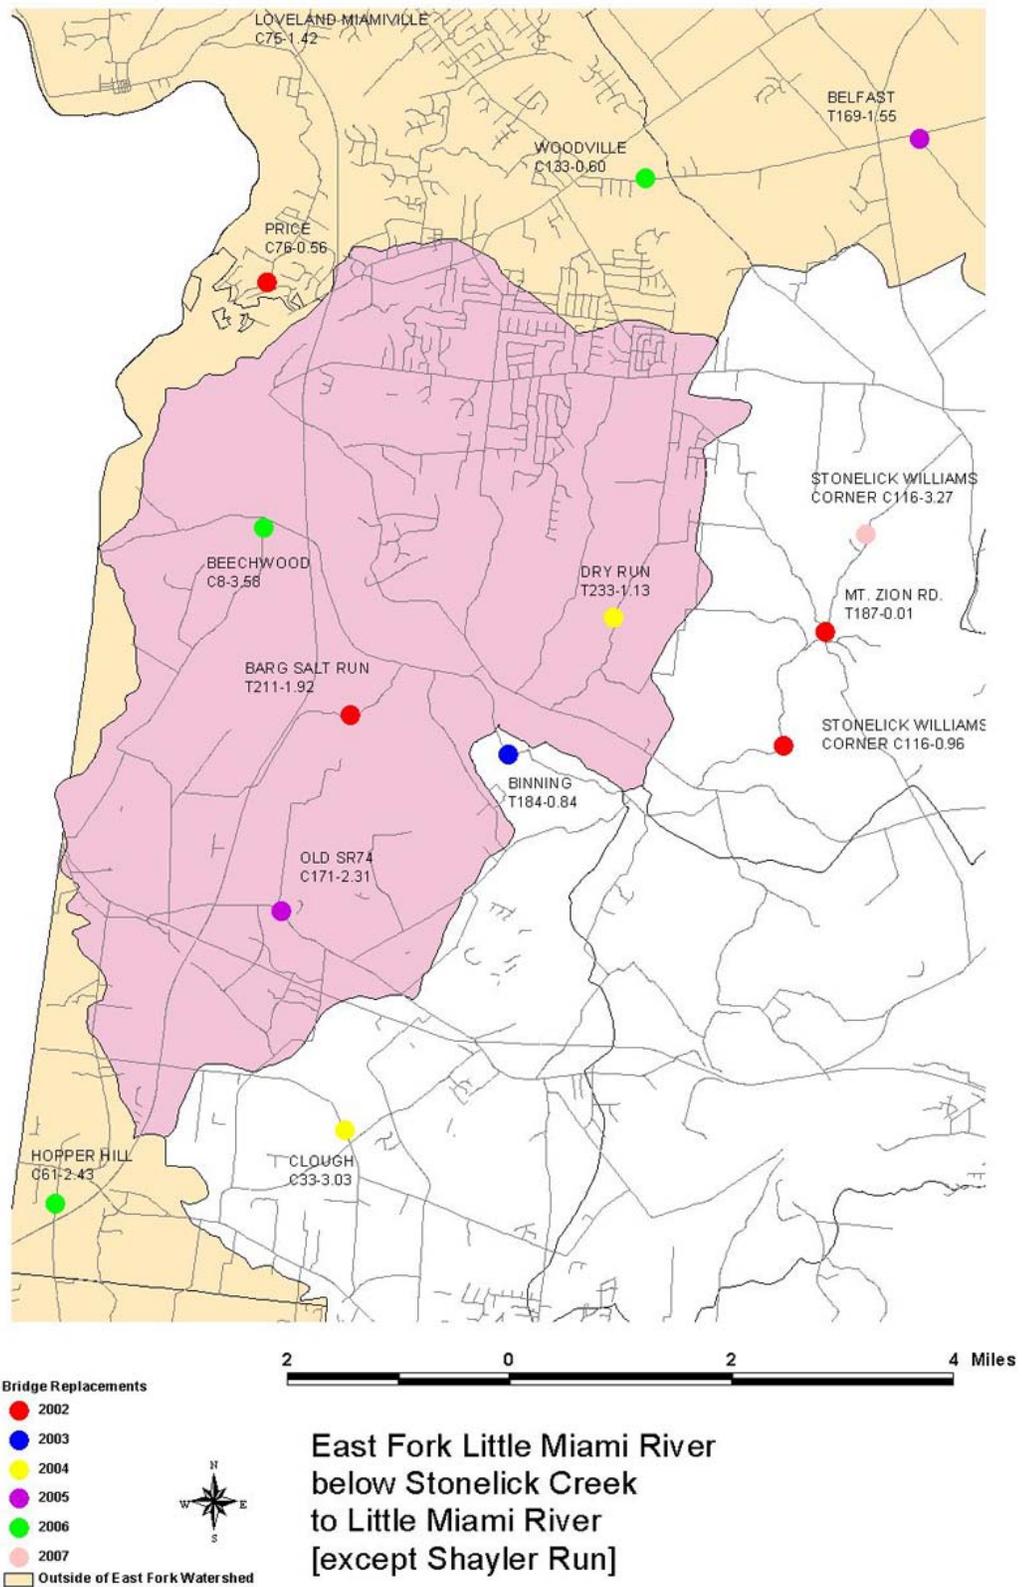
Figure 39: Location of bridges to be replaced in Lower East Fork subwatershed by 2007.

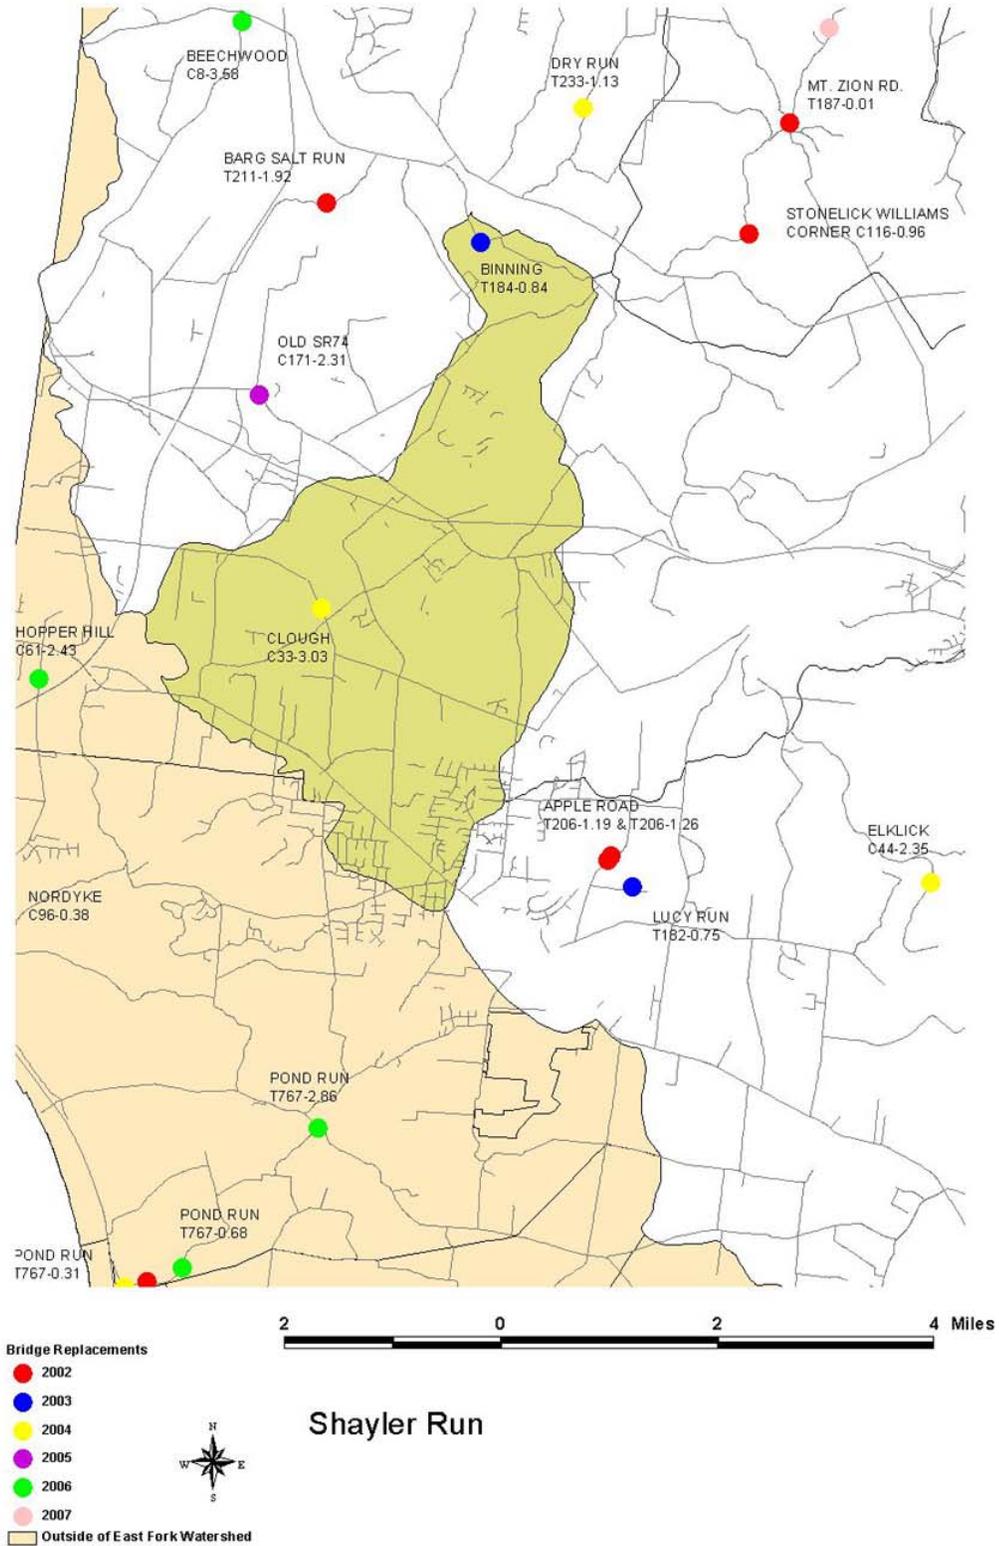
Figure 40: Location of bridges to be replaced in the Shayler Run subwatershed by 2007.
